Inspection Report

1234 Sample Dr Colorado Springs, Colorado 80919

Stan Buyer 1234 Sample Dr Page 1 of 37

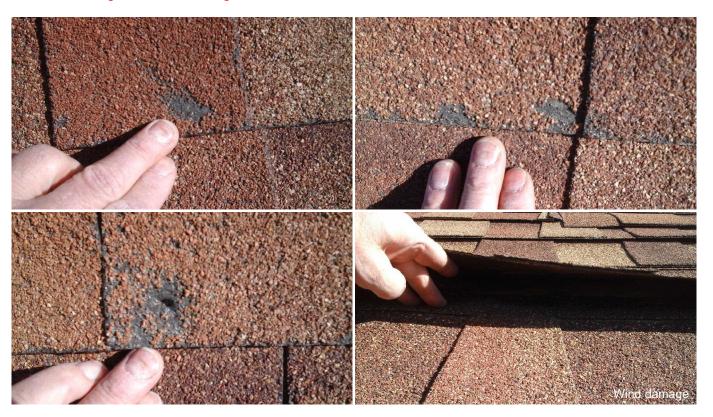
- 1. This roof is newer than the last recorded year a permit was pulled for the roof (with occupancy, 1982). You may want to consider asking the seller if they have information as to the year this roof was installed and to pull the appropriate permits and have the roof inspected by Regional Building.
- 2. There are signs of possible hail damage on the roof shingles in the form of granular loss. Recommend a licensed roofer evaluate and certify the roof.
- 3. There are signs of wind damage to the roof.
