Pro-Check Home Inspections

Property Inspection Report

10518 Sample Pt
Fountain, Colorado 80817

08/24/2018

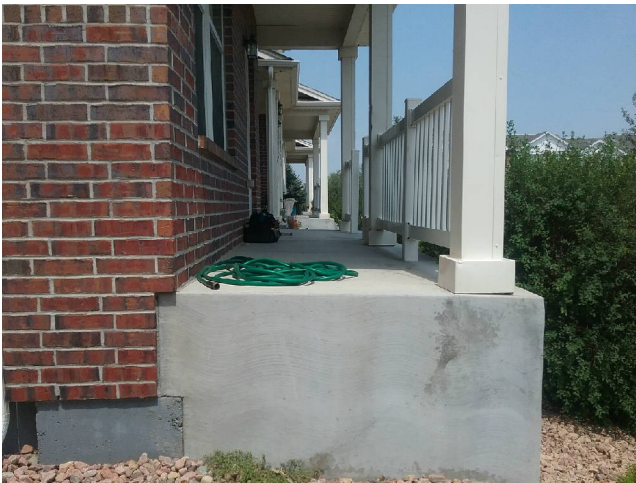
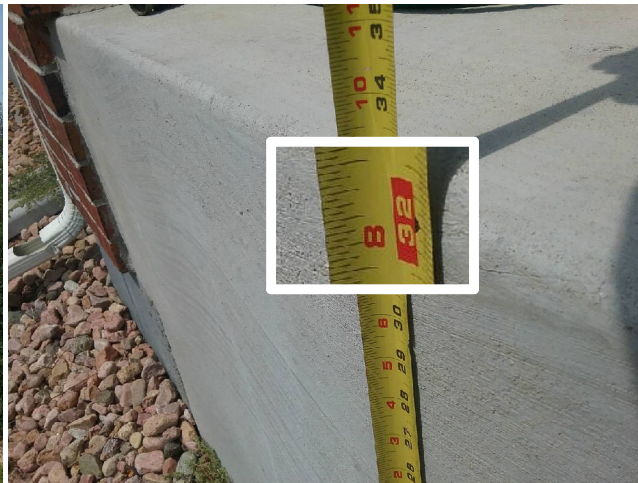
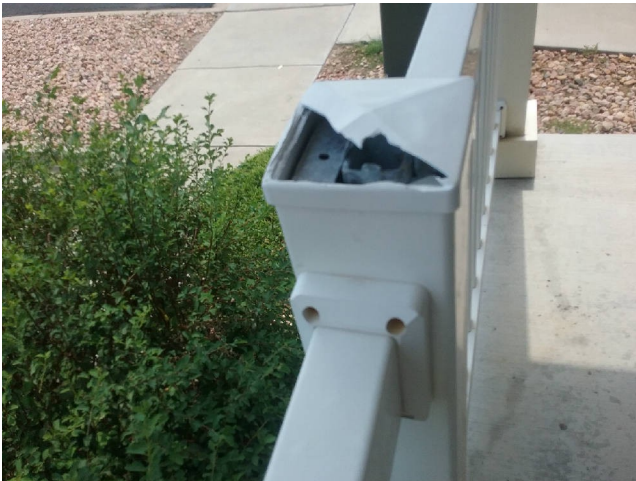
Porch: Concrete -

1. The drop off of the South end of the front porch to the ground is over 30 inches. Current building safety standards require a guardrail for any drop over 30 inches. Recommend, for safety, that a guardrail be installed.
2. There is hail damage to the front porch guardrail.

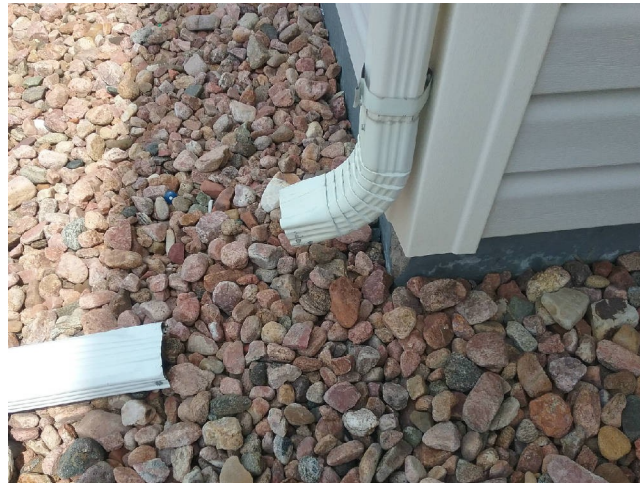
Leader/Extension: Extension needed -

We recommend installing downspout extensions where there are none currently. This is to ensure that water does not pool next to the foundation.

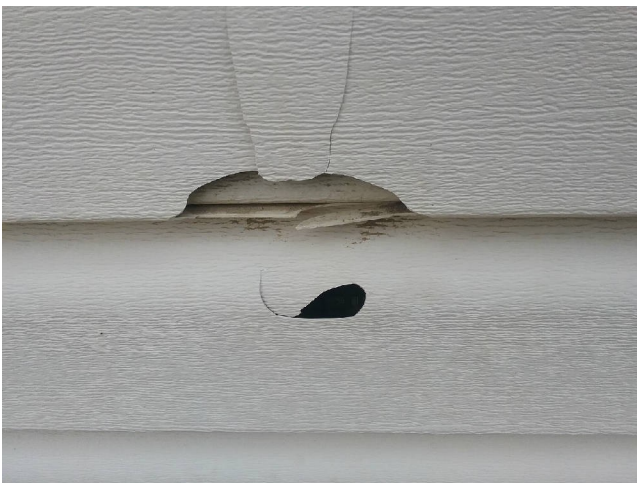
Siding type: Vinyl/Brick -

There is hail damaged to the vinyl siding.

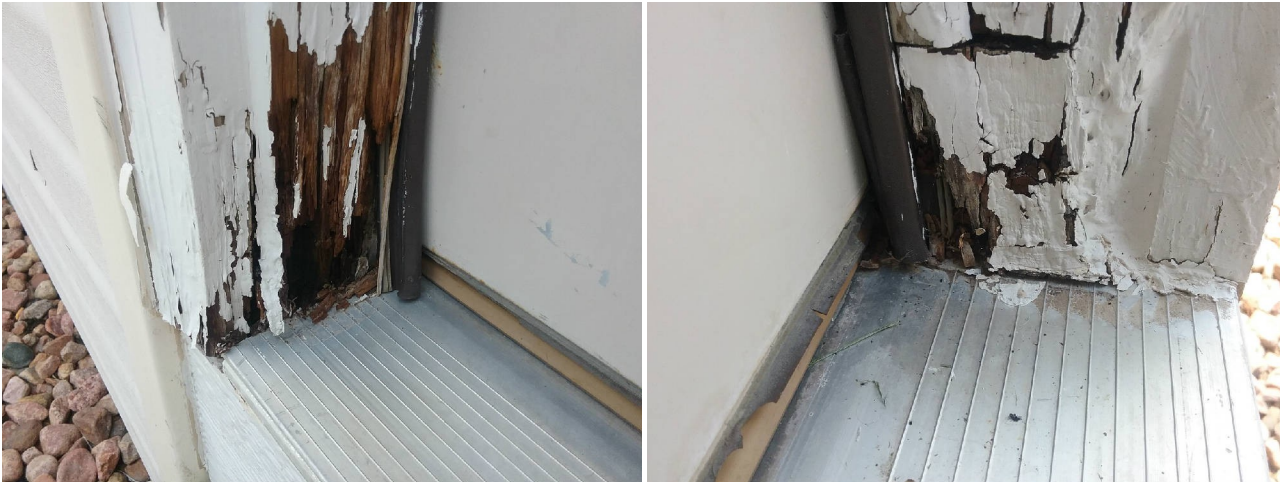
Entry Doors: Fiberglass/Metal -

1. The back entry door jamb is dry rotted at the bottom.

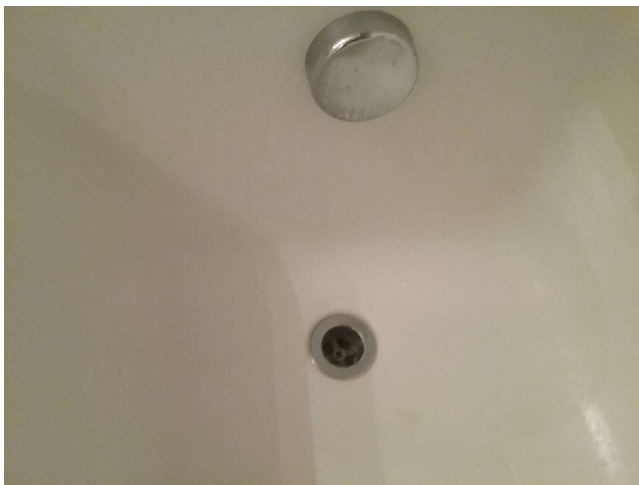
Tub/Showers: Fiberglass tub and fiberglass surround -

The 2nd floor main bathroom tub is missing it's pop-up stopper. Missing stoppers can allow small items (toys, rings, hair pins, etc.) to clog the drain.

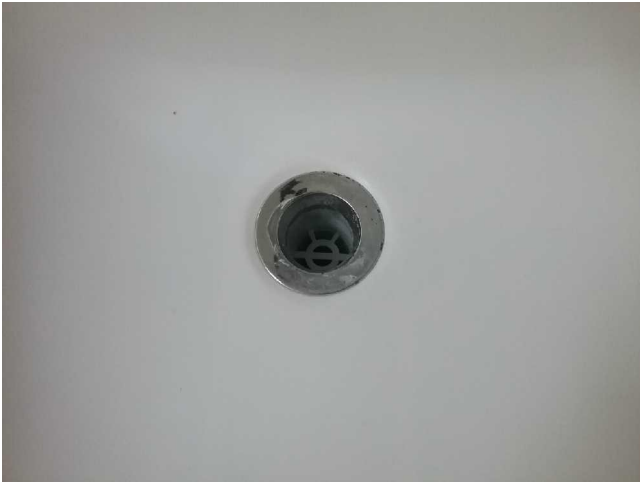
Traps & Drains: Appears functional -

The master bathroom sink is missing its pop-up stopper. Missing stoppers can allow small items (toys, rings, hair pins, etc.) to clog the drain.

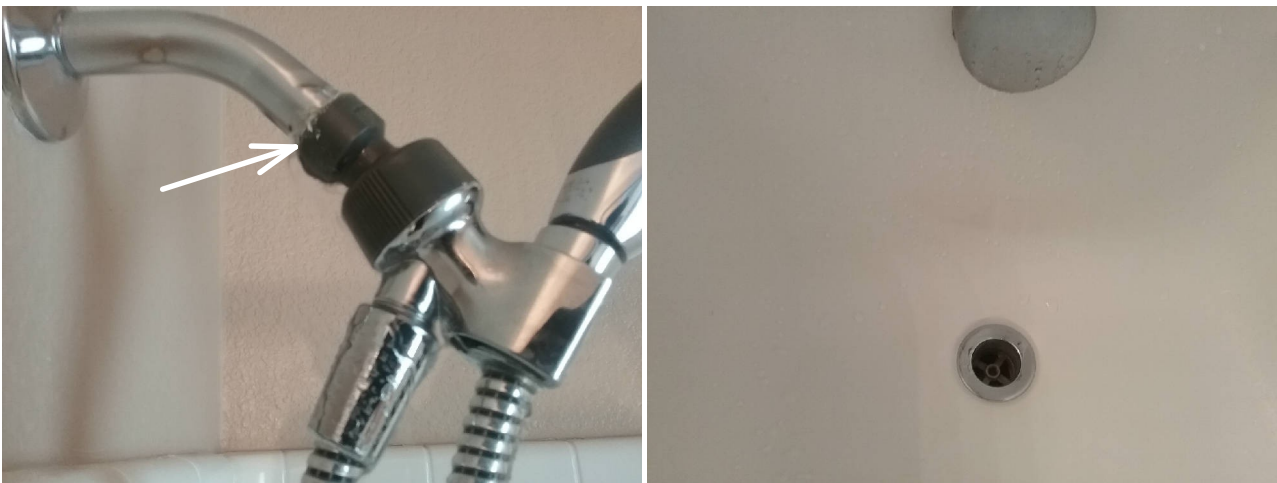
Tub/Showers: Fiberglass tub and fiberglass surround -

1. The master bathroom tub is missing its pop-up stopper. Missing stoppers can allow small items (toys, rings, hair pins, etc.) to clog the drain.

2. Water leaks from around the master bathroom shower head at the threads.

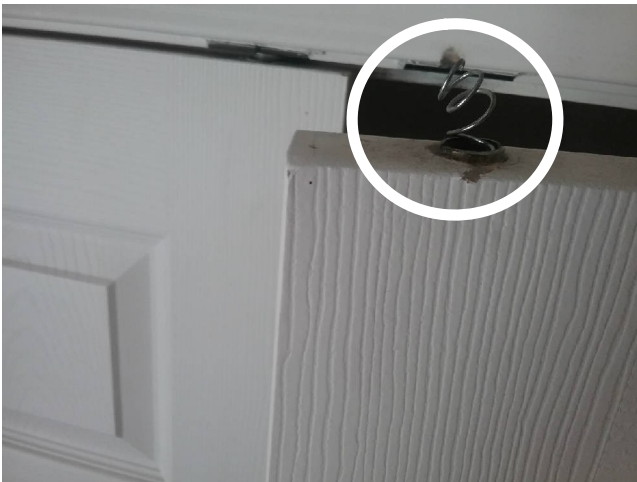
The top of the right laundry room door had missing hardware needed for the door to function properly. Recommend having appropriate hardware installed.

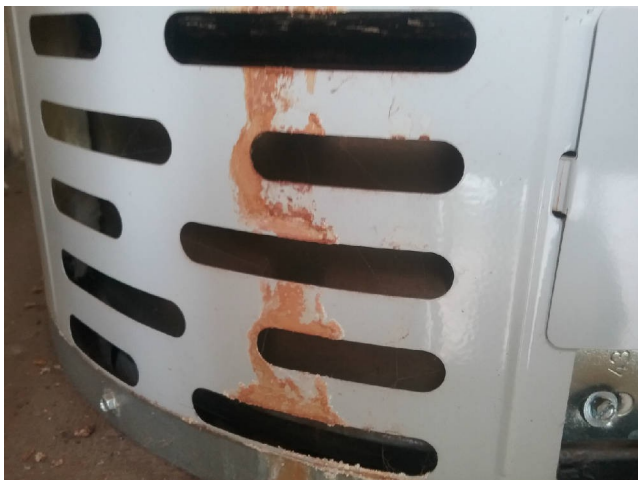
Water Heater Operation: Adequate -

There are signs of a past leak and the water heater.

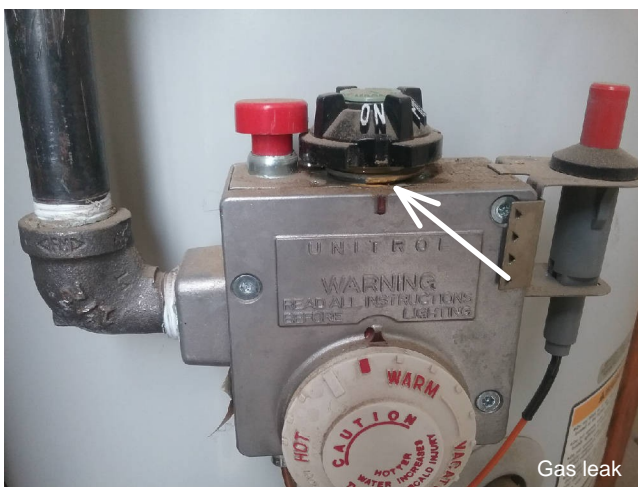
Gas Lines Check For Leaks: Yes -

While testing the gas lines with my gas detector, a gas leak was detected at the water heater gas control valve. Recommend having a licensed plumber make repairs.

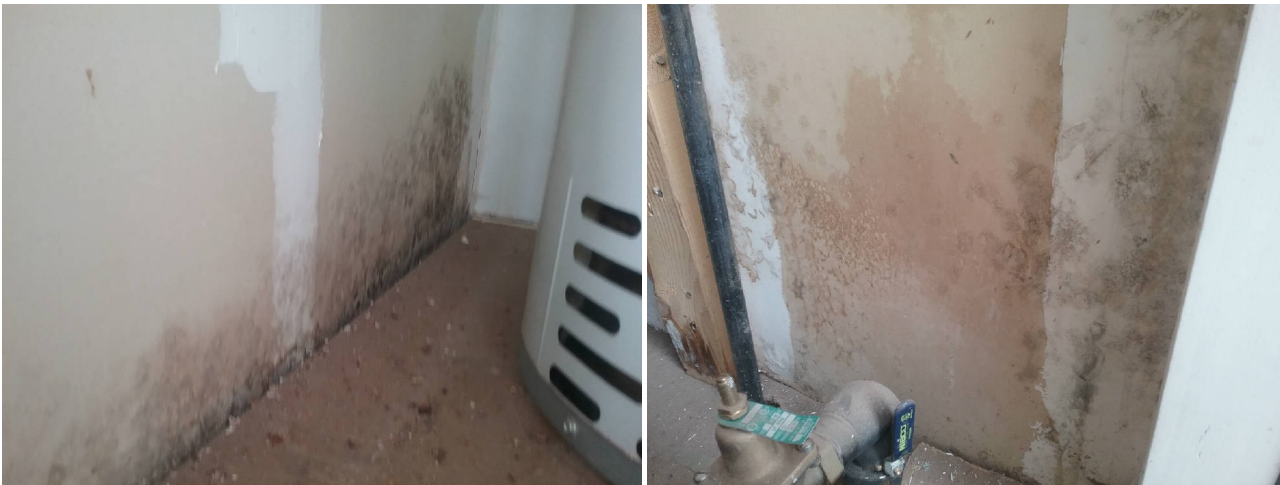
Organic Substance: Utility closet -

There is a black mold like substance in the water heater utility closet.

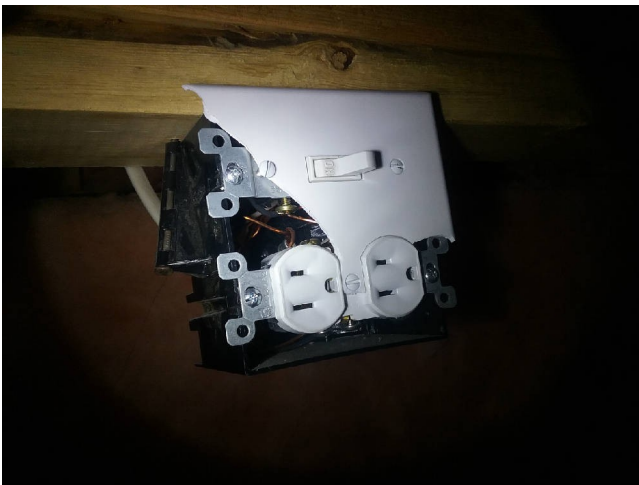
Electrical: 110 VAC -

The crawlspace Switch/outlet cover plate is broken.

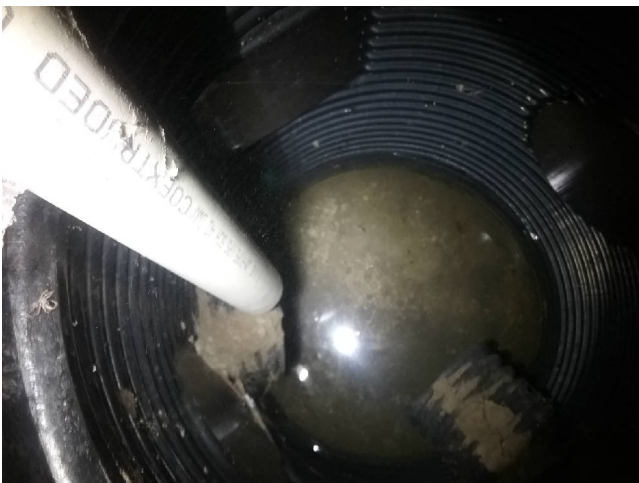
Sump Pump: Not Present -

There is a sump pit that is holding water with no sump pump installed. Recommend monitoring this after storms to see if a pump may need to be installed.

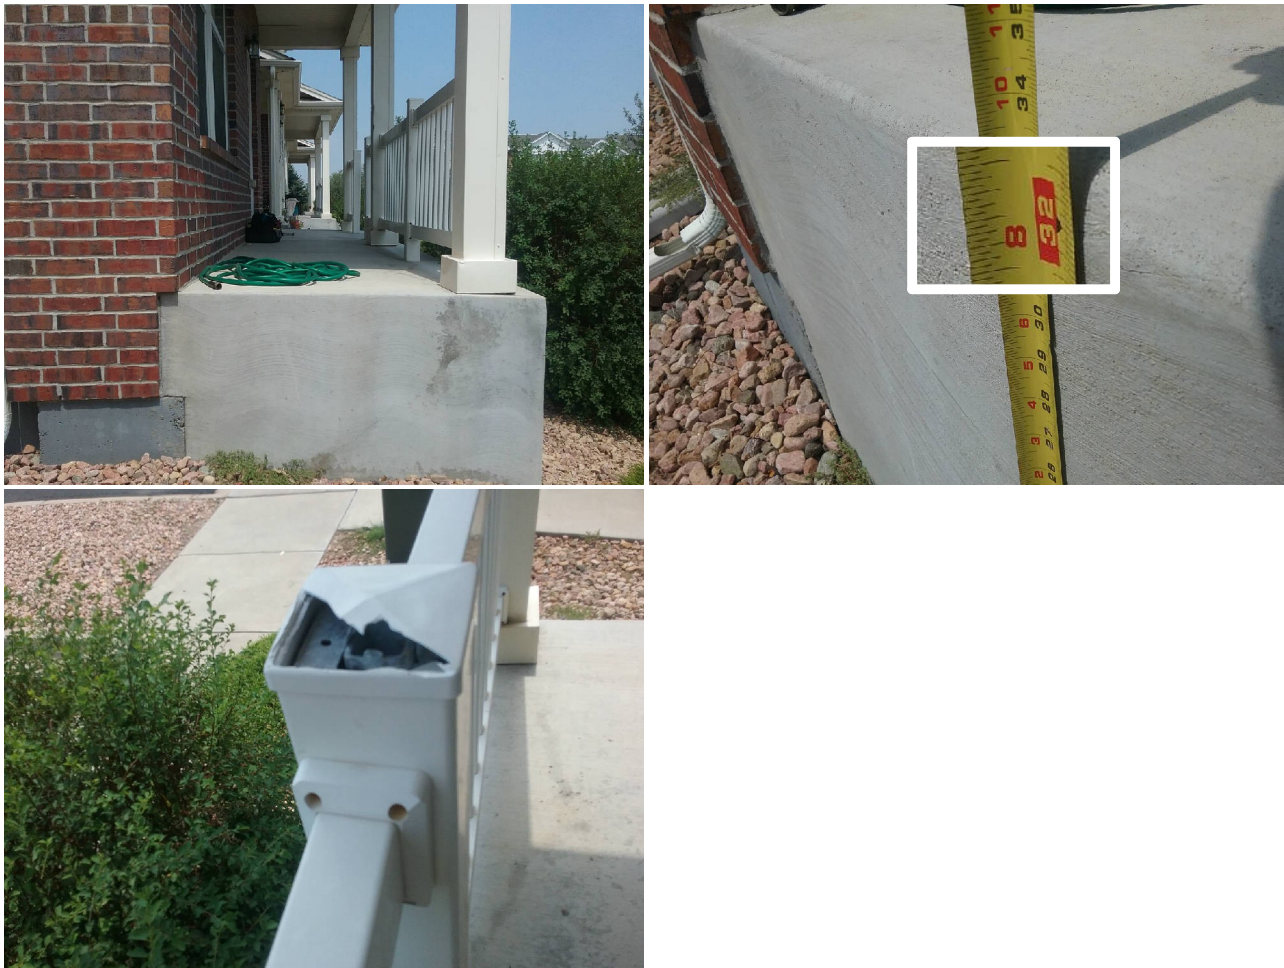
1. Porch: Concrete -

1. The drop off of the South end of the front porch to the ground is over 30 inches. Current building safety standards require a guardrail for any drop over 30 inches. Recommend, for safety, that a guardrail be installed.
2. There is hail damage to the front porch guardrail.

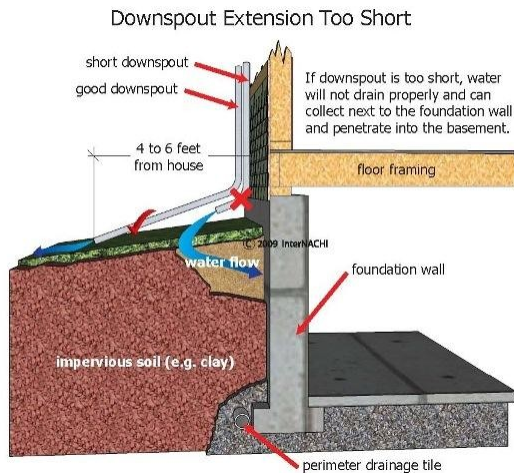
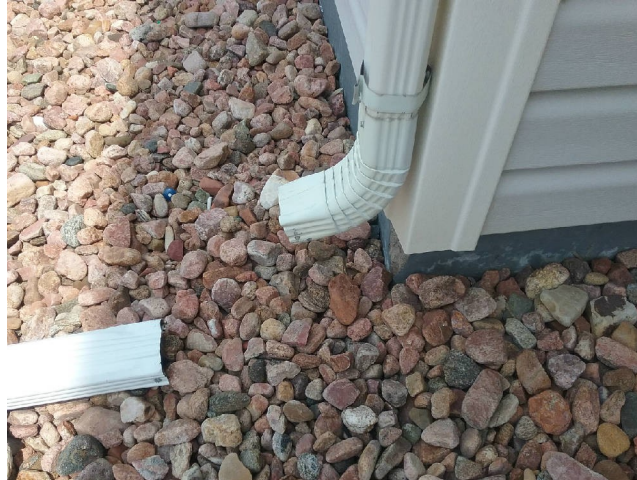
2. Leader/Extension: Extension needed -

- We recommend installing downspout extensions where there are none currently. This is to ensure that water does not pool next to the foundation.

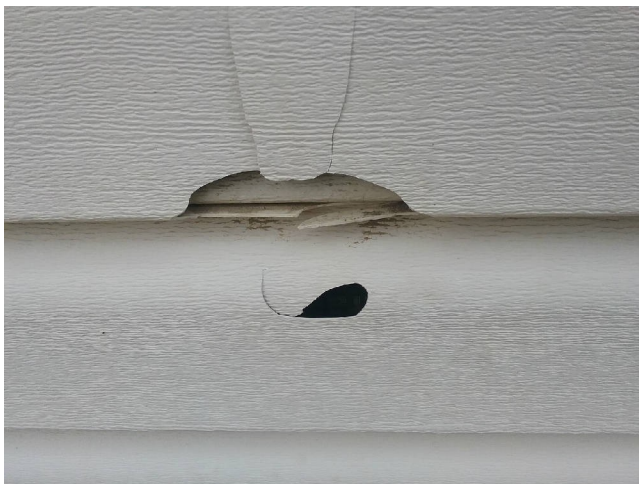
3. Siding type: Vinyl/Brick -

There is hail damaged to the vinyl siding.

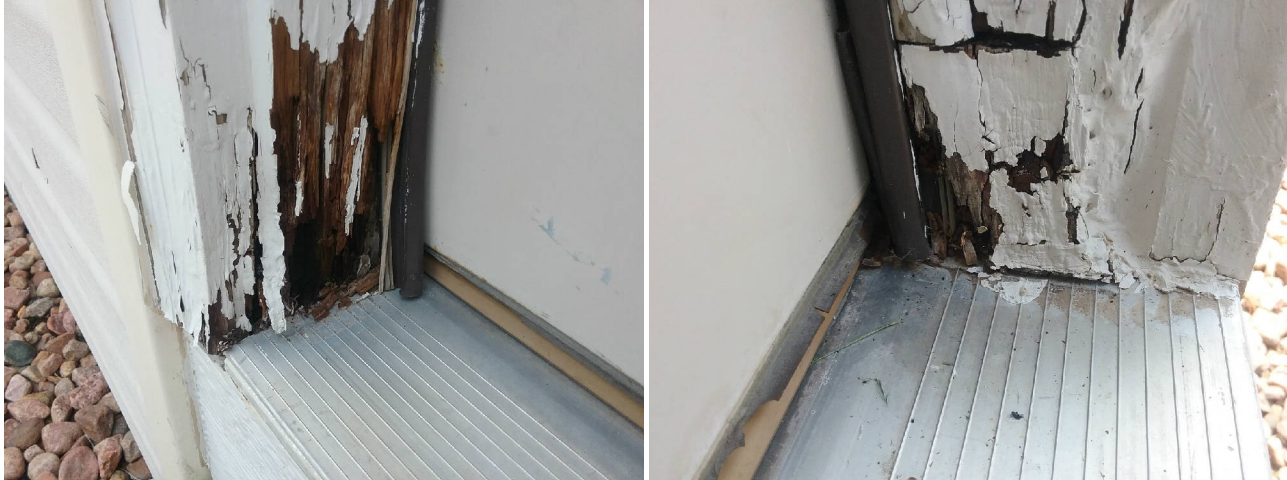
4. Entry Doors: Fiberglass/Metal -

1. The back entry door jamb is dry rotted at the bottom.

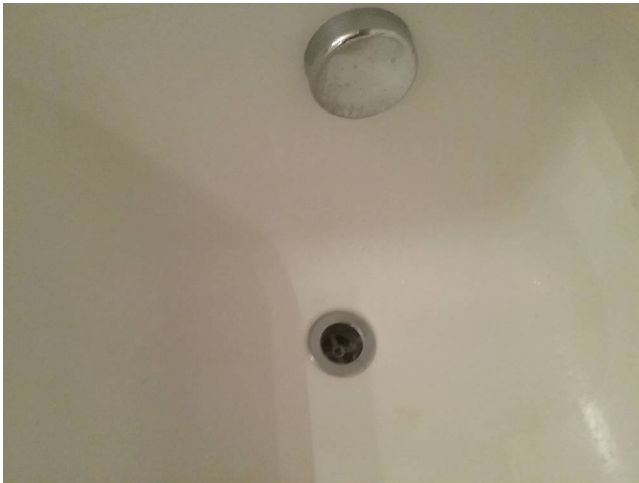
11. 1st floor half bath Bathroom Traps & Drains: Appears functional -
The 1st floor half bathroom sink is missing it's pop-up stopper. Missing stoppers can allow small items (toys, rings, hair pins, etc.) to clog the drain.
12. 1st floor half bath Bathroom HVAC Source: Heating system register -
There is currently no heat vent in the 1st floor half bath. This room may be cool in the winter.
13. 1st floor half bath Bathroom Vent Fan: Electric ventilation fan -
The 1st floor half bathroom exhaust fan and fan cover are dirty. Recommend cleaning these so they continue to function properly.
14. 2nd floor main Bathroom Tub/Showers: Fiberglass tub and fiberglass surround -
The 2nd floor main bathroom tub is missing it's pop-up stopper. Missing stoppers can allow small items (toys, rings, hair pins, etc.) to clog the drain.

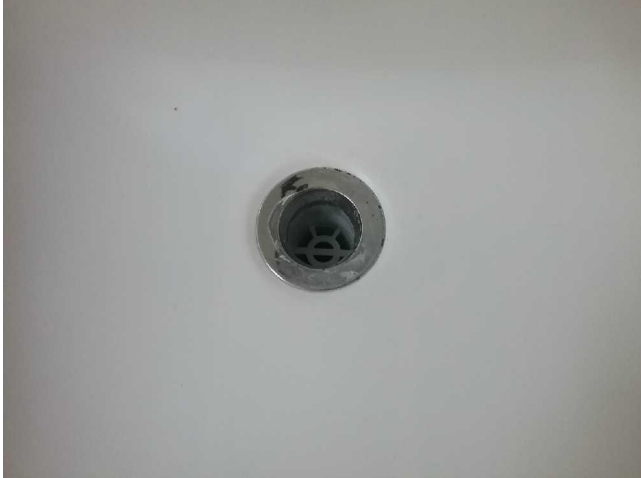
15. Master Bathroom Traps & Drains: Appears functional -
The master bathroom sink is missing it's pop-up stopper. Missing stoppers can allow small items (toys, rings, hair pins, etc.) to clog the drain.

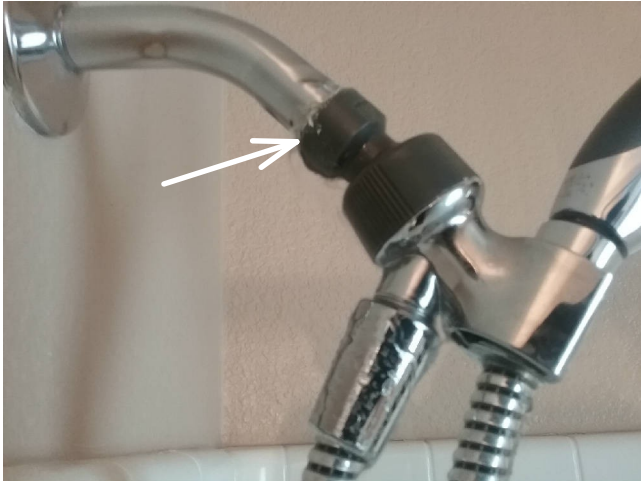
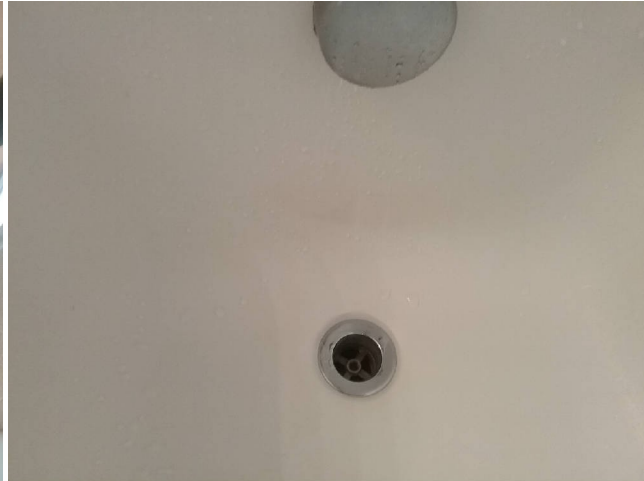
16. Master Bathroom Tub/Showers: Fiberglass tub and fiberglass surround -

1. The master bathroom tub is missing it's pop-up stopper. Missing stoppers can allow small items (toys, rings, hair pins, etc.) to clog the drain.
2. Water leaks from around the master bathroom shower head at the threads.

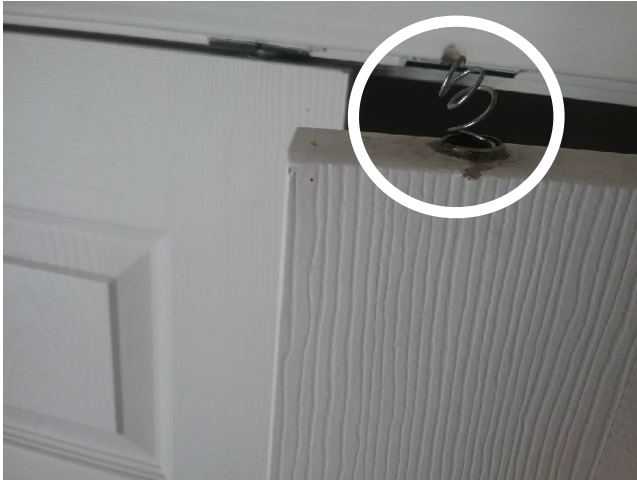
19. 1st Floor Laundry Room/Area Doors: Hollow wood -

The top of the right laundry room door had missing hardware needed for the door to function properly. Recommend having appropriate hardware installed.

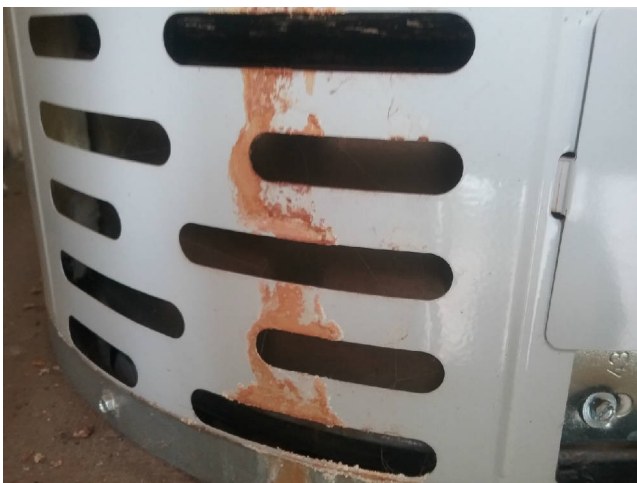
20. Utility Closet Water Heater Water Heater Operation: Adequate -

There are signs of a past leak and the water heater.

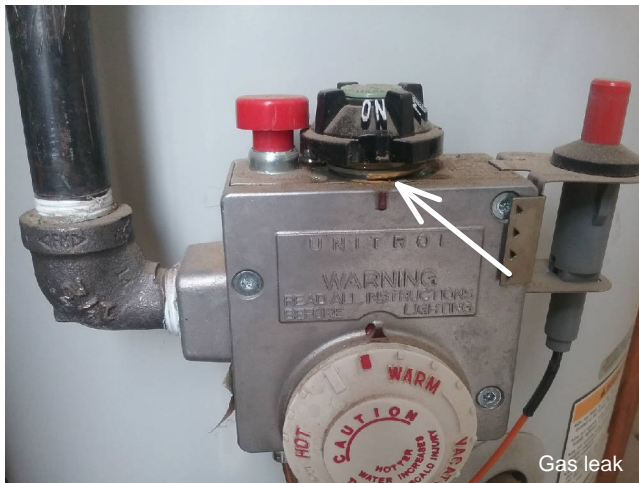
21. Utility Closet Water Heater Gas Lines Check For Leaks: Yes -

While testing the gas lines with my gas detector, a gas leak was detected at the water heater gas control valve. Recommend having a licensed plumber make repairs.

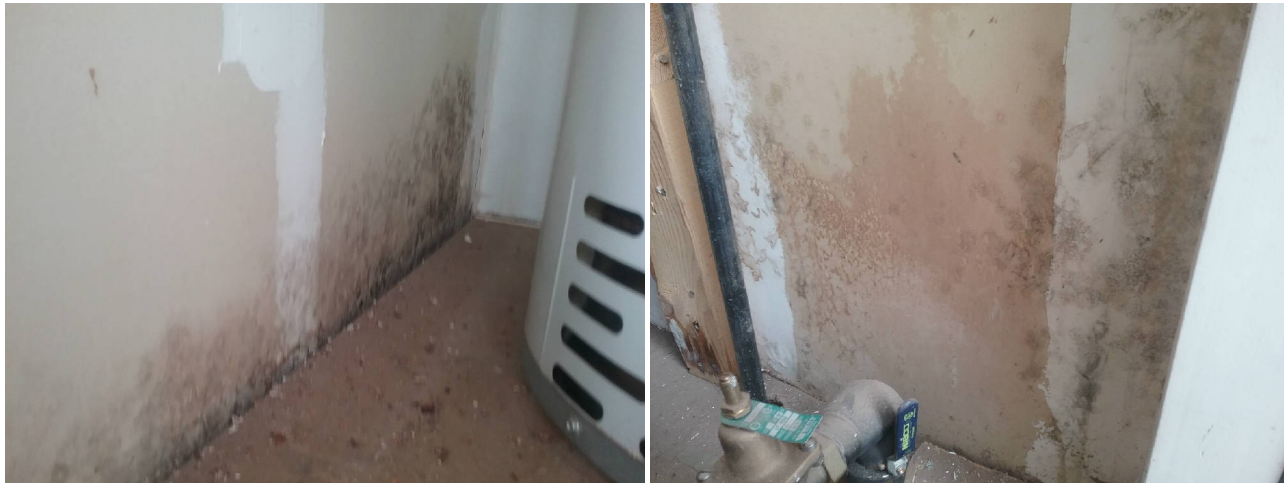
22. Organic Substance: Utility closet -

There is a black mold like substance in the water heater utility closet.

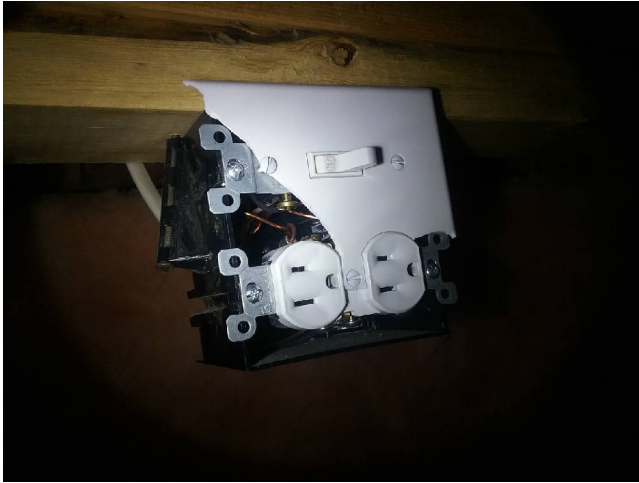
23. Main Crawl Space Electrical: 110 VAC -

The crawlspace Switch/outlet cover plate is broken.

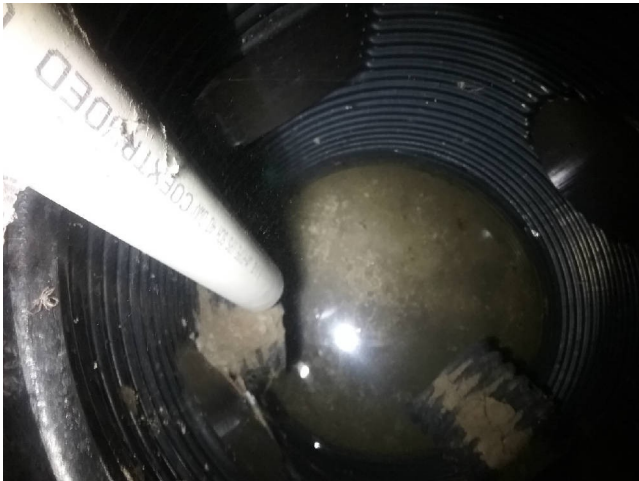
24. Main Crawl Space Sump Pump: Not Present -

There is a sump pit that is holding water with no sump pump installed. Recommend monitoring this after storms to see if a pump may need to be installed.
