Pro-Check Home Inspections

Property Inspection Report

622 Sample Circle
Colorado Springs, Colorado 80919

08/25/2018

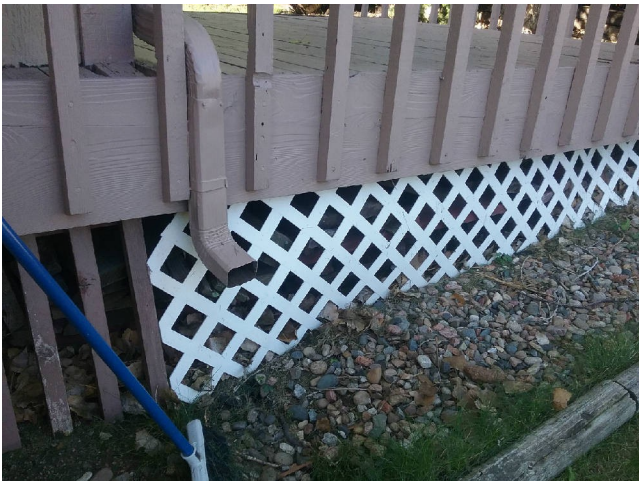
Deck: Stained wood -

There areas on the back deck that are soft/spongy, indicating possible dry rot of the joist. There is no access to inspect underneath.

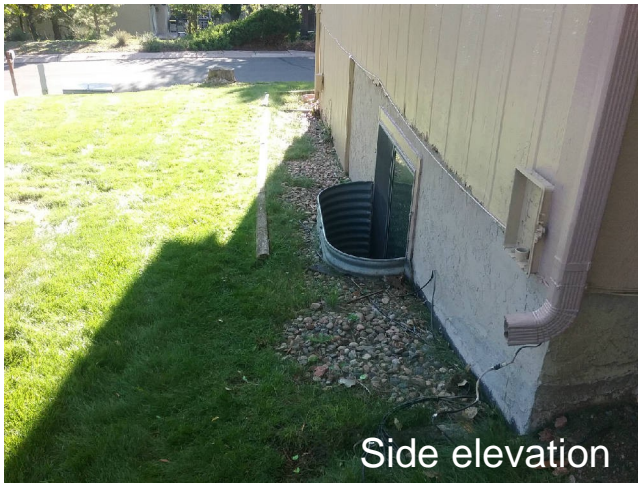
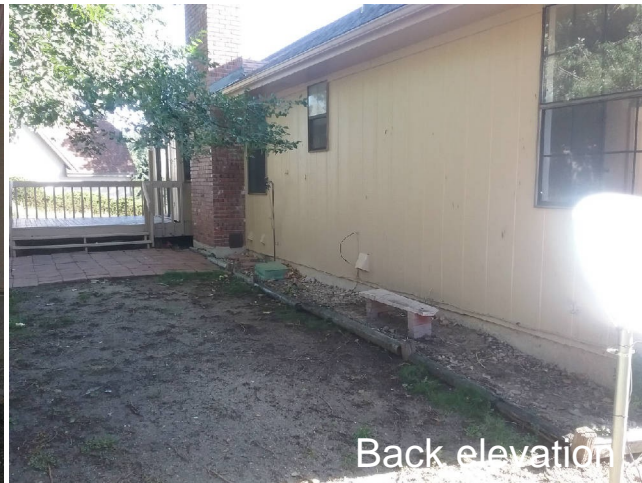
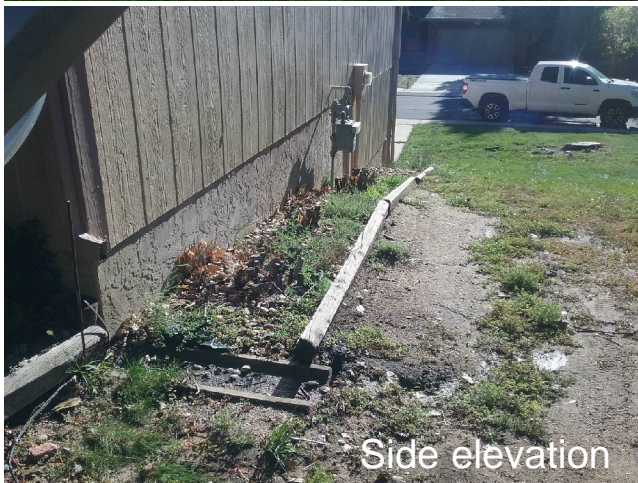
Grading: Minor slope -

There is a low area at the sprinkler zone valve box in the back that may have contributed to pooling water. It appears water has run over the gutters and may have pooled in this area and found it way into the garage and utility room.

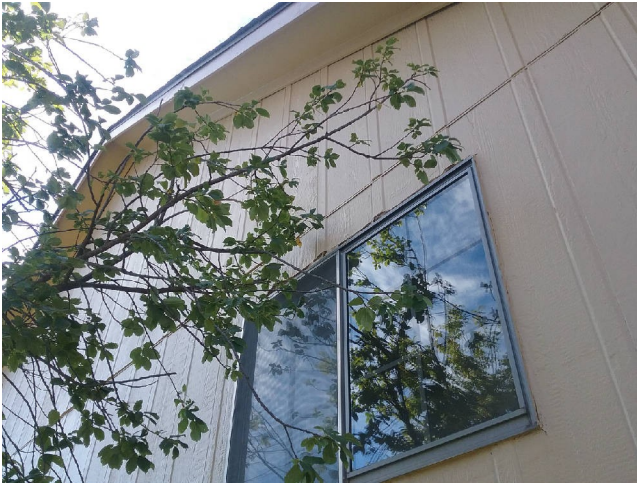
Vegetation such as trees, shrubs and/or vines are in contact with or less than one foot from the structure's exterior. Vegetation can serve as a conduit for wood destroying insects and may retain moisture against the exterior after it rains. Vegetation should be pruned and/or removed as necessary to maintain a one foot clearance between it and the structure's exterior.

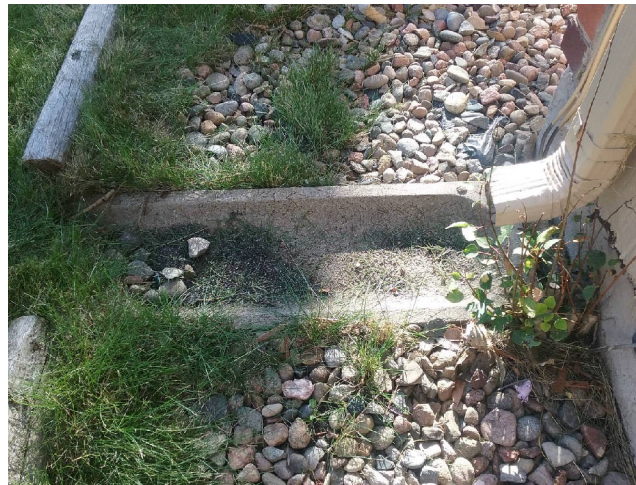
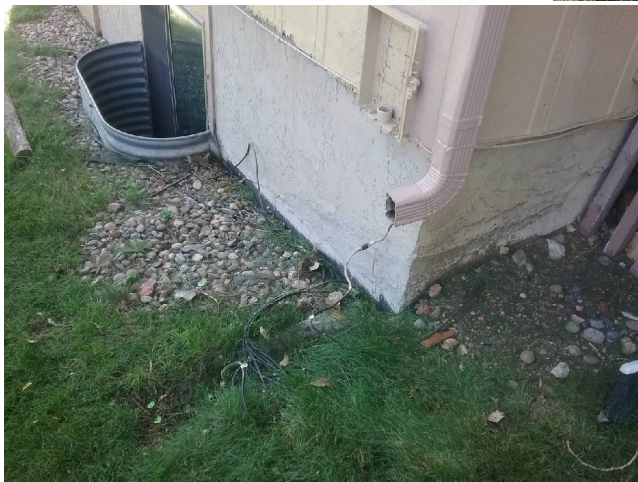
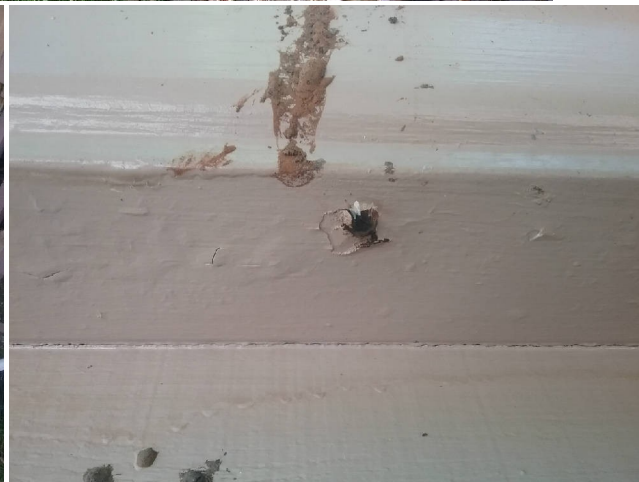
Leader/Extension: Extension needed -

1. We recommend installing downspout extensions where there are none currently. Current splash blocks do not allow water to run off. Downspouts will discharge water away from the foundation. Storm water should be encouraged to flow away from the building at the point of discharge. Adding downspout extensions will help prevent water from pooling next to the foundation.
2. The galvanized gutter over the deck has rusted through.

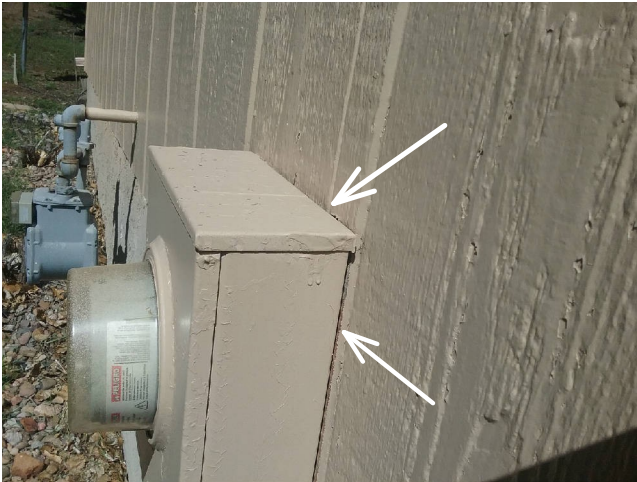
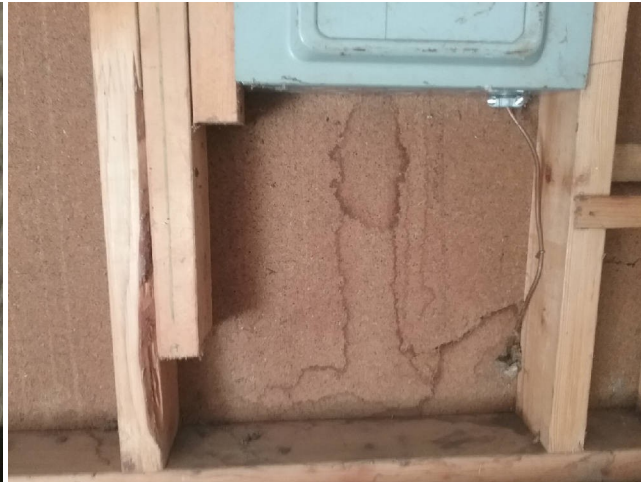
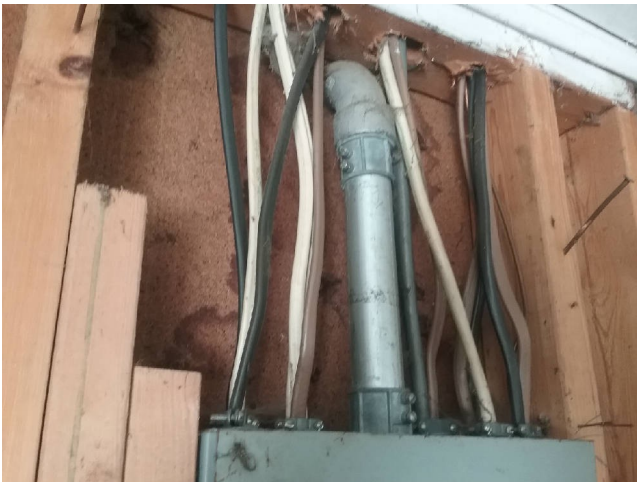
Penetrations in the siding are in need of caulking (around electrical meter box). This has allow moisture penetration into the garage. These areas will need to be monitored and caulked as needed. This is a normal maintenance item.

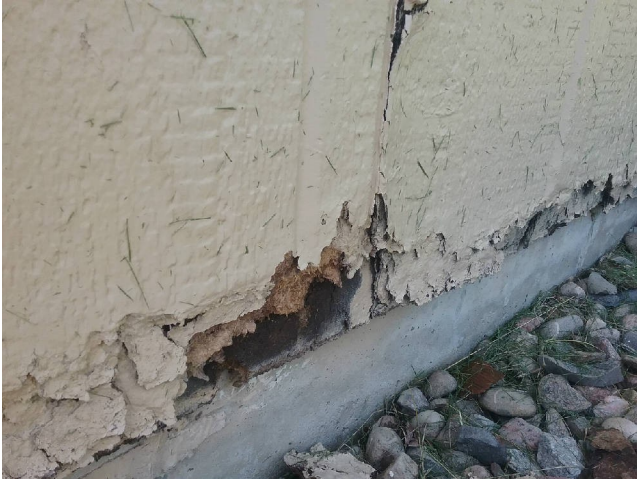
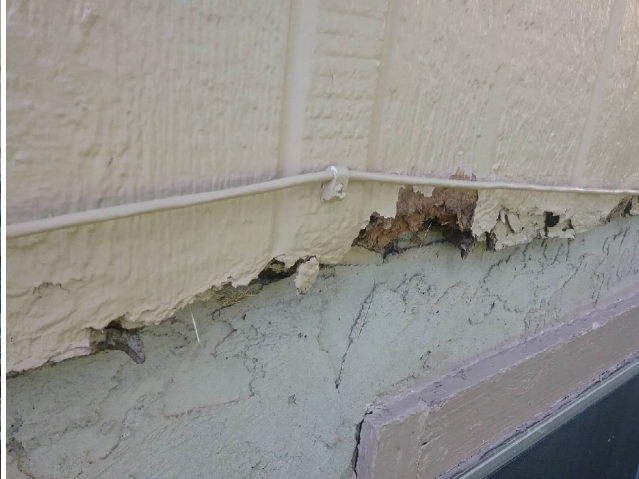
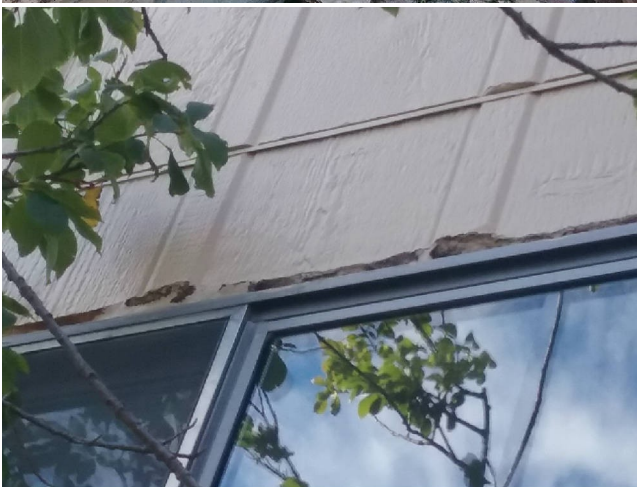
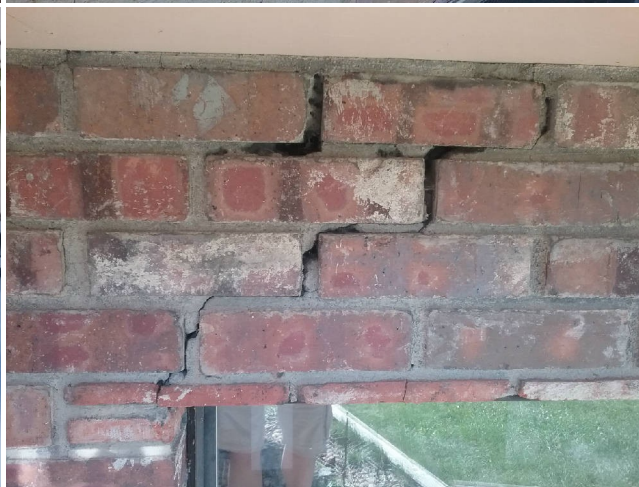
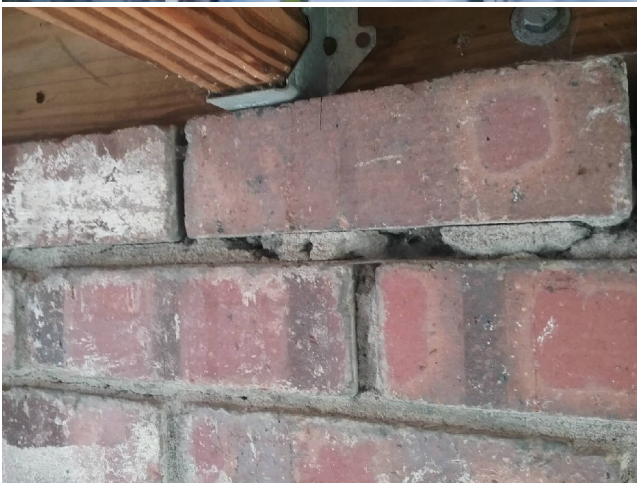
Siding type: Hardboard Siding -

1. There is deterioration of the North hardboard siding close to the ground and above windows. They will require at the very least regular painting and maintenance. It is possible they may need to be replaced.
2. There is mortar missing in some areas of the front brick veneer. The type of repair is called "tuck pointing". Recommend a licensed contractor evaluate and make repairs.

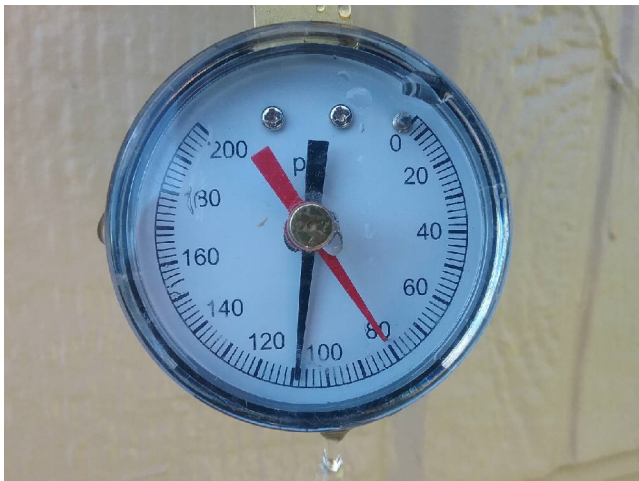
Home water supply pressure exceeded the 80 pounds per square inch (PSI) limit considered the maximum allowable by generally-accepted current standards. Excessively high water pressure is likely to cause leaks. The Inspector recommends service by a qualified plumbing contractor.

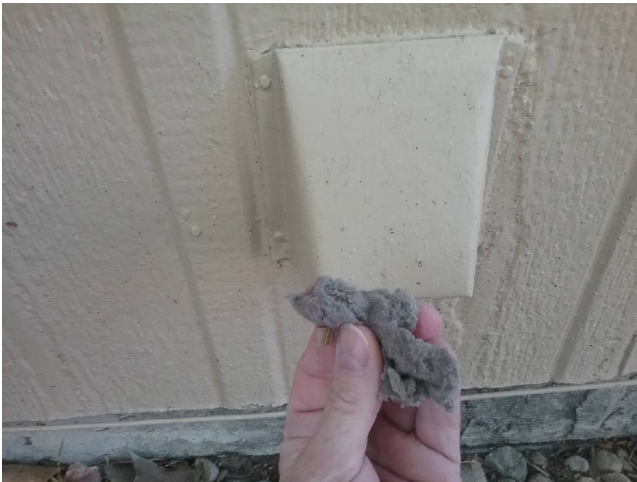
Recommend the dryer vent line leading to the exterior of the house be cleaned and insure the flapper closes. During the inspection we were able to reach inside the exterior vent cap and pull out a handful of lint.

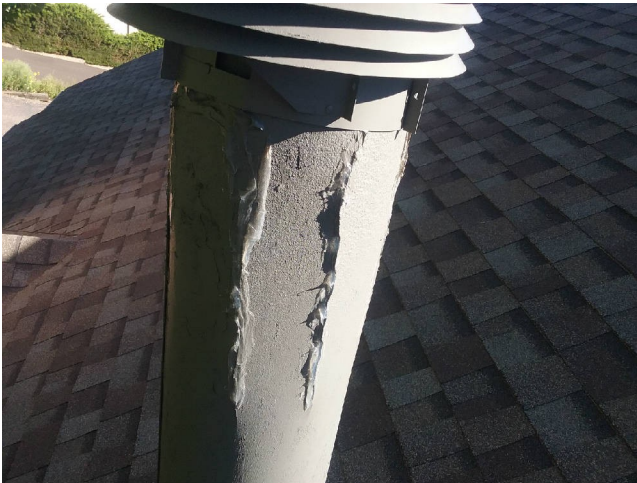
The furnace and water heater flue pipe is rusting and cracked on the roof. The pipe has been caulked, however this is a temporary fix and will need to be replaced at some point. Recommend this section of flue on the roof be replaced.

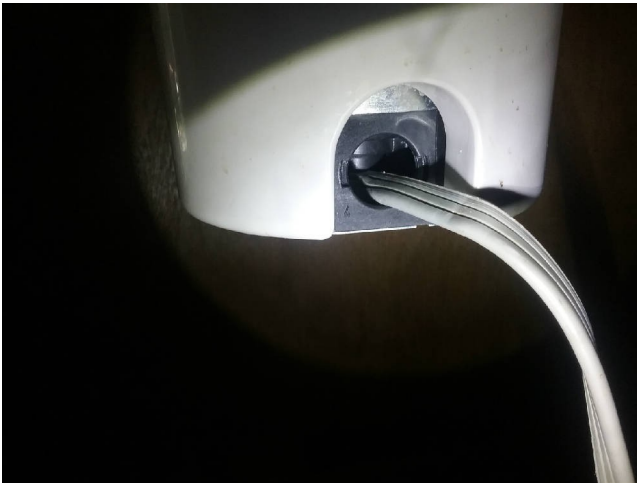
There is no wire clamp to secure the electrical wire entering the garbage disposal. This is a potential shock hazard.

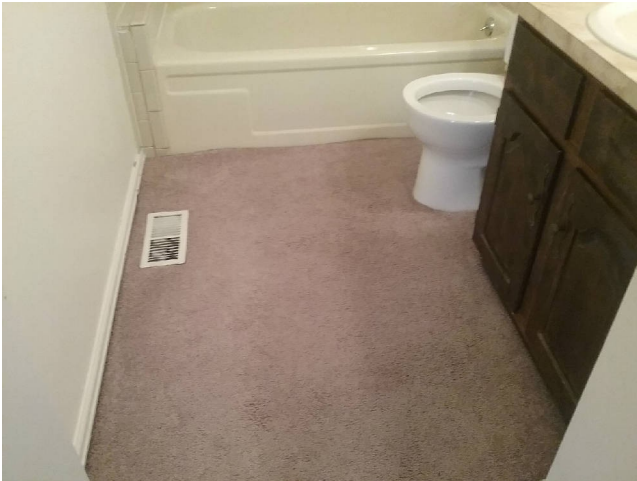
Carpet installed in bath areas are a potential contamination issue. We were not able to inspect under the carpet, so there is no way to determine if the toilet is or has been leaking.

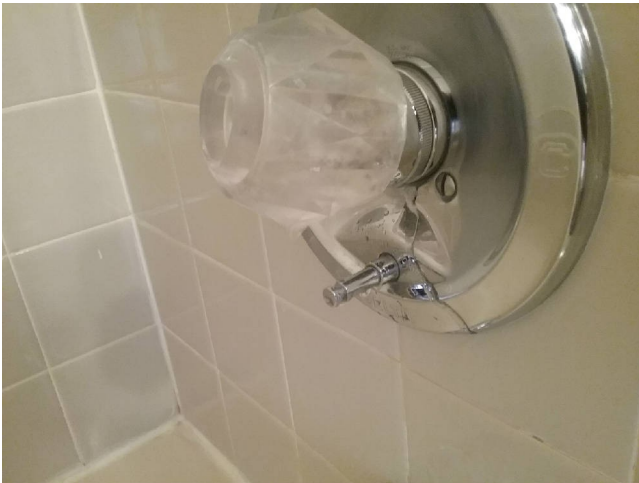
The main hall bathroom tub faucet leaks from the handle when in the on position.

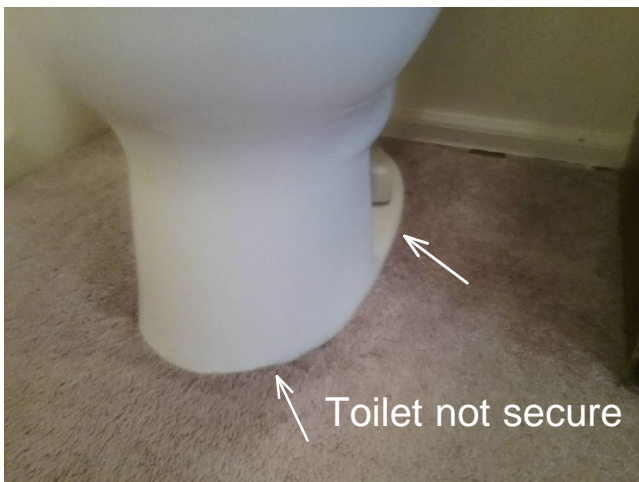
The main hall bathroom toilet is not secure at floor. Condition typically is caused by loose bolts. Loose toilets can result in damage to water supply lines, cause leaks, water damage, and mold, as well as damage to the toilet. Repairs may involve installing a new wax seal at the base of the toilet. It is recommended that this be repaired by a qualified plumbing contractor.

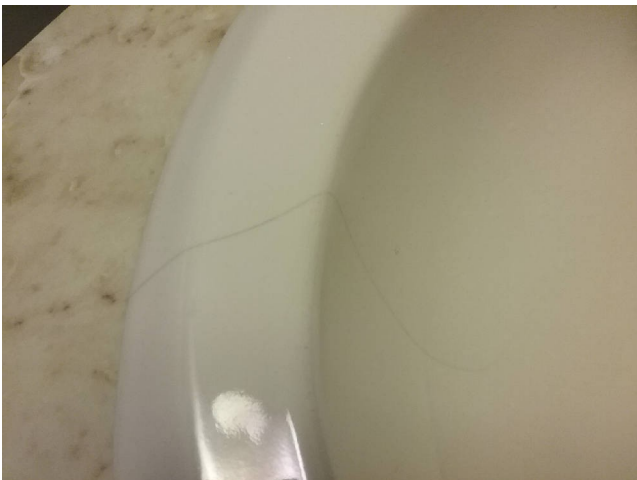
There is a crack in the master bathroom ceramic sink.

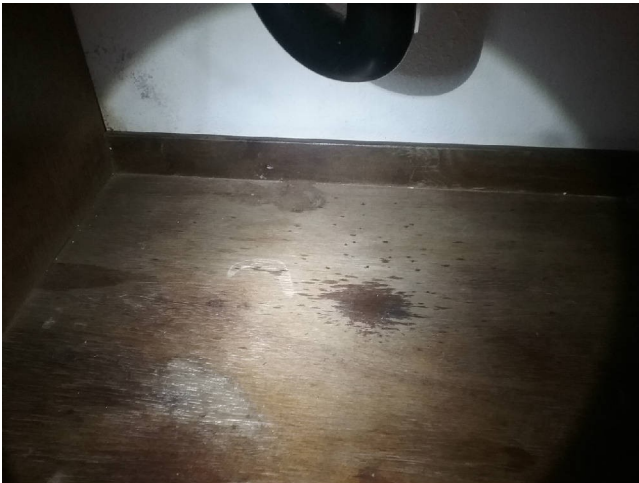
The basement bathroom sink drain line leaks. Condition will result in moisture damage and possible organic growth. Recommend a qualified plumber repair leak.

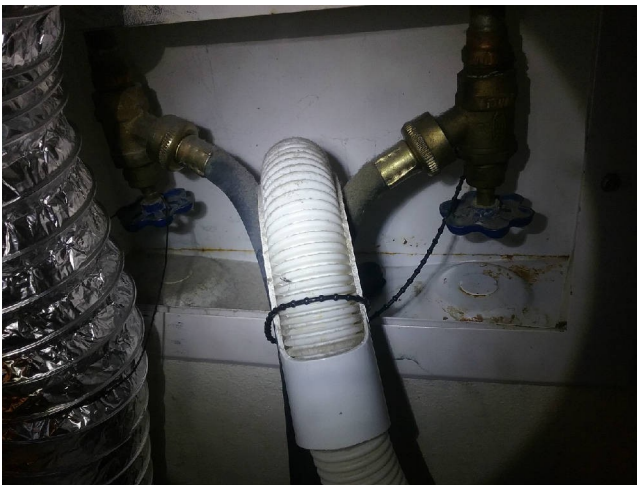
Recommend replacement of rubber washing machine hoses with long-life burst resistant hoses.. As rubber ages, it loses it's flexibility and under constant water pressure, these hoses are prone to leaks or even bursting. No-burst hoses are encased in a woven metal sleeve that prevents weak spots in the rubber from developing into leaks.

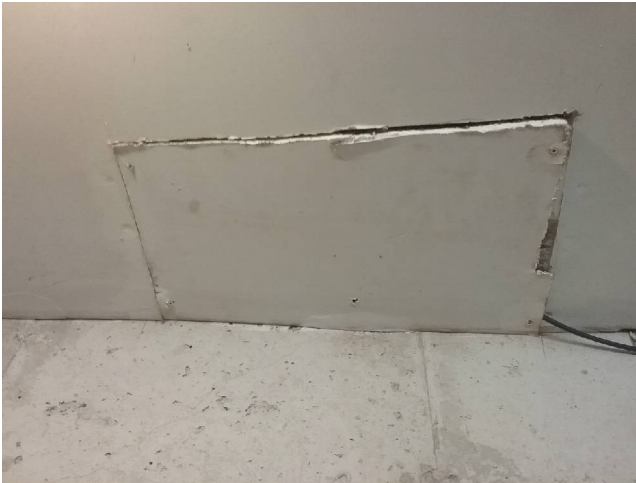
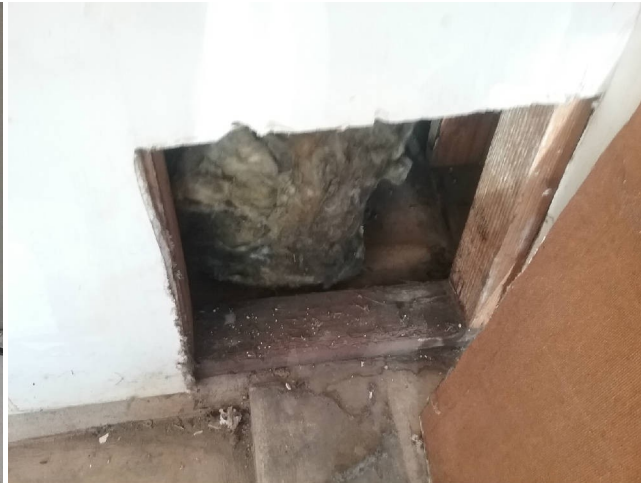
Holes have been cut in the garage firewall ceiling. The drywall has been put back in place, but the cut seams need tape and mud. (This drywall "envelope" serves as a fire wall between the garage and living space and when holes are present it compromises the fire rating).

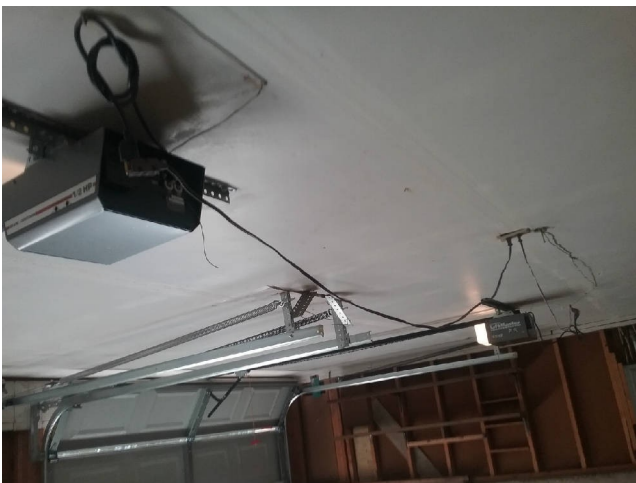
1. The garage GFCI was tripped and would not reset. This outlet may need to be replaced.
2. Extension cords are not made to be used as permanent wiring. Recommend adding the correct type of permanent wiring and discarding the extension cord to the garage door opener.

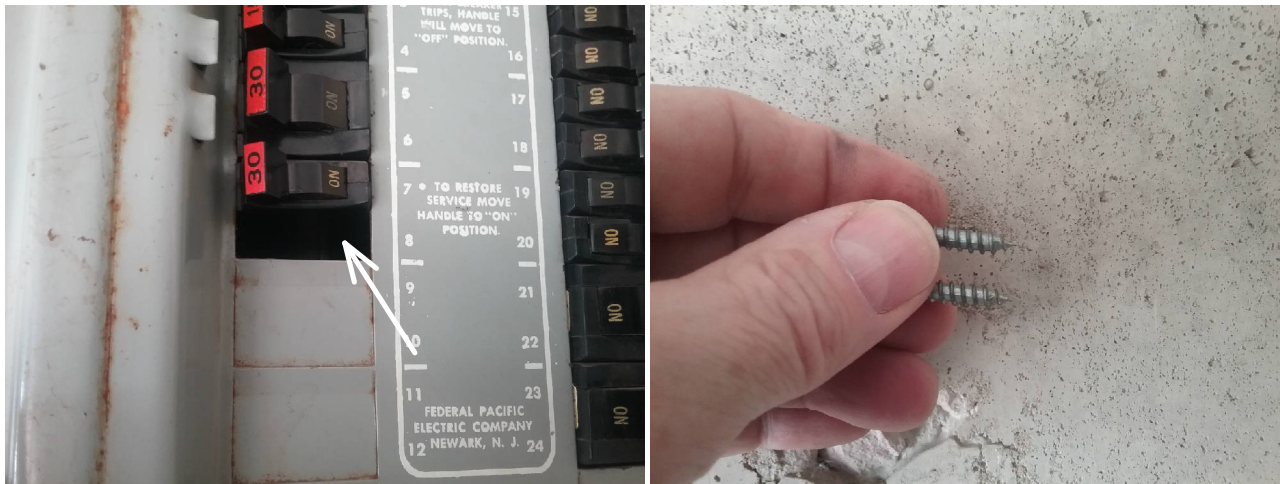
1. The main electric service panel was manufactured by Federal Pacific. Federal Pacific Stab-Lok model panels are known to have a high rate of failure of circuit breakers. Failure of circuit breakers can result in a fire and/or electrocution. I recommend the Federal Pacific Stab-Lok main electric panel be evaluated by a qualified electrical contractor. Information about Federal Pacific panels is available at www.inspect-ny.com/fpe/fpepanel.htm.
2. Knockout missing in electrical panel cover require snap-in caps. Have certified electrician evaluate and repair as necessary.
3. Non-standard panel cover screws present. Sharp pointed screws can come in contact with wiring and cause a fire hazard. Recommend screws be replaced with proper panel screws.

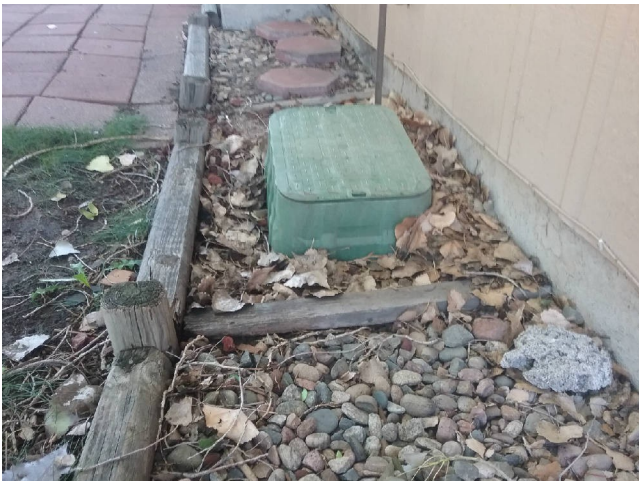
There is a low area at the sprinkler zone valve box in the back that may have contributed to pooling water. It appears water has run over the gutters and may have pooled in this area and found its way into the garage and utility room.

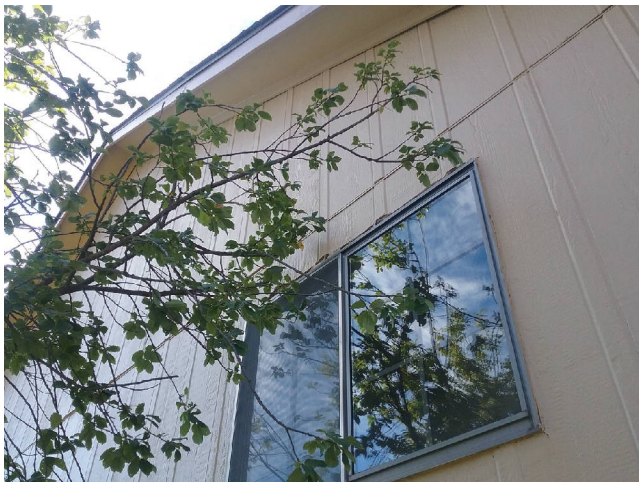
4. Vegetation: Trees -

Vegetation such as trees, shrubs and/or vines are in contact with or less than one foot from the structure's exterior. Vegetation can serve as a conduit for wood destroying insects and may retain moisture against the exterior after it rains. Vegetation should be pruned and/or removed as necessary to maintain a one foot clearance between it and the structure's exterior.

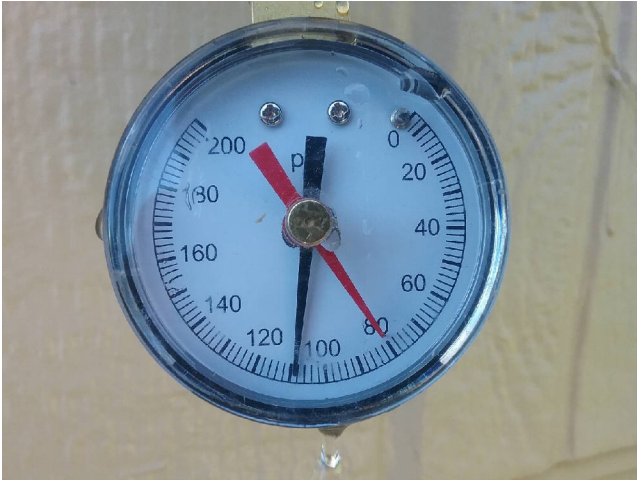
Home water supply pressure exceeded the 80 pounds per square inch (PSI) limit considered the maximum allowable by generally-accepted current standards. Excessively high water pressure is likely to cause leaks. The Inspector recommends service by a qualified plumbing contractor.

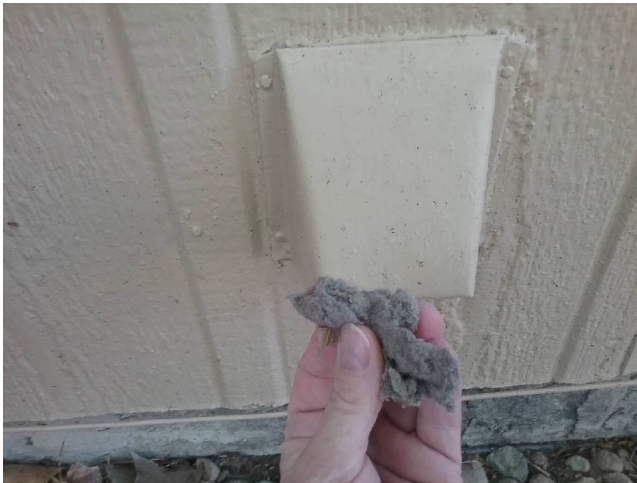
10. Dryer Vent: Metal flex -

Recommend the dryer vent line leading to the exterior of the house be cleaned and insure the flapper closes. During the inspection we were able to reach inside the exterior vent cap and pull out a handful of lint.

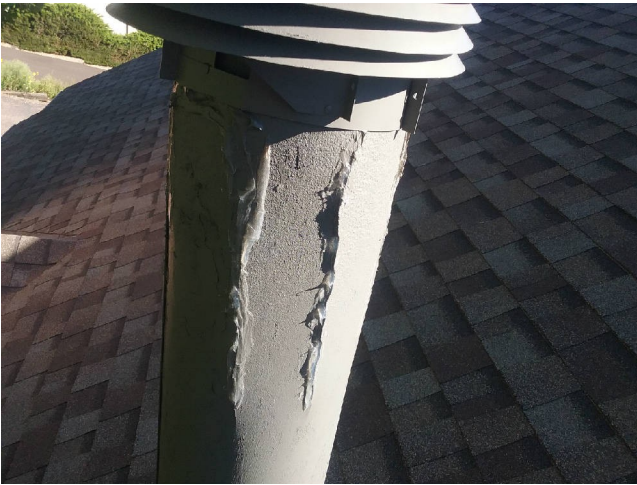
The furnace and water heater flue pipe is rusting and cracked on the roof. The pipe has been caulked, however this is a temporary fix and will need to be replaced at some point. Recommend this section of flue on the roof be replaced.

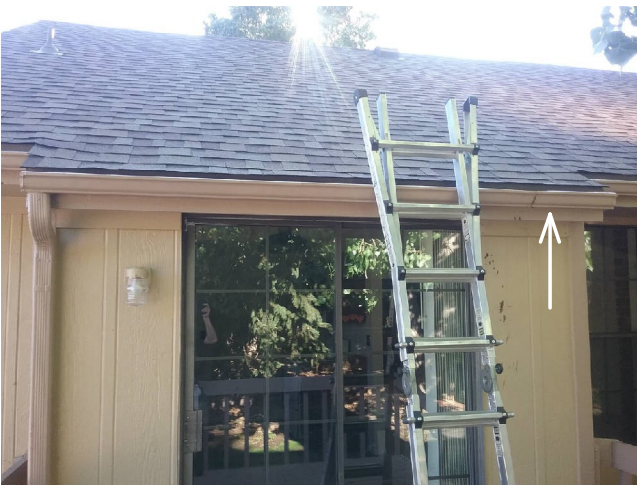
12. Gutters & Downspouts: Galvanized/aluminum -

The gutter over the back deck has negative flow and is holding water. Recommend the slope of the gutter be fixed to allow the water to flow all the way to the downspout.

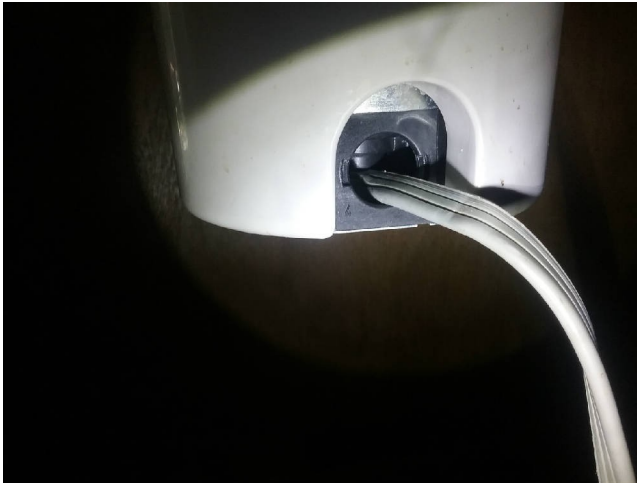
There is no wire clamp to secure the electrical wire entering the garbage disposal. This is a potential shock hazard.

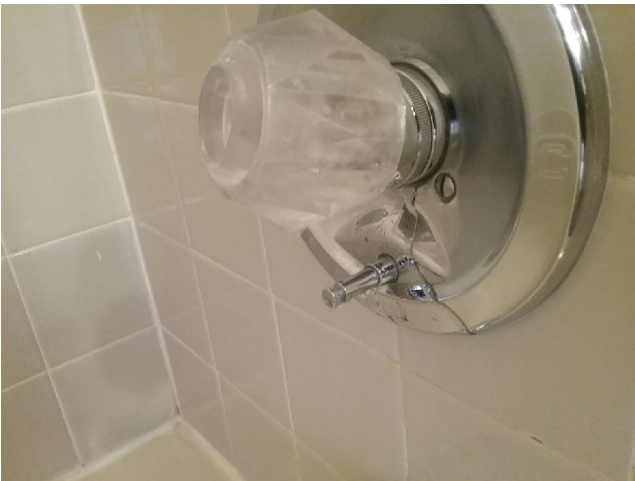
21. Main hall bath Bathroom Tub/Showers: Cast iron tub -
The main hall bathroom tub faucet leaks from the handle when in the on position.

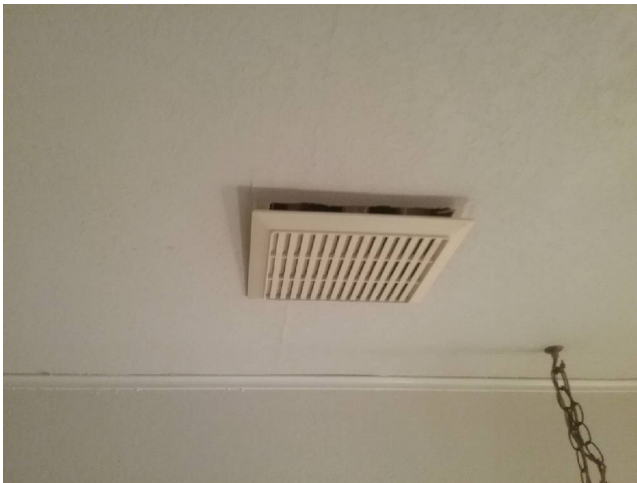
23. Main hall bath Bathroom Vent Fan: Electric ventilation fan -
The main hall bathroom vent fan cover is not secure to the ceiling.

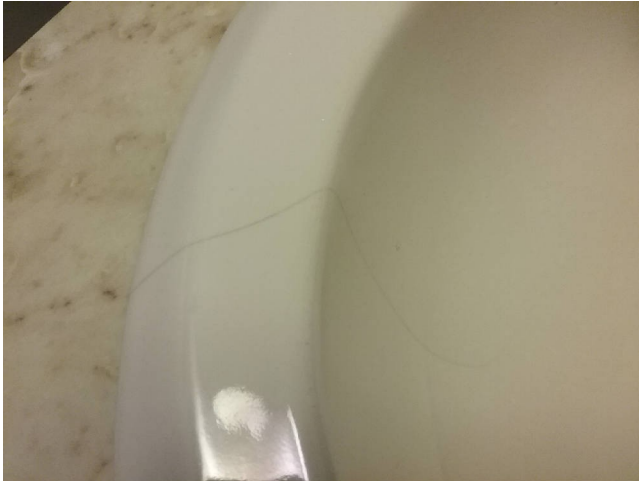
There is a crack in the master bathroom ceramic sink.

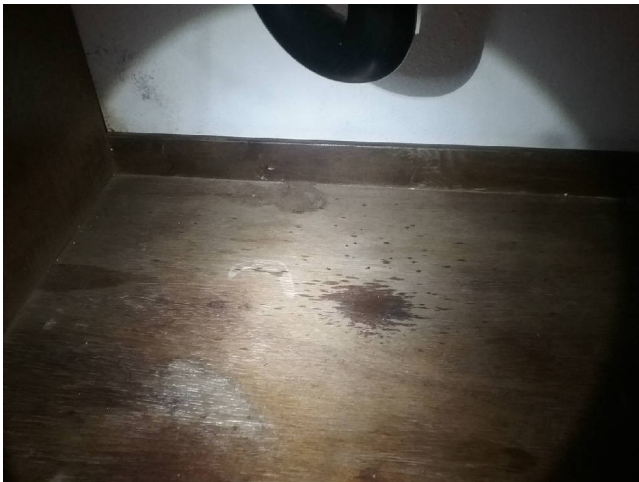
The basement bathroom sink drain line leaks. Condition will result in moisture damage and possible organic growth. Recommend a qualified plumber repair leak.

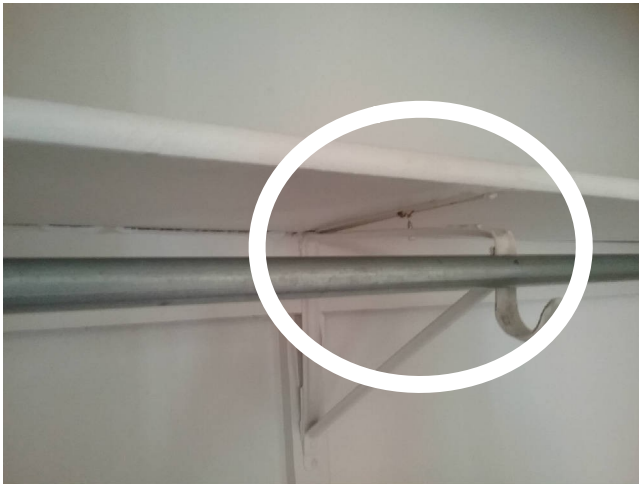
The master bedroom closet clothes pole support bracket is not secure.

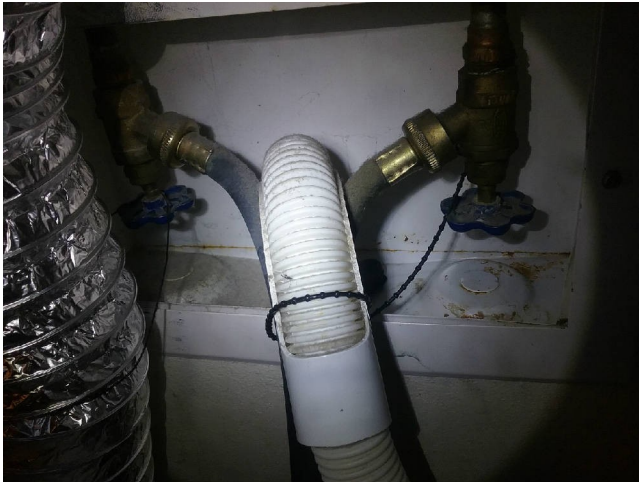
Recommend replacement of rubber washing machine hoses with long-life burst resistant hoses.. As rubber ages, it loses its flexibility and under constant water pressure, these hoses are prone to leaks or even bursting. No-burst hoses are encased in a woven metal sleeve that prevents weak spots in the rubber from developing into leaks.

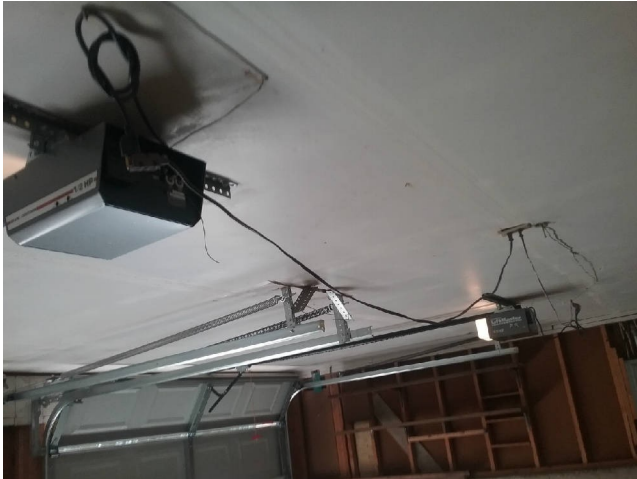
36. Attached Garage Electrical: 110 VAC -

1. The garage GFCI was tripped and would not reset. This outlet may need to be replaced.
2. Extension cords are not made to be used as permanent wiring. Recommend adding the correct type of permanent wiring and discarding the extension cord to the garage door opener.
