Pro-Check Home Inspections

Property Inspection Report

2634-2636 W Sample Ave
Colorado Springs, Colorado 80904

08/25/2018

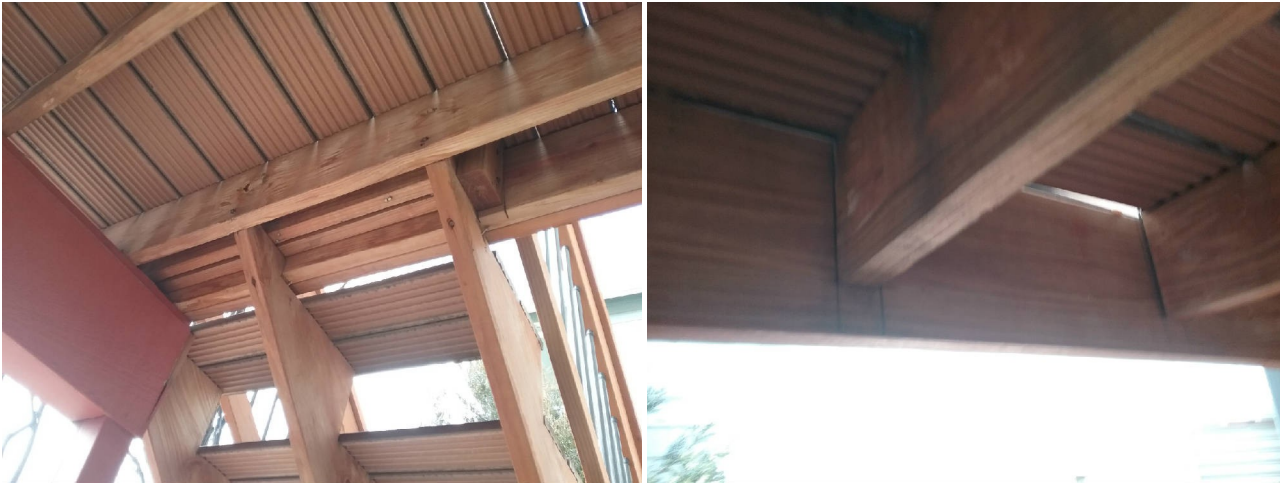
1. There were no permits pulled for the front deck installation. Permits for deck installations are required if the deck connects to the home. Recommend a licensed contractor evaluate the deck and pull the appropriate permit.
2. The deck stair stringers are not properly attached to the deck. Recommend having a licensed contractor evaluate and make necessary repairs.
3. There are no joist hanger installed on the deck landing framing.

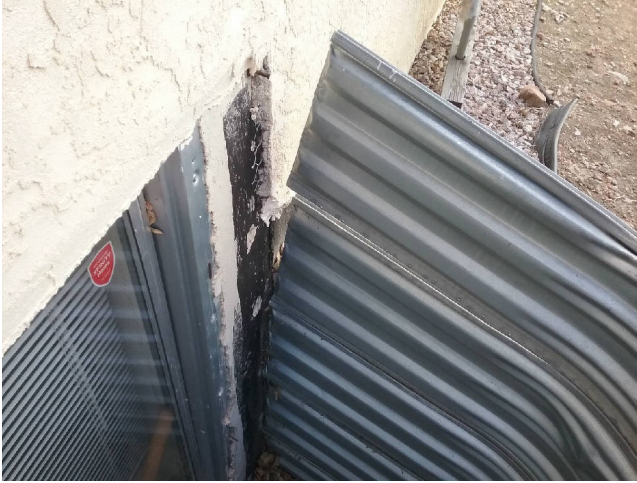
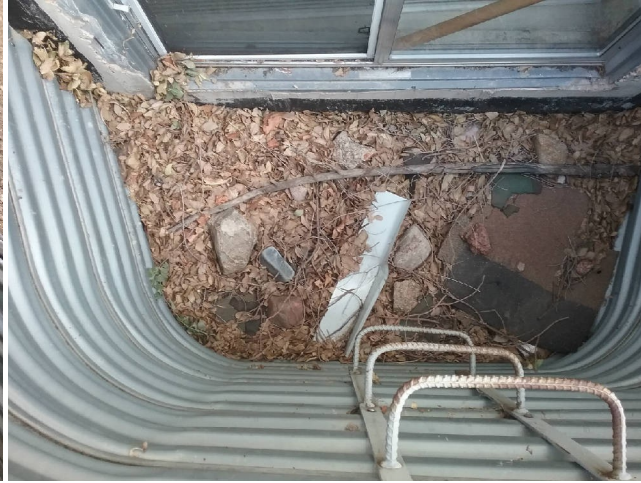
1. The West window well is not secured to the house.
2. Window wells had accumulated debris which should be cleared to encourage proper drainage and minimize the retaining of moisture near the foundation and habitat for pests and insects.

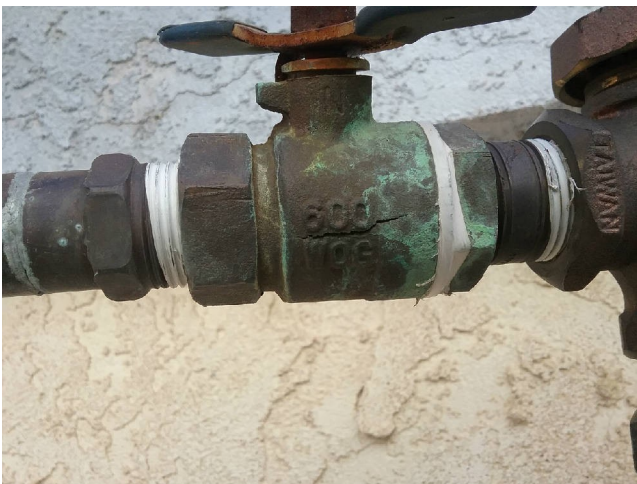
Lawn Sprinklers: Front and back yard -

There is frost damage to the 2636 sprinkler supply shut off valve. This will need to be repaired before the sprinkler is operational.

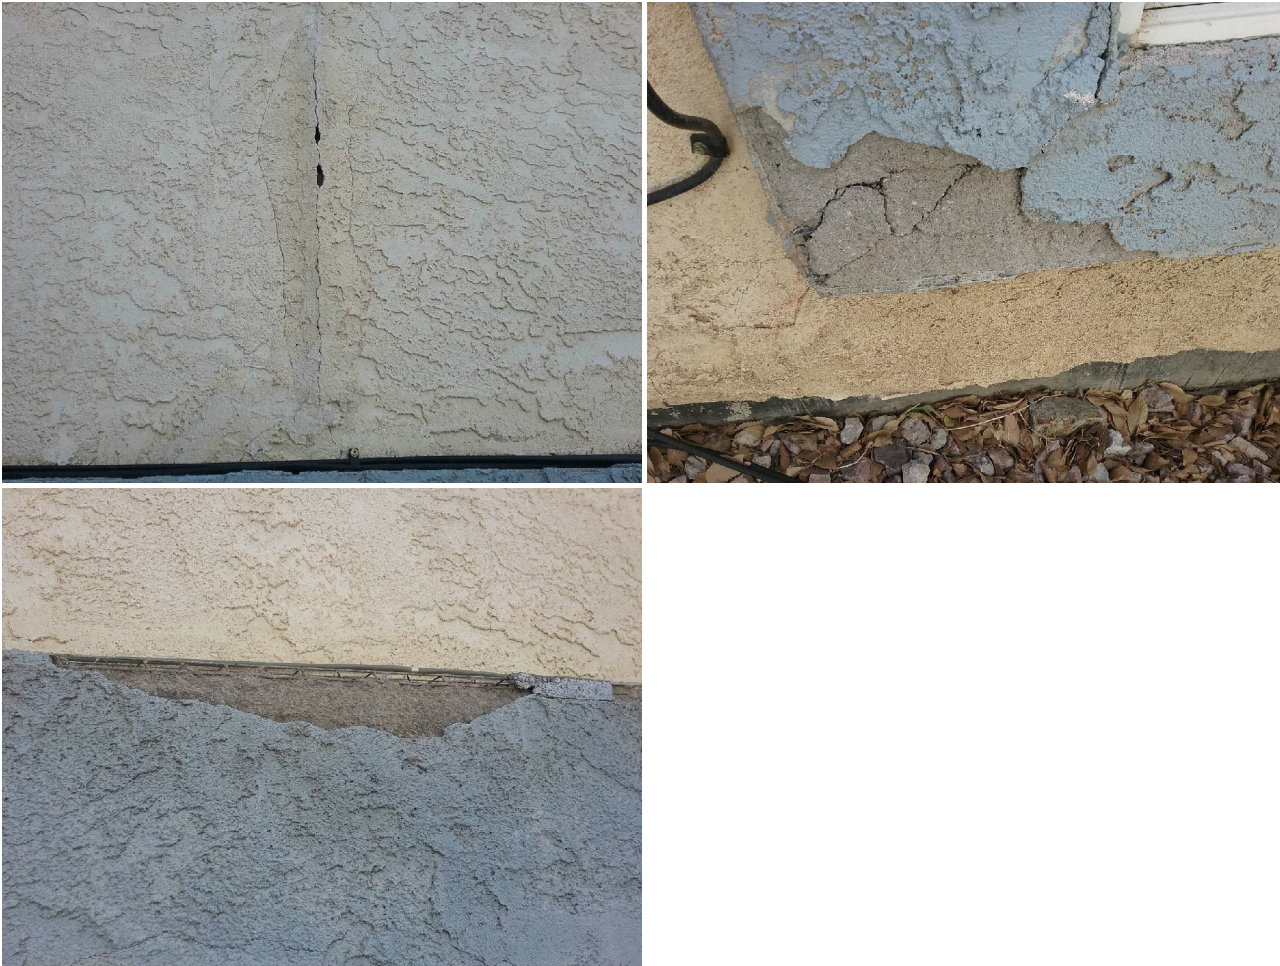
There are a few major cracks in the stucco (especially on the West) that may need maintenance. Recommend a licensed contractor evaluate the whole stucco facade and make all necessary repairs. (Cracks that you can fit a credit card into and bigger need to be evaluated by a licensed contractor).

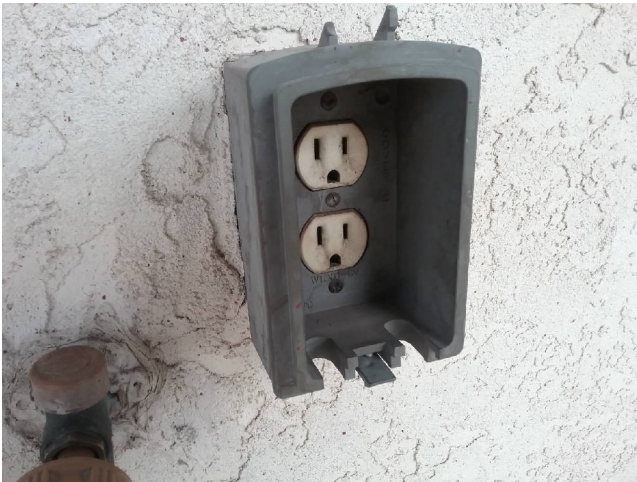
Both front exterior outlets are missing their moisture cover.
2. The 3634 back exterior GFCI outlet would not trip when tested.

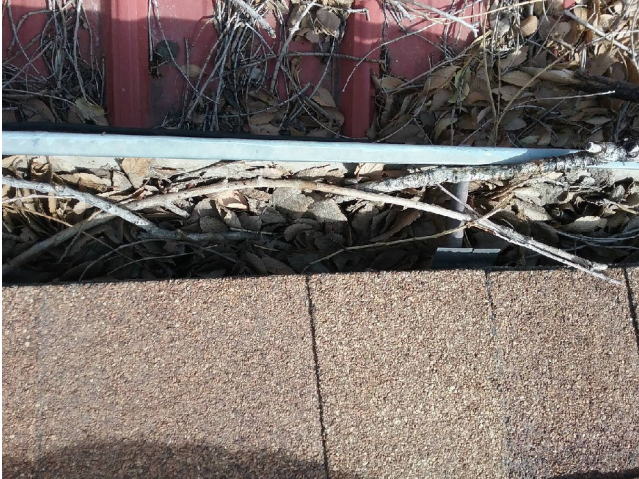
Debris (leaves, needles, etc) has accumulated in the gutters. This prevents the gutters from doing their job (directing rain water away from the foundation). In winter, water will freeze in the gutters and damage them. It may also cause ice jams on the roof. This can lead to leaks. Therefore, it is recommended that the gutters be cleaned at least twice a year to prevent debris buildup.

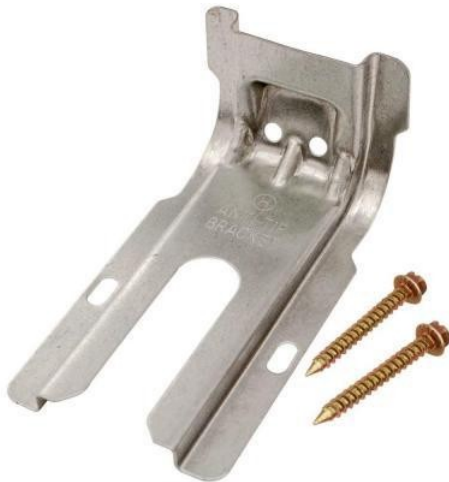
Range Anti-tip Bracket: None present -

Recommend installing an anti-tip bracket on the range. These brackets have been a safety requirement since 1991.

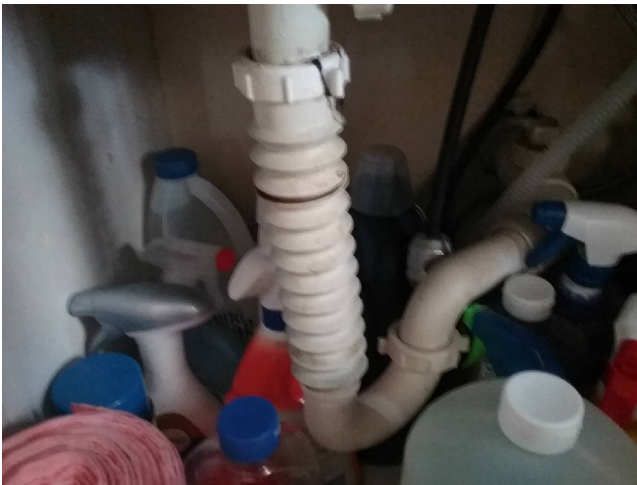
There was an unapproved, flexible, corrugated drainpipe in the 2636 kitchen that will contribute to blockages. Although it is functioning, it is recommended that this be replaced with the proper drain material.

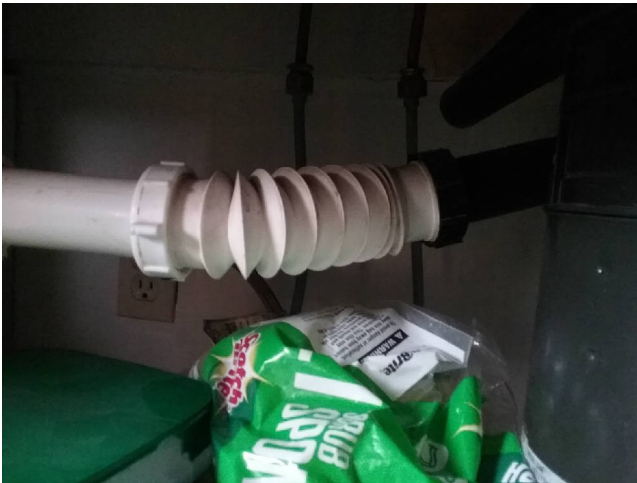
There was an unapproved, flexible, corrugated drainpipe in the 2634 kitchen that will contribute to blockages. Although it is functioning, it is recommended that this be replaced with the proper drain material.

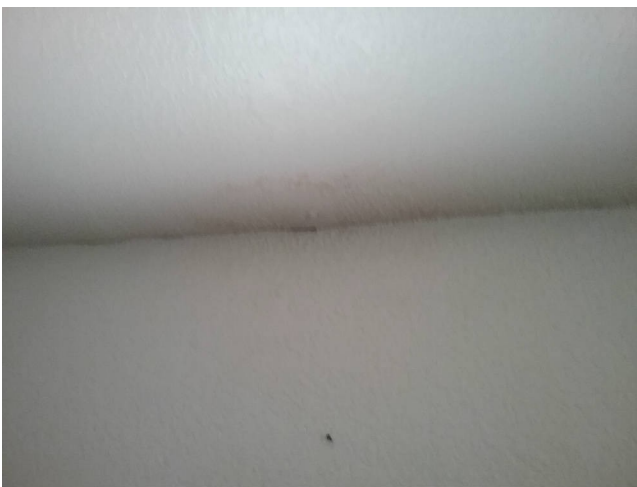
There is a water stain in the family room ceiling over the South 2636 window. This is due to there not being any ledger installed on upper deck. Recommend having a licensed contractor evaluate and make necessary repairs.

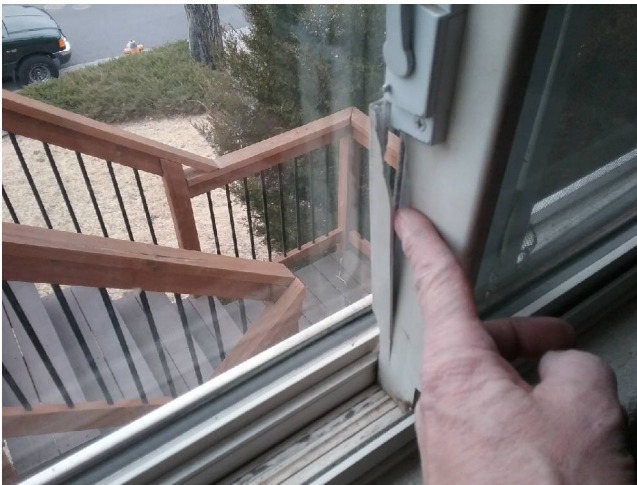
1. The pane of the South 2636 family room window is broken. Recommend replacing this window pane.
2. The West 2636 family room window has a broken seal, there is visible condensation marks between the two panes of glass (This does not mean the window will leak, but it will mean the window will stay foggy and it will lower its energy efficiency).
3. There is damage to the 2636 living room vinyl window.

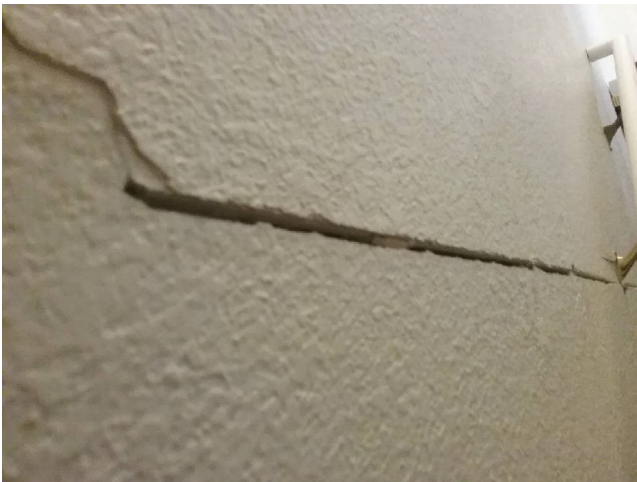
There were some significant cracks in the 2624 walls.

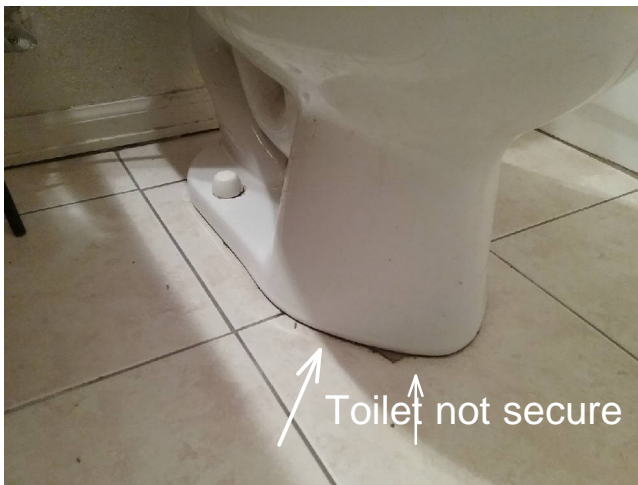
The 2634 lower level bathroom toilet is not secure at floor. Condition typically is caused by loose bolts. Loose toilets can result in damage to water supply lines, cause leaks, water damage, and mold, as well as damage to the toilet. Repairs may involve installing a new wax seal at the base of the toilet. It is recommended that this be repaired by a qualified plumbing contractor.

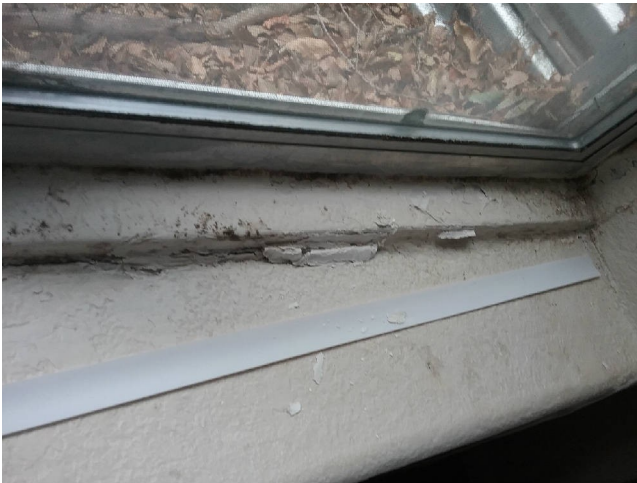
There is a mold like substance around the 2636 Lower level bedroom window.

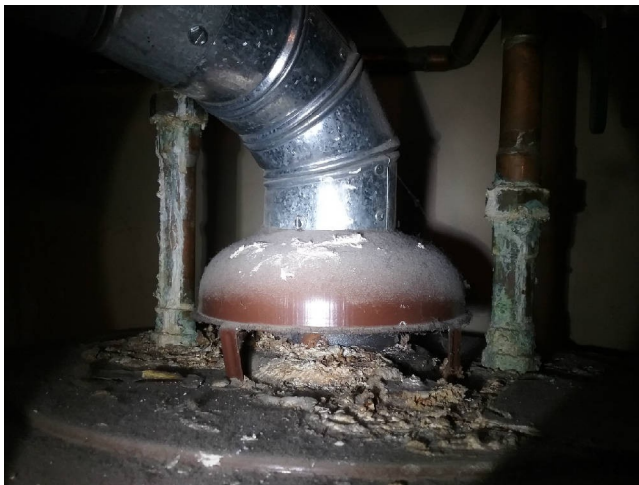
1. The 2634 water heater, although functional during the inspection, is beyond its "approximate" life expectancy (12 to 15 years) You may need to replace this water heater at some point in the near future.
2. There is corrosion on the 2634 water heater water pipes. Indicating a past water leak.

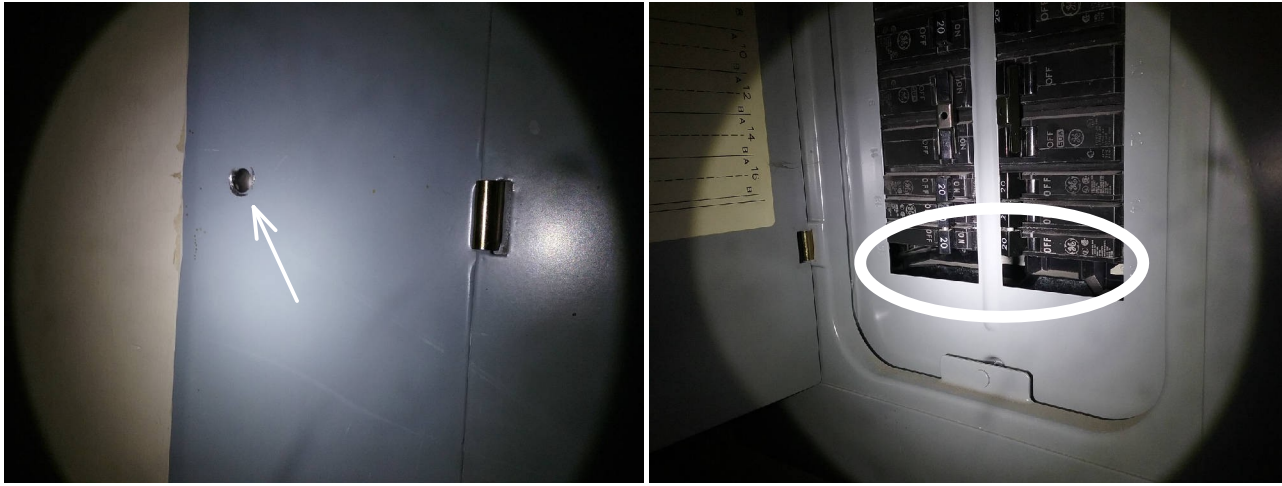
1. There is a panel screw missing on the 2636 electrical panel dead front cover. Recommend replacing screw with proper panel screw.
2. Knockouts missing in 2636 main electrical panel cover require snap-in caps. Have certified electrician evaluate and repair as necessary.

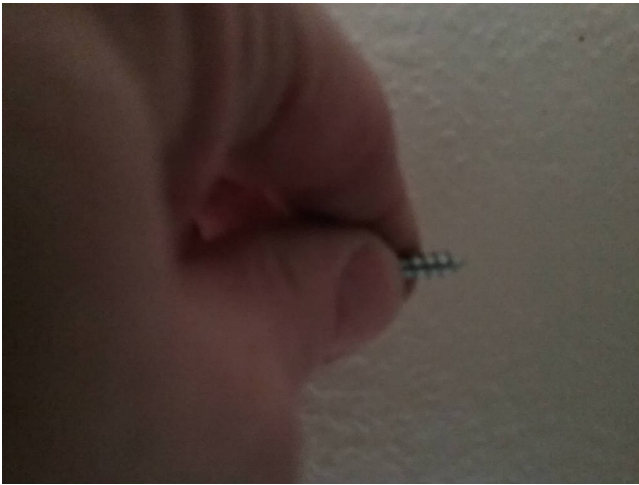
2. Non-standard panel cover screws present in both sub panels. Sharp pointed screws can come in contact with wiring and cause a fire hazard. Recommend screws be replaced with proper panel screws.

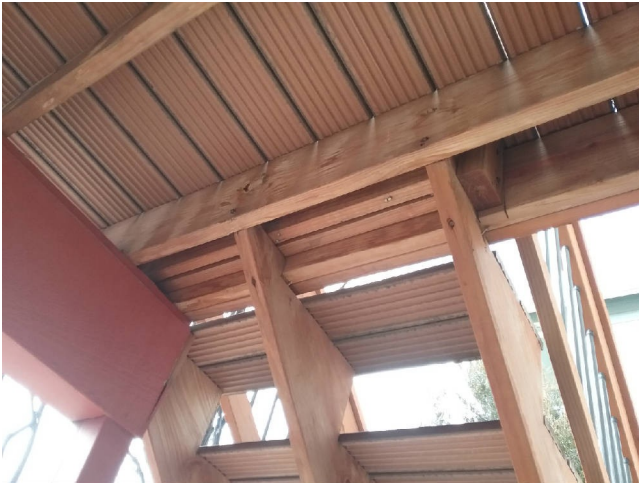
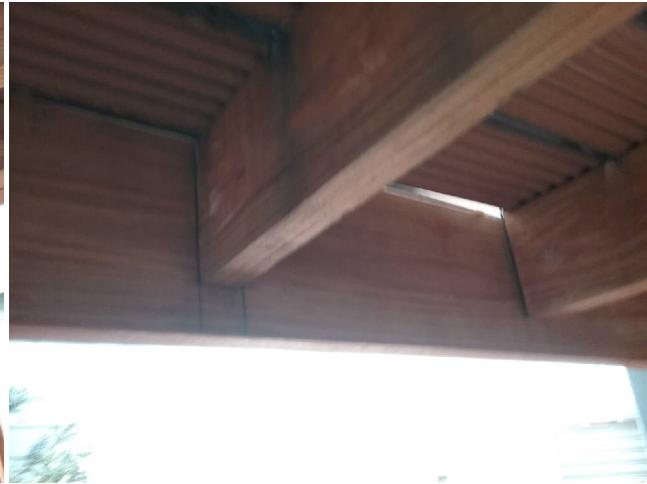
1. There were no permits pulled for the front deck installation. Permits for deck installations are required if the deck connects to the home. Recommend a licensed contractor evaluate the deck and pull the appropriate permit.
2. The deck stair stringers are not properly attached to the deck. Recommend having a licensed contractor evaluate and make necessary repairs.
3. There are no joist hanger installed on the deck landing framing.

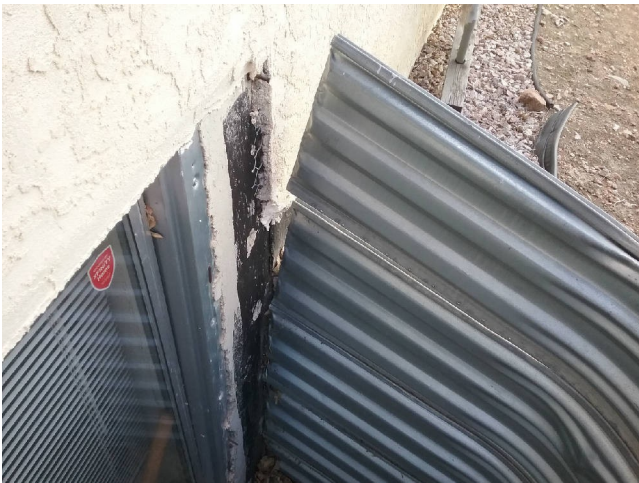
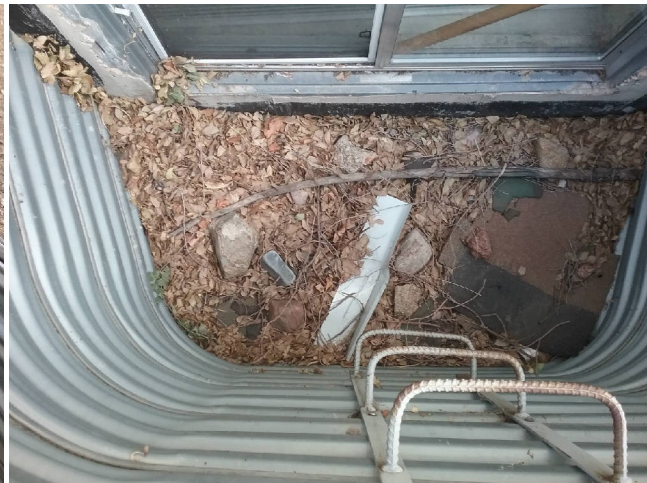
2. Window Wells: Not covered -

1. The West window well is not secured to the house.
2. Window wells had accumulated debris which should be cleared to encourage proper drainage and minimize the retaining of moisture near the foundation and habitat for pests and insects.

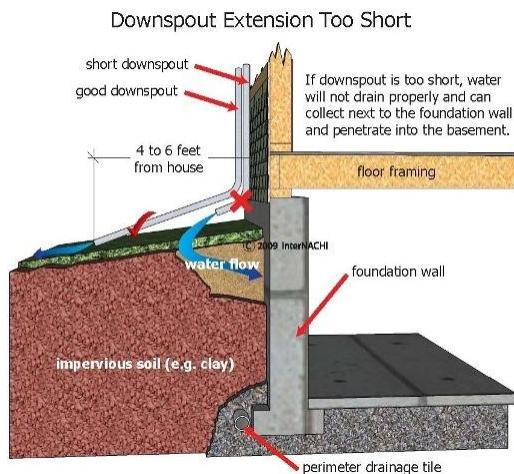
The Southeast rain leader (underground gutter drain) has pulled loose from the downspout on the side of the home. This should be reattached so that water does not pool next to the foundation.

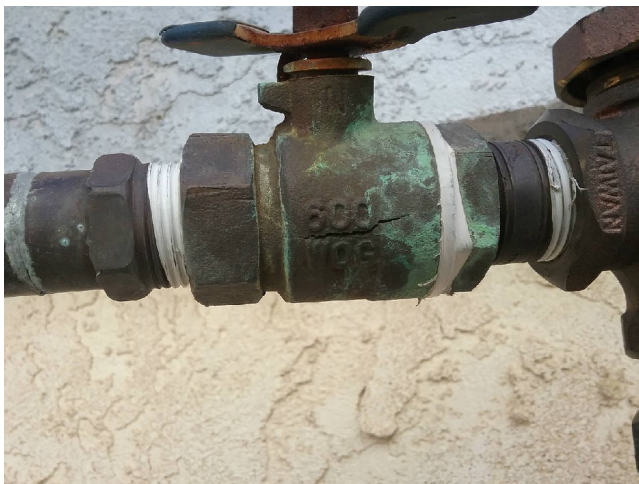
4. Lawn Sprinklers: Front and back yard -

There is frost damage to the 2636 sprinkler supply shut off valve. This will need to be repaired before the sprinkler is operational.

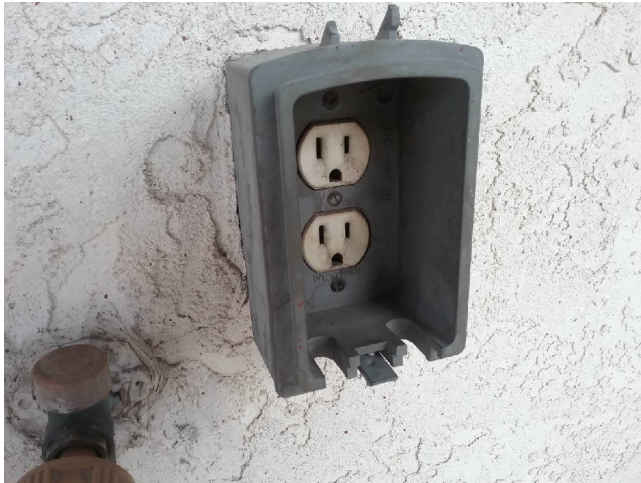
- Both front exterior outlets are missing their moisture cover.
- 2. The 3634 back exterior GFCI outlet would not trip when tested.

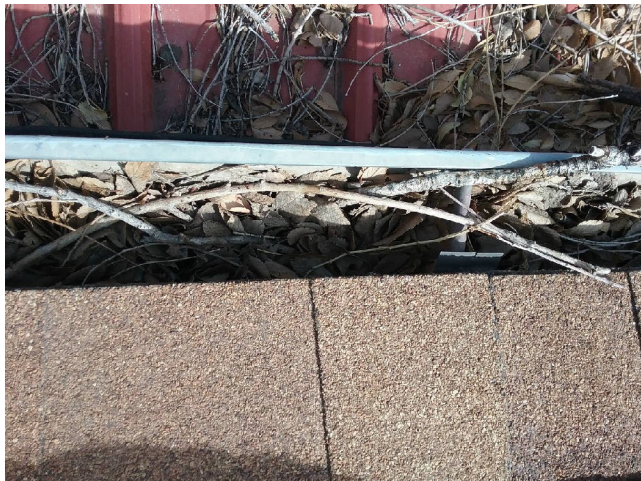
Debris (leaves, needles, etc) has accumulated in the gutters. This prevents the gutters from doing their job (directing rain water away from the foundation). In winter, water will freeze in the gutters and damage them. It may also cause ice jams on the roof. This can lead to leaks. Therefore, it is recommended that the gutters be cleaned at least twice a year to prevent debris buildup.

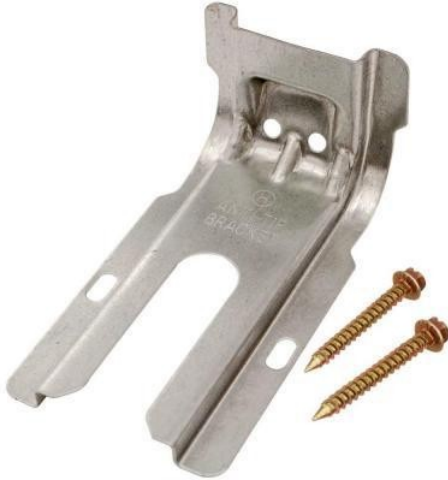
Recommend installing an anti-tip bracket on the range. These brackets have been a safety requirement since 1991.

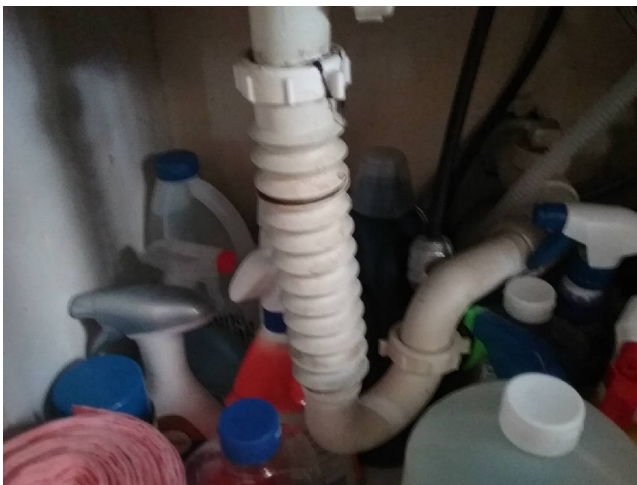
There was an unapproved, flexible, corrugated drainpipe in the 2636 kitchen that will contribute to blockages. Although it is functioning, it is recommended that this be replaced with the proper drain material.

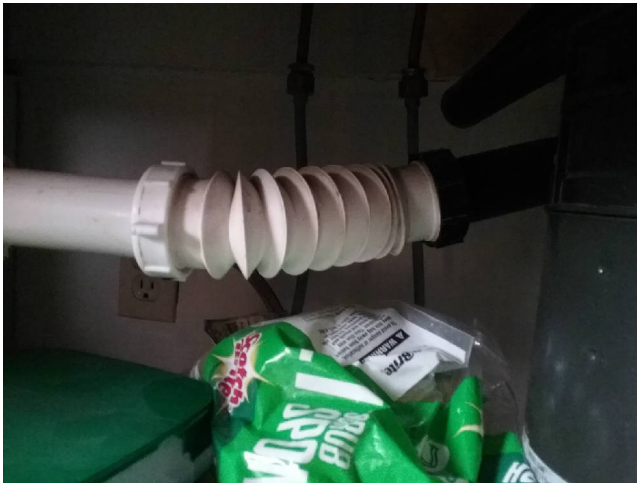
There was an unapproved, flexible, corrugated drainpipe in the 2634 kitchen that will contribute to blockages. Although it is functioning, it is recommended that this be replaced with the proper drain material.

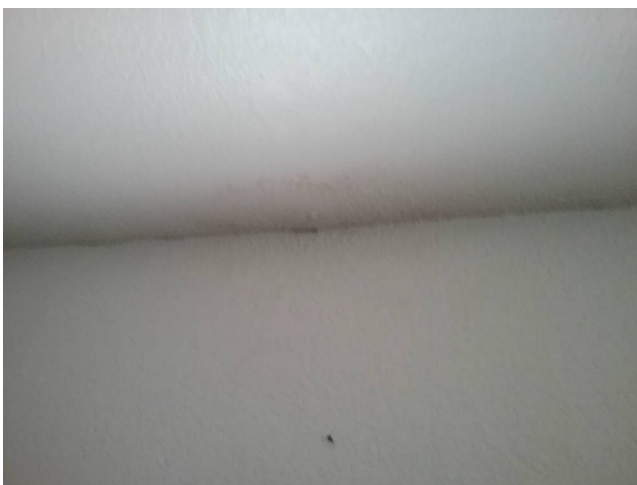
There is a water stain in the family room ceiling over the South 2636 window. This is due to there not being any ledger installed on upper deck. Recommend having a licensed contractor evaluate and make necessary repairs.

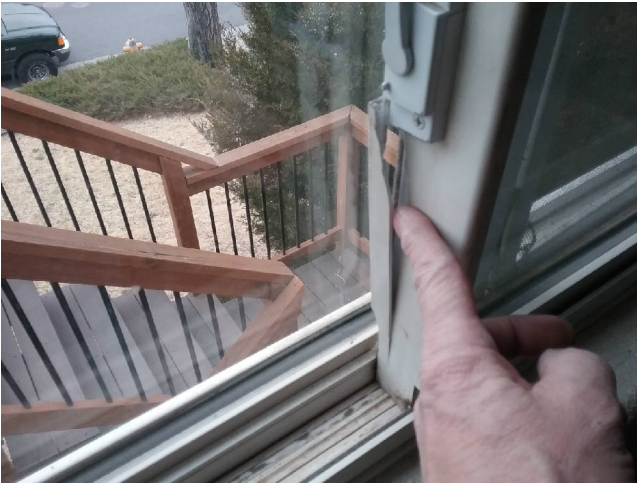
1. The pane of the South 2636 family room window is broken. Recommend replacing this window pane.
2. The West 2636 family room window has a broken seal, there is visible condensation marks between the two panes of glass (This does not mean the window will leak, but it will mean the window will stay foggy and it will lower its energy efficiency).
3. There is damage to the 2636 living room vinyl window.

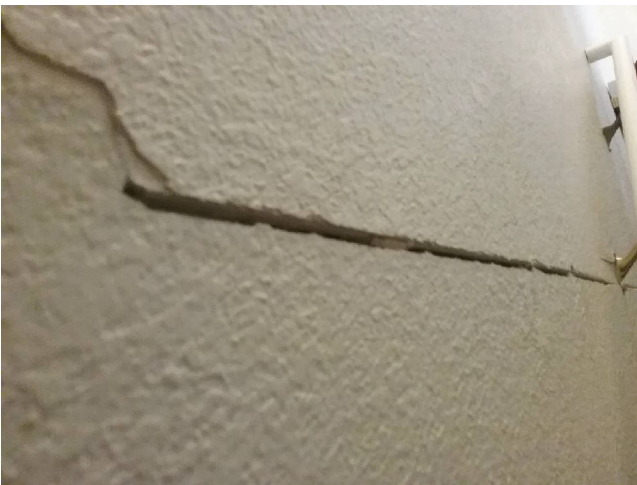
19. 2634 Living Space Walls: Drywall -

There were some significant cracks in the 2624 walls.

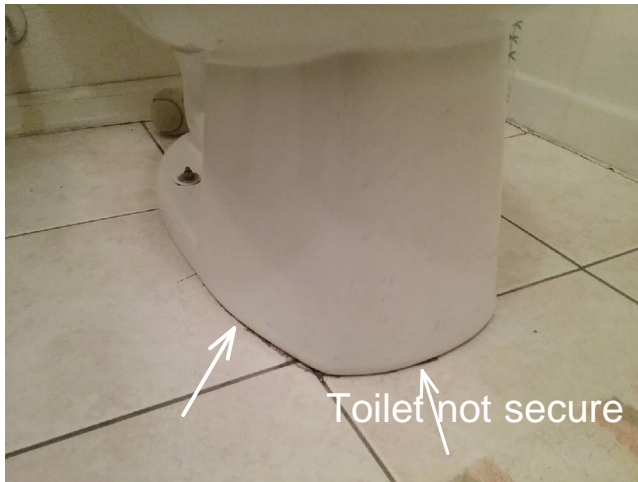
The 2634 main bathroom toilet is not secure at floor. Condition typically is caused by loose bolts. Loose toilets can result in damage to water supply lines, cause leaks, water damage, and mold, as well as damage to the toilet. Repairs may involve installing a new wax seal at the base of the toilet. It is recommended that this be repaired by a qualified plumbing contractor.

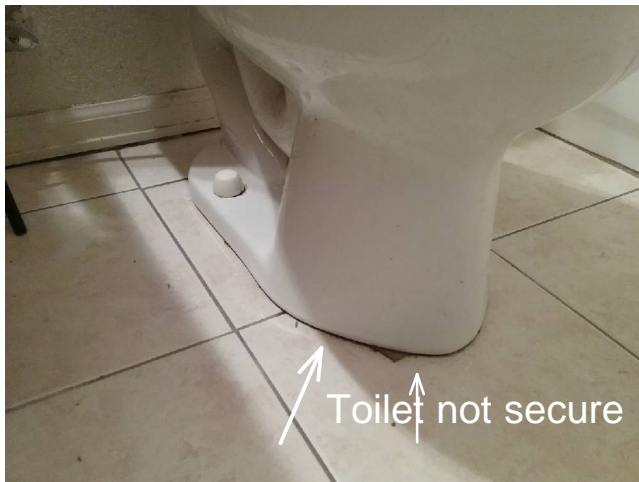
The 2634 lower level bathroom toilet is not secure at floor. Condition typically is caused by loose bolts. Loose toilets can result in damage to water supply lines, cause leaks, water damage, and mold, as well as damage to the toilet. Repairs may involve installing a new wax seal at the base of the toilet. It is recommended that this be repaired by a qualified plumbing contractor.

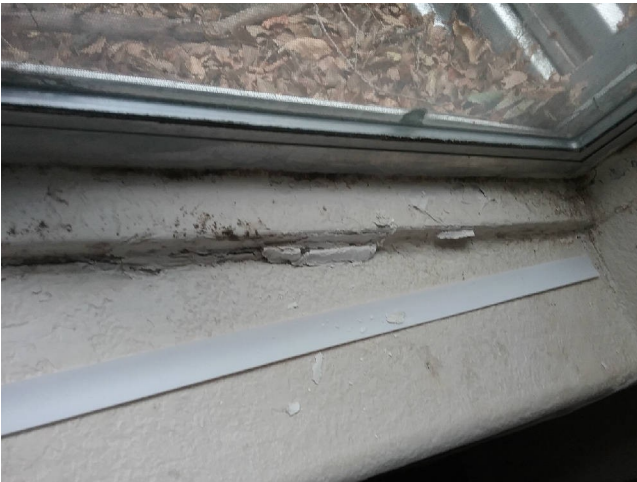
38. 2636 lower level Bedroom Windows: Aluminum slider -
There is a mold like substance around the 2636 Lower level bedroom window.

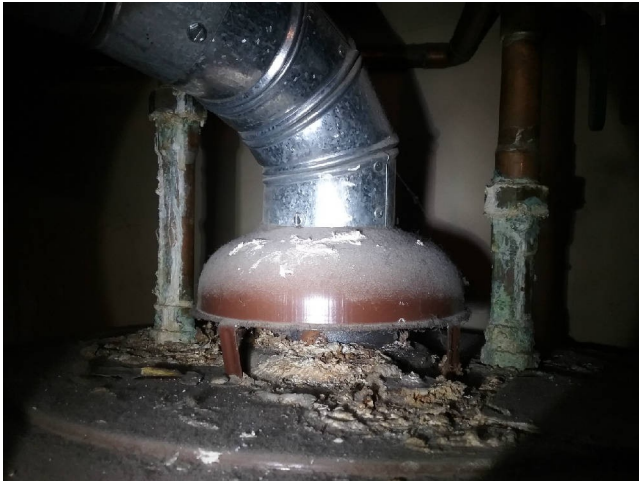
1. The 2634 water heater, although functional during the inspection, is beyond its "approximate" life expectancy (12 to 15 years) You may need to replace this water heater at some point in the near future.
2. There is corrosion on the 2634 water heater water pipes. Indicating a past water leak.

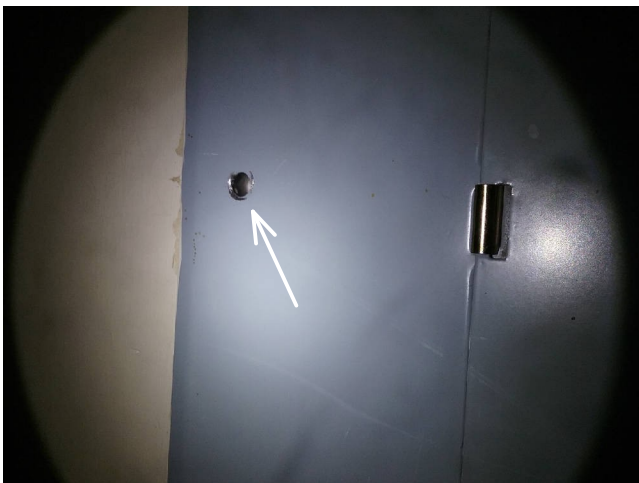
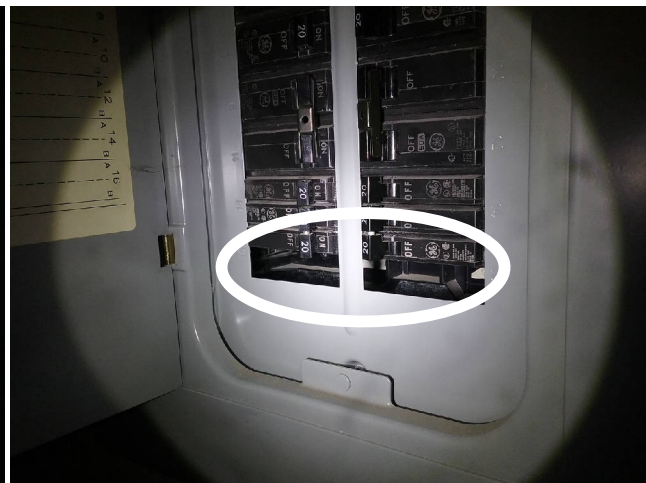
1. There is a panel screw missing on the 2636 electrical panel dead front cover. Recommend replacing screw with proper panel screw.
2. Knockouts missing in 2636 main electrical panel cover require snap-in caps. Have certified electrician evaluate and repair as necessary.

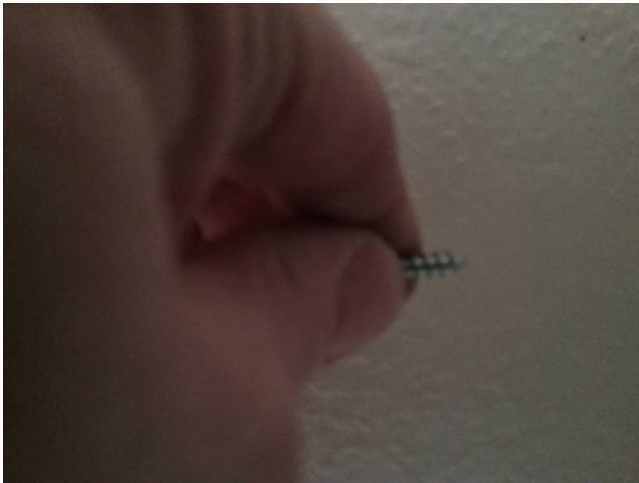
2. Non-standard panel cover screws present in both sub panels. Sharp pointed screws can come in contact with wiring and cause a fire hazard. Recommend screws be replaced with proper panel screws.
