Pro-Check Home Inspections

Property Inspection Report

618 Sample St
Colorado Springs, Colorado 80903

08/25/2018

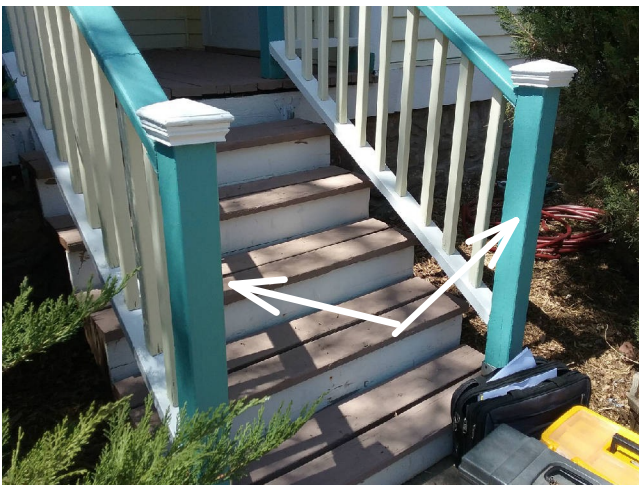
The lower newel posts on the front porch are not secure. Recommend having a licensed contractor evaluate and make necessary repairs.

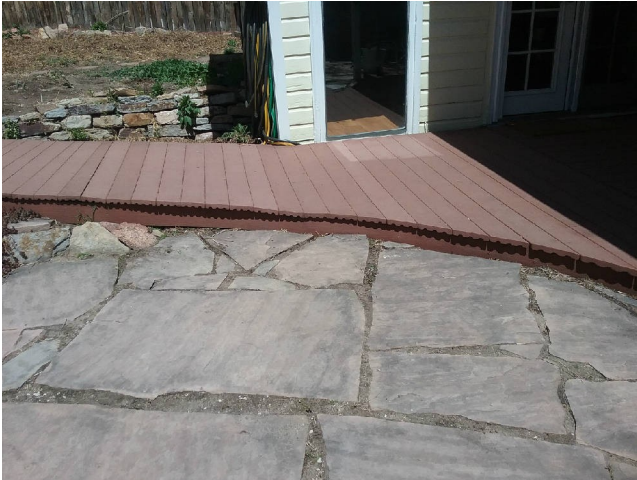
The wood deck was built on grade so we were unable to inspect the underside. It does appear functional with no observable signs of defects but decks built on grade are much more susceptible to dry rot. This deck may need maintenance within the next several years.

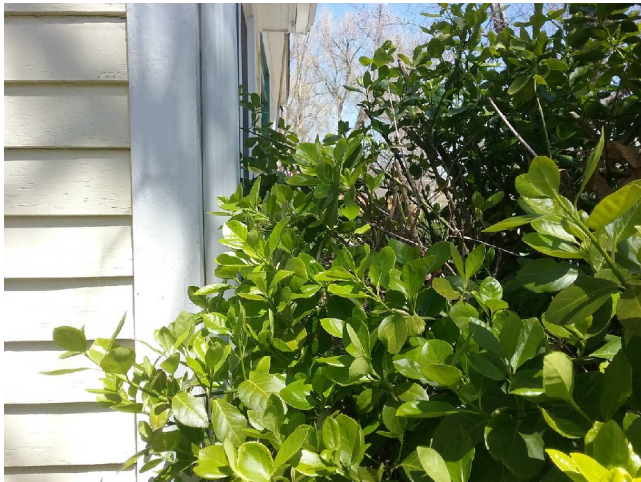
Vegetation: Trees -

Vegetation such as trees, shrubs and/or vines are in contact with or less than one foot from the structure's exterior. Vegetation can serve as a conduit for wood destroying insects and may retain moisture against the exterior after it rains. Vegetation should be pruned and/or removed as necessary to maintain a one foot clearance between it and the structure's exterior.

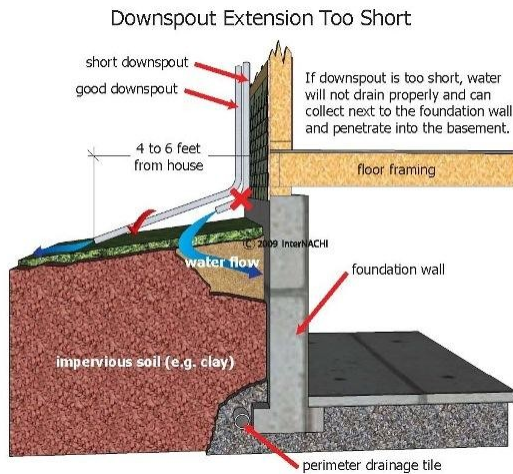
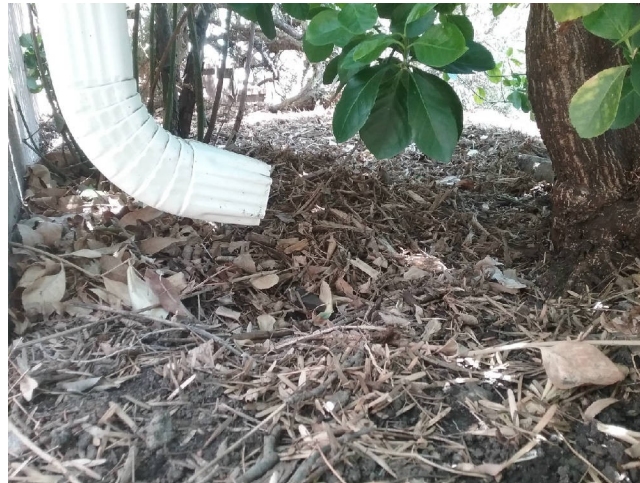
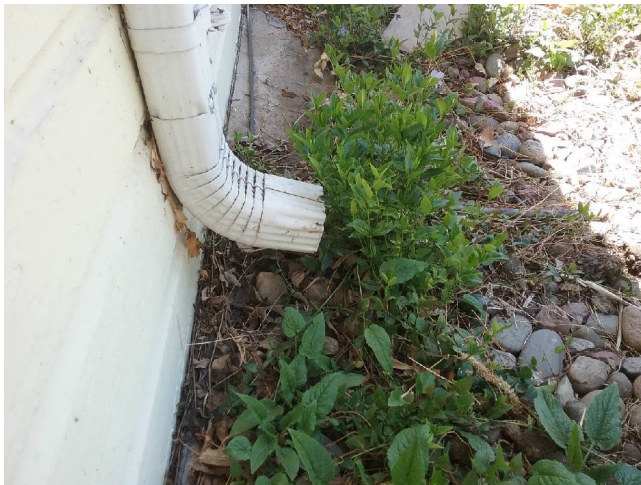
We recommend installing downspout extensions where there are none currently. This is to ensure that water does not pool next to the foundation.

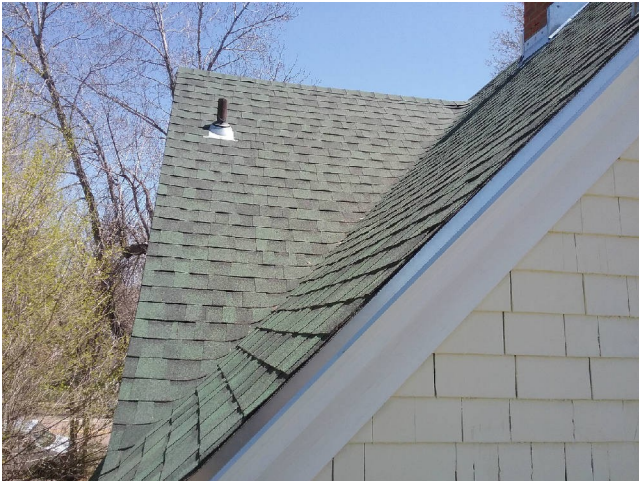
Because of the steep roof pitch we deemed it unsafe to walk to the roof. Because of this we were unable to inspect the roofing material up close. Recommend a licensed roofing contractor inspect and certify the roof.

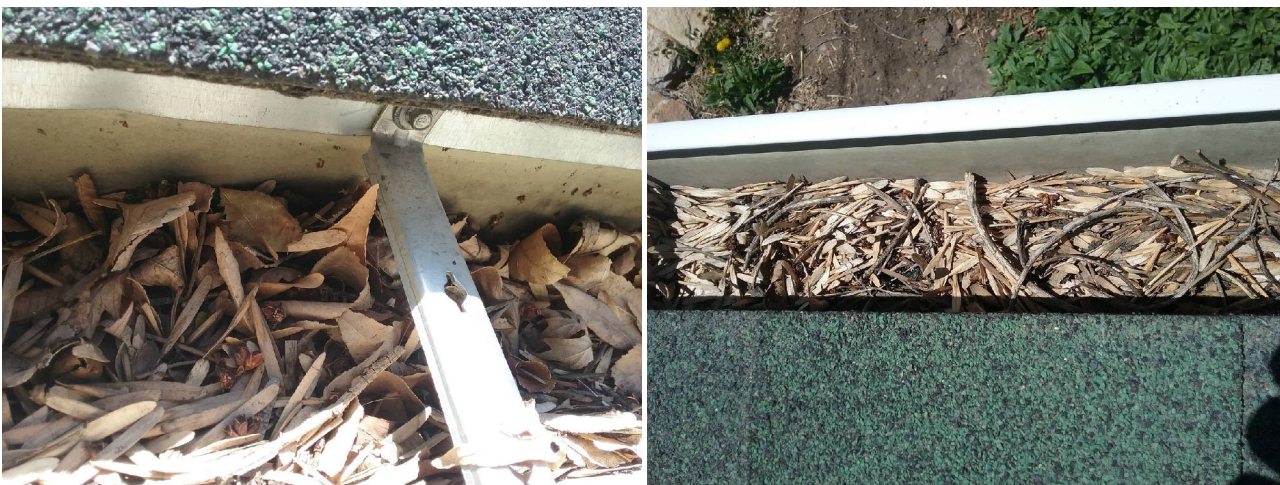
Debris (leaves, needles, etc) has accumulated in the gutters. This prevents the gutters from doing their job (directing rain water away from the foundation). In winter, water will freeze in the gutters and damage them. It may also cause ice jams on the roof. This can lead to leaks. Therefore, it is recommended that the gutters be cleaned at least twice a year to prevent debris buildup.

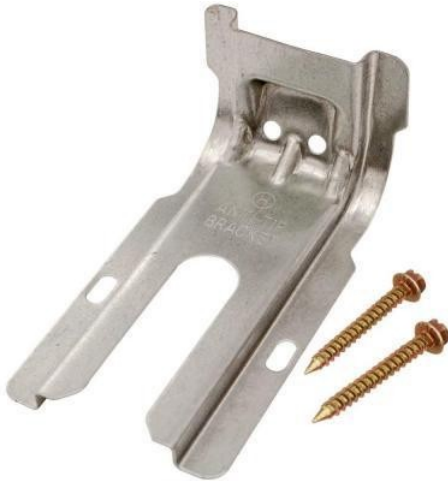
Range Anti-tip Bracket: None present -

Recommend installing an anti-tip bracket on the range. These brackets have been a safety requirement since 1991.

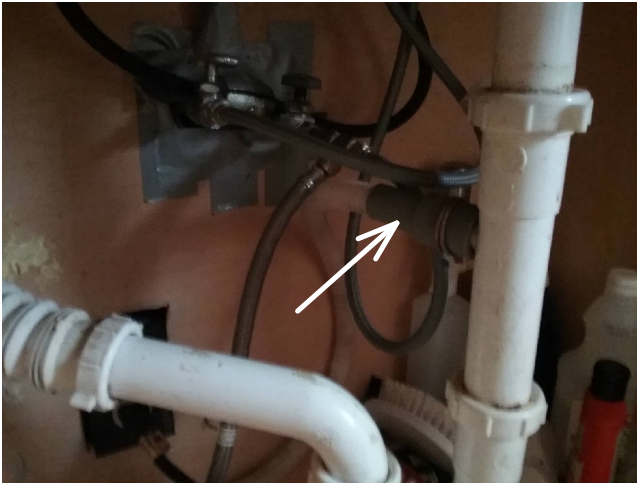
Dishwasher: Whirlpool -

The dishwasher is currently draining into the drain pipe with no "high-loop" in the drain line. Adding a "high-loop" in this drain line is required.

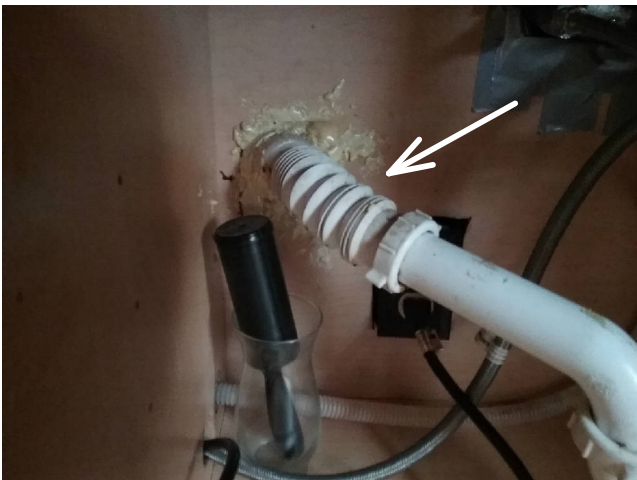
There was an unapproved, flexible, corrugated drainpipe in the kitchen that will contribute to blockages. Although it is functioning, it is recommended that this be replaced with the proper drain material.

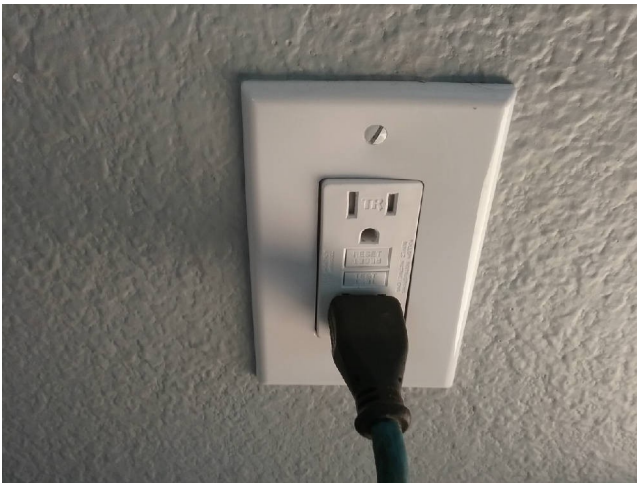
2. During the inspection the North and East living room 3-prong outlet was tested and found to not be grounded (open ground).

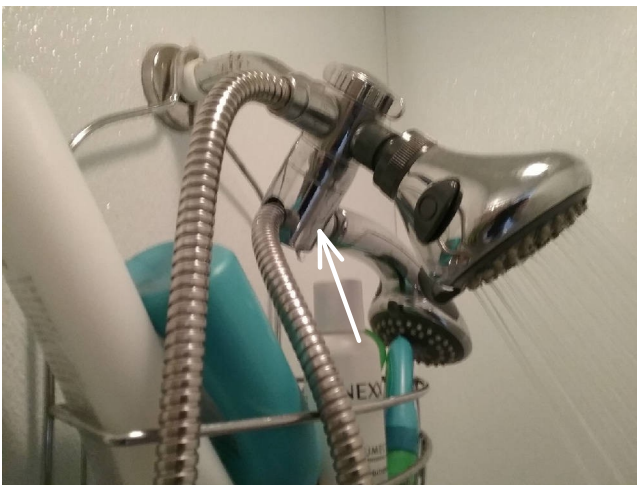
Water leaks from around the Jack and Jill bathroom shower head at the swivel.

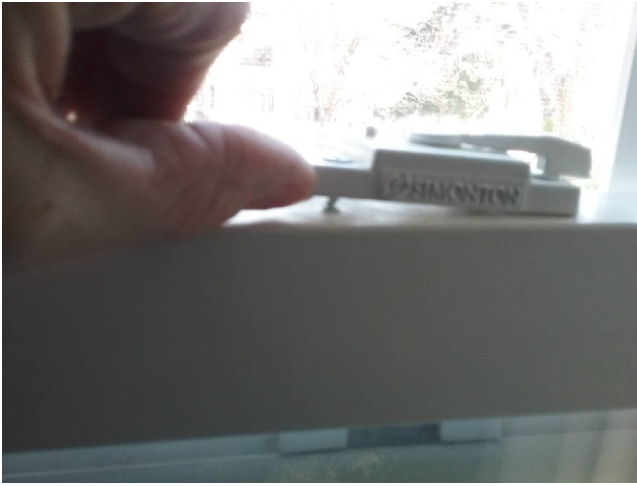
The right Southeast bedroom window lock is loose and should be secured to The sash.

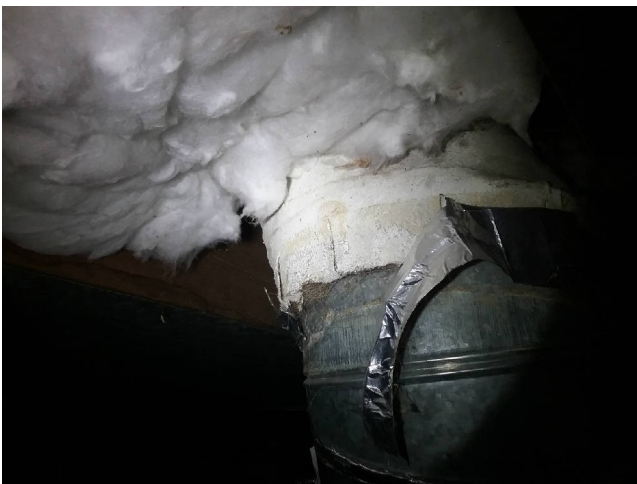
Distribution: Metal duct -

UNKNOWN MATERIAL / SUBSTANCE INSULATING DUCTS / PIPES / UNIT RECOMMEND TESTING FOR ASBESTOS - The inspector has indicated that there is an unknown substance/material insulating the ducts. The only way to positively identify this material is to have an approved lab test it for hazardous material including Asbestos. Asbestos is a carcinogen. If Asbestos or another hazardous material is detected, recommend having it properly removed by a qualified environmental company.

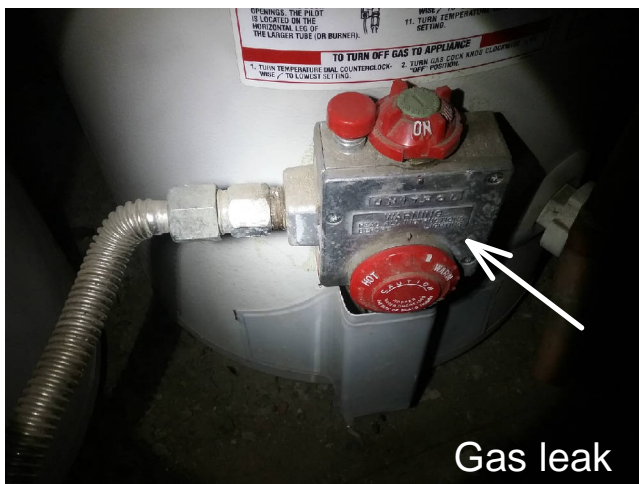
The GE water heater has a gas leak at it's control valve.

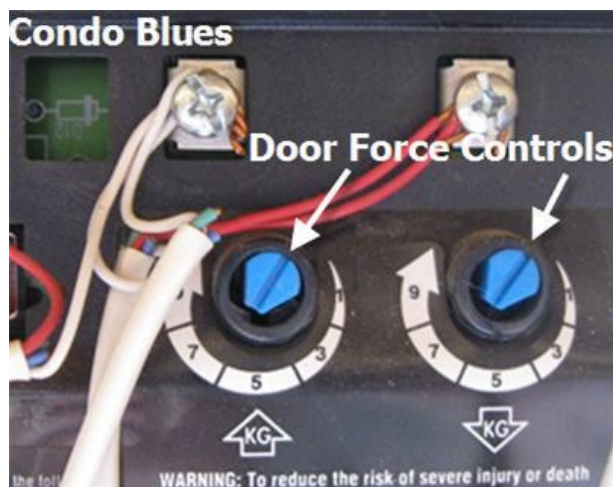
The South garage door opener did not automatically reverse under resistance to closing. There is a serious risk of injury, particularly to children, under this condition. The opener is tested with a 2x4 lying flat on the floor per most manufactures directions and the opener may need the force close adjusted or the unit may need replacement. Recommend a qualified trained professional for further review.

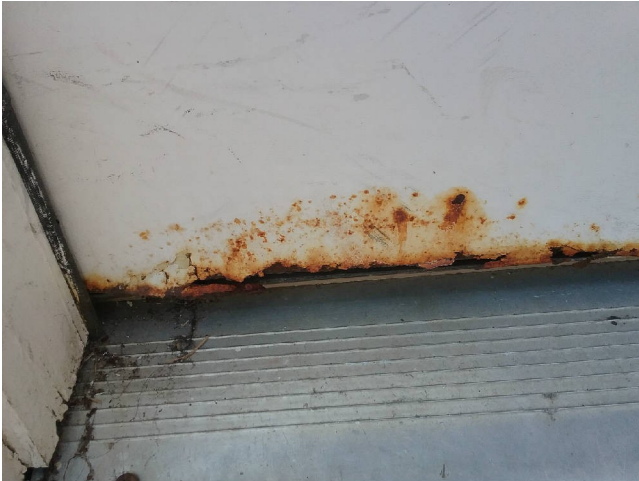
The garage entry door is rusted and deteriorating at the bottom.

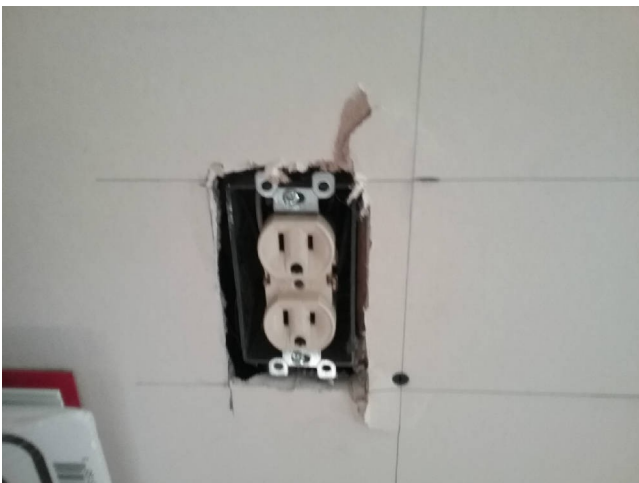
The South outlet in the garage is missing it's cover plate. This condition leaves energized electrical components exposed to touch.

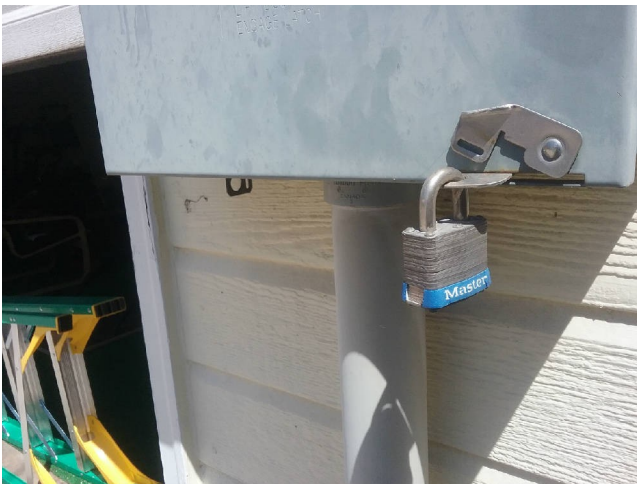
Garage service panel not inspected.

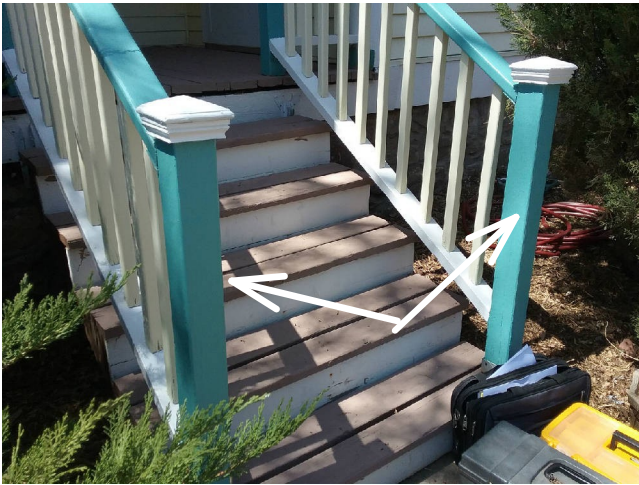
The lower newel posts on the front porch are not secure. Recommend having a licensed contractor evaluate and make necessary repairs.

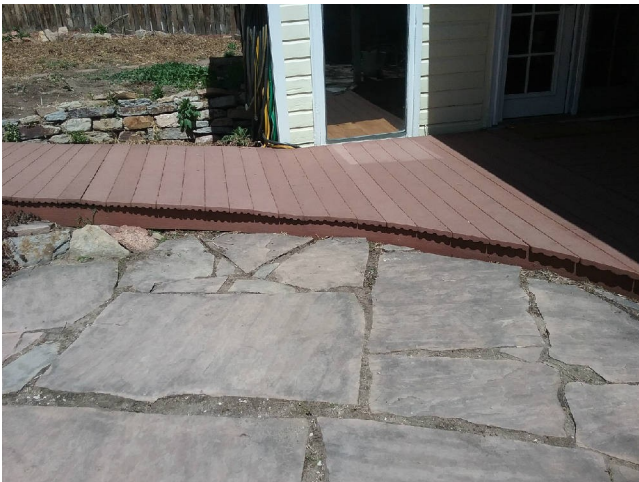
2. Deck: Composite -

The wood deck was built on grade so we were unable to inspect the underside. It does appear functional with no observable signs of defects but decks built on grade are much more susceptible to dry rot. This deck may need maintenance within the next several years.

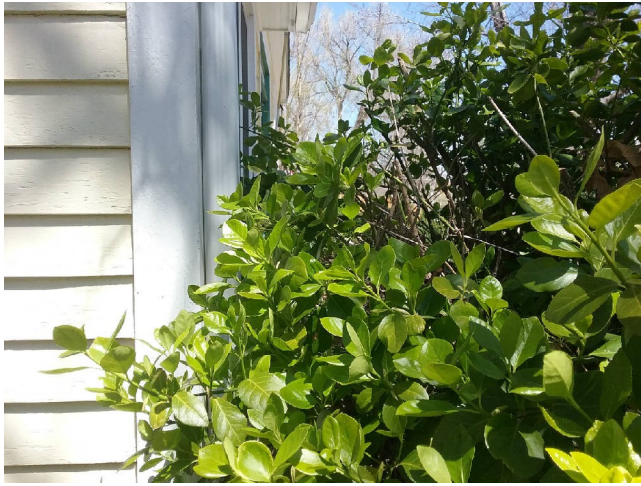
Vegetation such as trees, shrubs and/or vines are in contact with or less than one foot from the structure's exterior. Vegetation can serve as a conduit for wood destroying insects and may retain moisture against the exterior after it rains. Vegetation should be pruned and/or removed as necessary to maintain a one foot clearance between it and the structure's exterior.

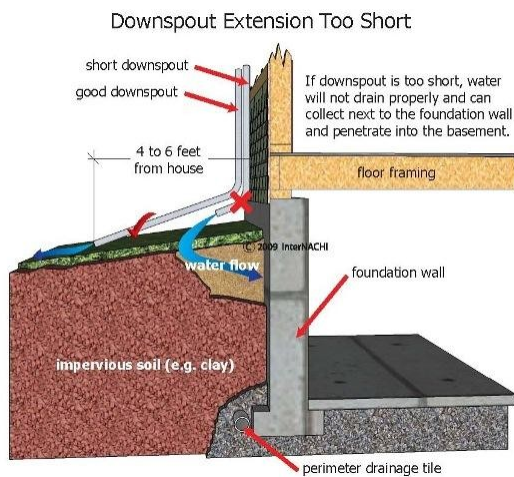
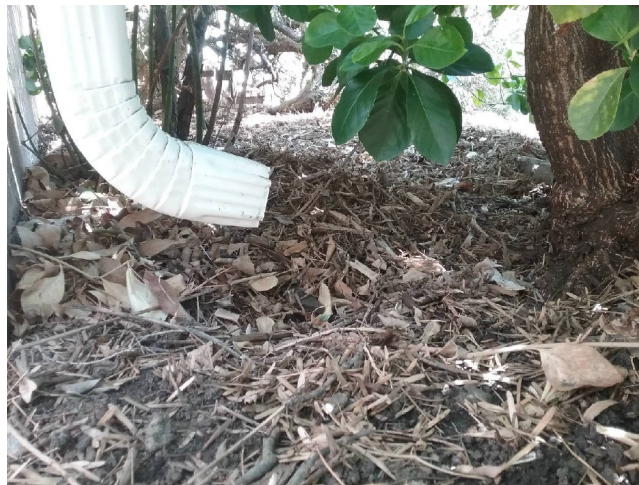
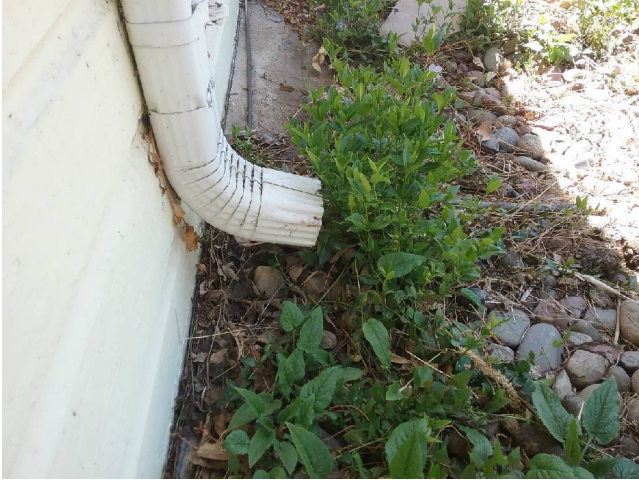
4. Leader/Extension: Extension needed -

We recommend installing downspout extensions where there are none currently. This is to ensure that water does not pool next to the foundation.

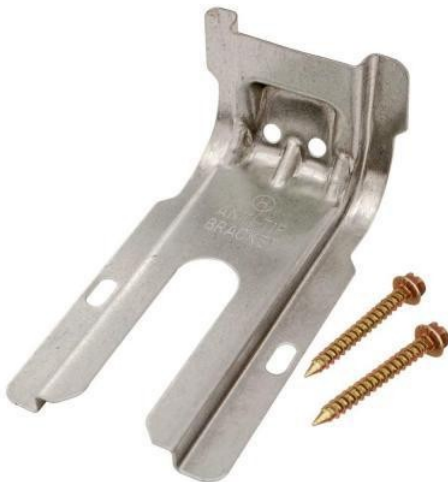
Recommend installing an anti-tip bracket on the range. These brackets have been a safety requirement since 1991.

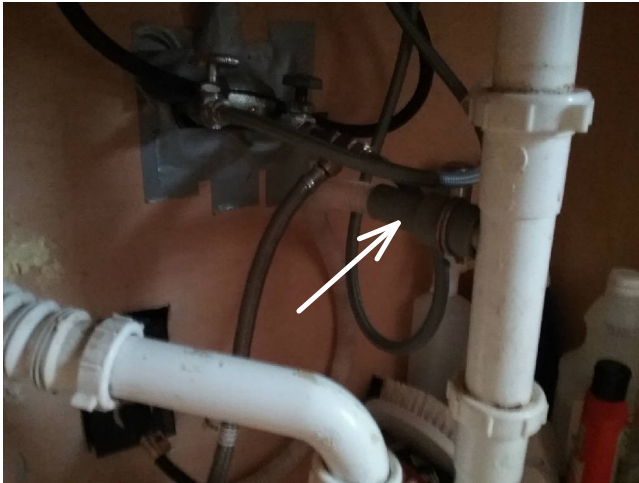
The dishwasher is currently draining into the drain pipe with no "high-loop" in the drain line. Adding a "high-loop" in this drain line is required.

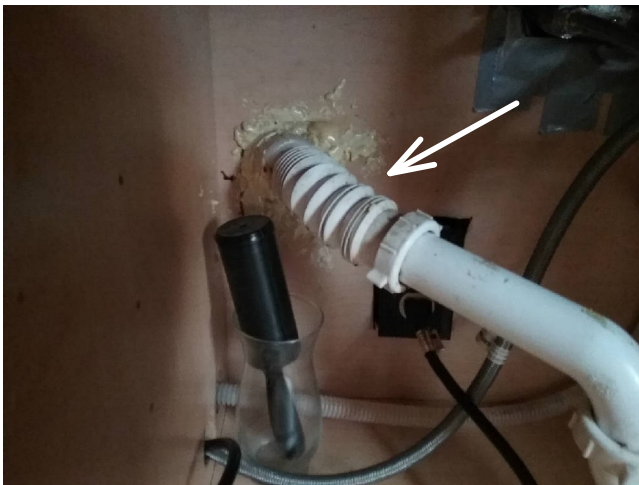
12. 1st Floor Kitchen Traps & Drains: Appears functional -

There was an unapproved, flexible, corrugated drainpipe in the kitchen that will contribute to blockages. Although it is functioning, it is recommended that this be replaced with the proper drain material.

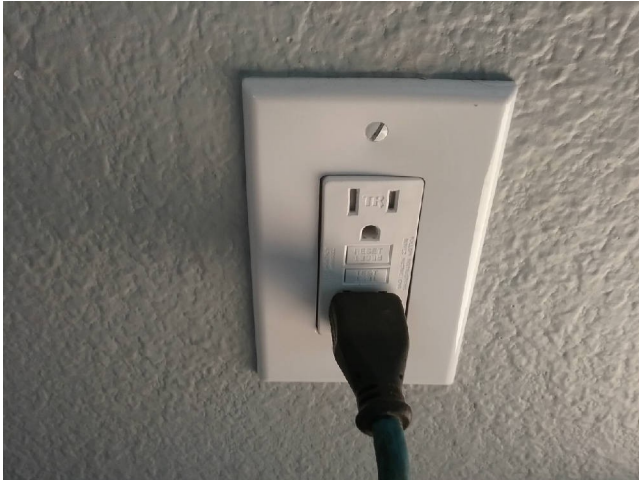
1. The sun room GFCI outlet is not properly wired. Would not trip.
2. During the inspection the North and East living room 3-prong outlet was tested and found to not be grounded (open ground).

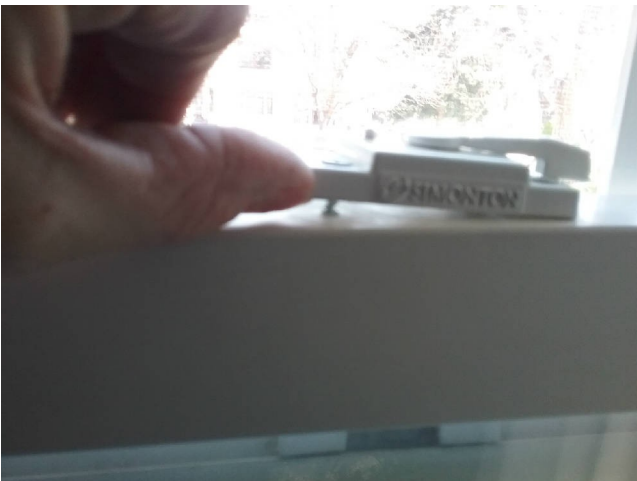
The right Southeast bedroom window lock is loose and should be secured to The sash.

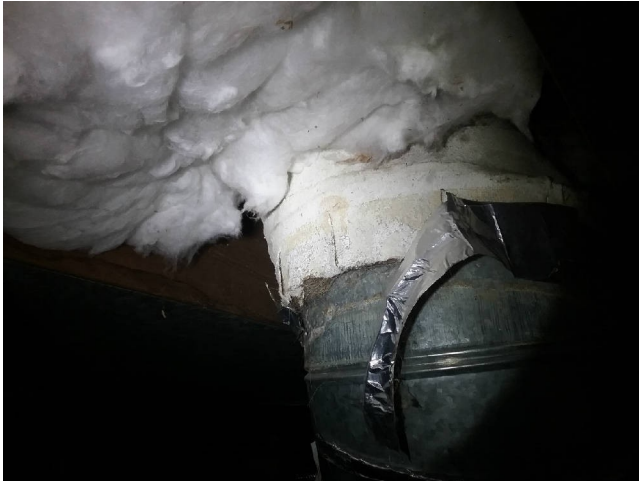
26. Basement Heating System Distribution: Metal duct -
UNKNOWN MATERIAL / SUBSTANCE INSULATING DUCTS / PIPES / UNIT RECOMMEND TESTING FOR ASBESTOS - The inspector has indicated that there is an unknown substance/material insulating the ducts. The only way to positively identify this material is to have an approved lab test it for hazardous material including Asbestos. Asbestos is a carcinogen. If Asbestos or another hazardous material is detected, recommend having it properly removed by a qualified environmental company.

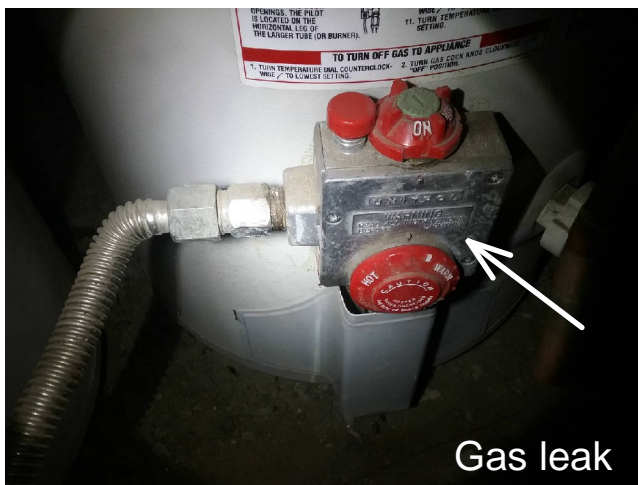
The GE water heater has a gas leak at it's control valve.

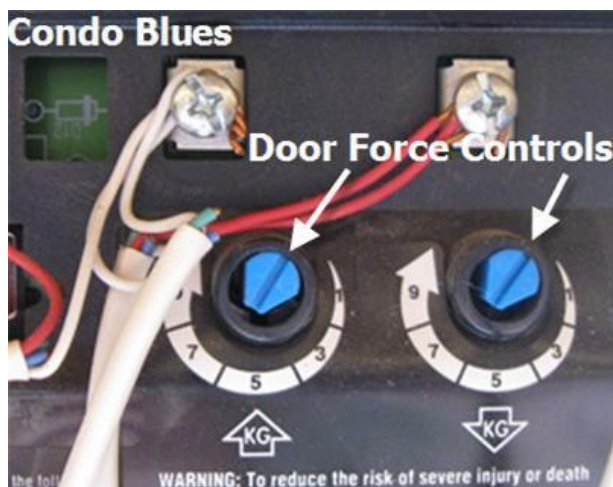
The South garage door opener did not automatically reverse under resistance to closing. There is a serious risk of injury, particularly to children, under this condition. The opener is tested with a 2x4 lying flat on the floor per most manufactures directions and the opener may need the force close adjusted or the unit may need replacement. Recommend a qualified trained professional for further review.

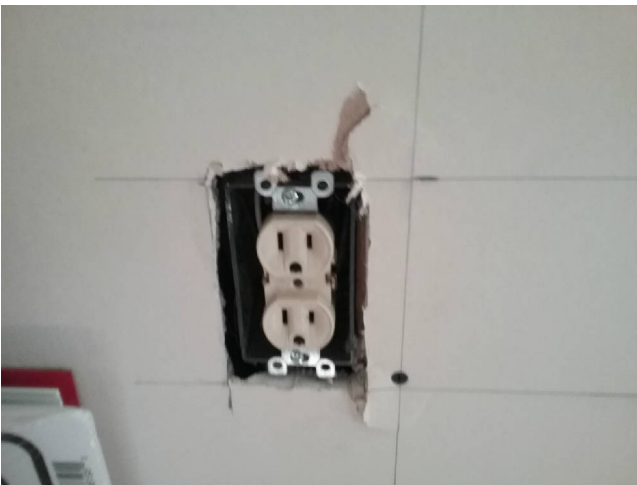
40. Detached Garage Electrical: 110 VAC -

The South outlet in the garage is missing it's cover plate. This condition leaves energized electrical components exposed to touch.
