Pro-Check Home Inspections

Property Inspection Report

2017 - 2031 E Sample St
Colorado Springs, Colorado 80909

10/01/2018

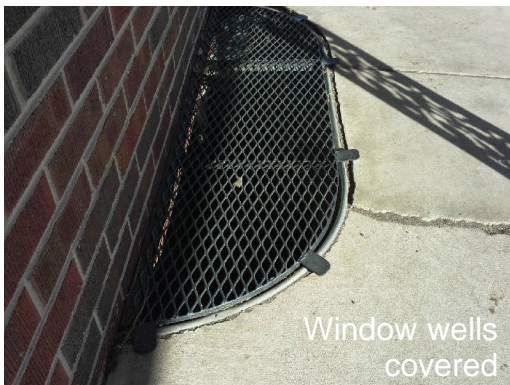
Window Wells: Covered

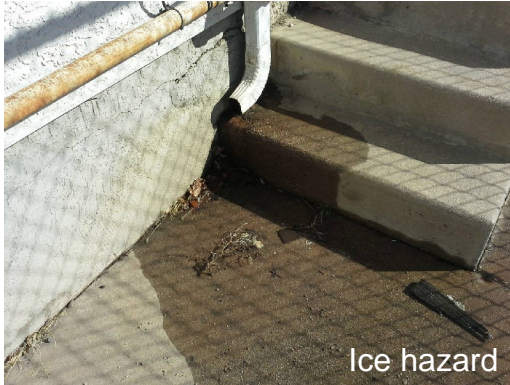
Leader/Extension: Functional - 1. The rear downspout at 2025 is discharging water on bottom step. This is a potential ice hazard in the winter.

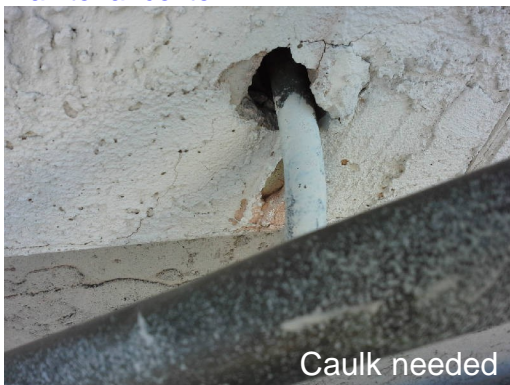
Siding type: Wood/Brick - 1. Penetrations in the stucco are in need of caulking (around pipes). This can allow moisture and insect entry. These areas will need to be monitored and caulked as needed. This is a normal maintenance item.

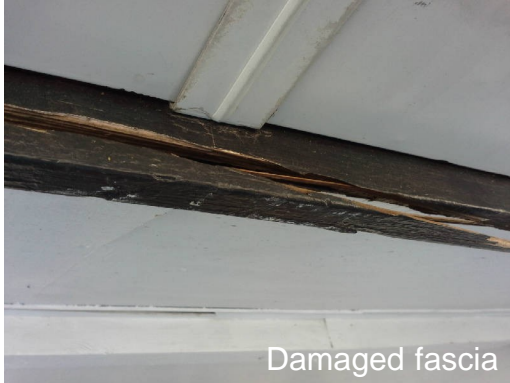
Fascia & Soffits: Wood - 1. There is damage to the fascia at 2029.

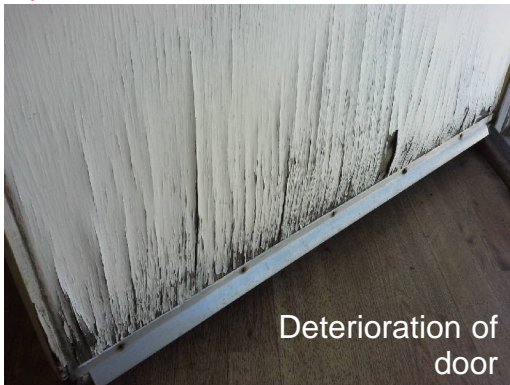
Entry Doors: Aluminum full glass - 1. The rear wood entry door in unit 2017 is deteriorated. This door will need replacement soon.

1. The rear wood entry door in unit 2017 is deteriorated. This door will need replacement soon.

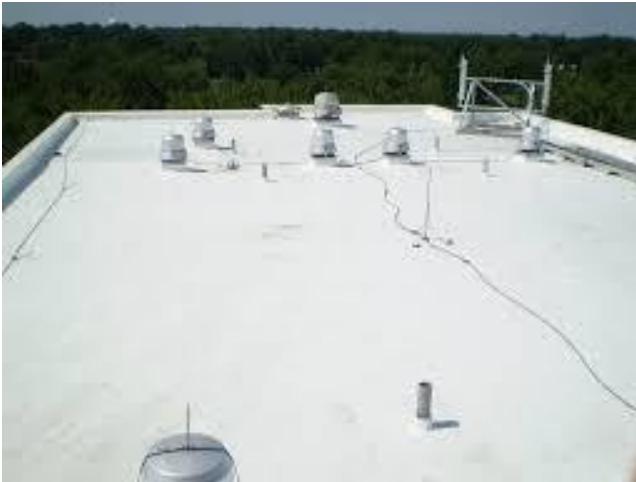
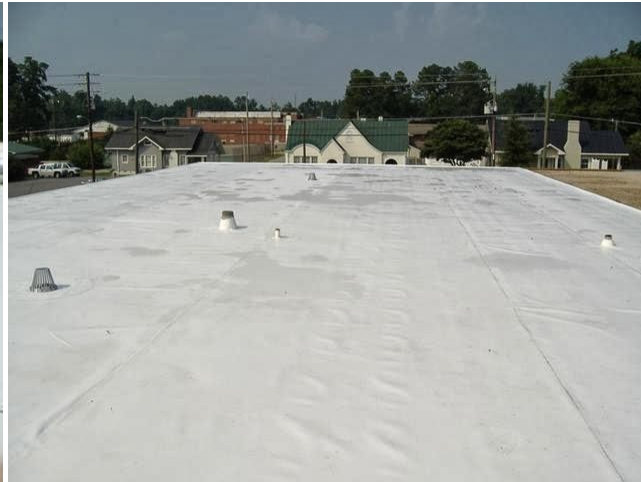
Material: Vinyl sheet

Number of Layers Present: 1 Layer

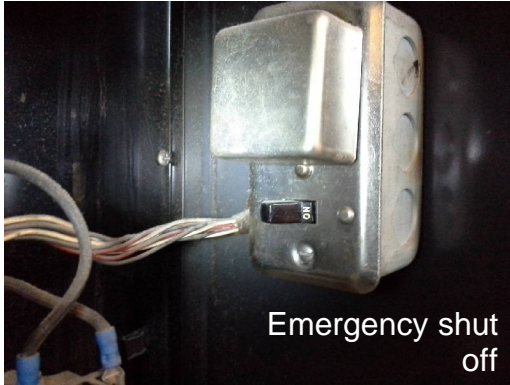
Emergency Shut Off: Yes See picture. Use this switch when doing any work on the furnace and when changing the furnace filter.

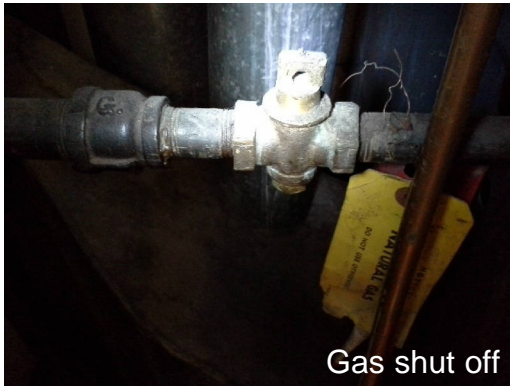
Gas Shut Off: Yes See picture. You can turn the handle a quarter turn to shut off the valve. When the handle is in line with the pipe it is on and when it is perpendicular with the pipe it is off.

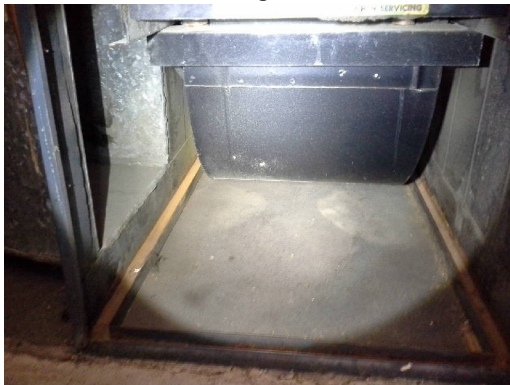
Furnace Filter: Fiberglass 16 X 25 & 20 X 25

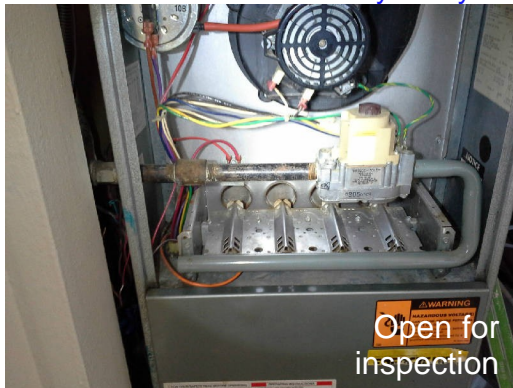
Heating System Operation: Adequate - 1. The furnace is a little bit dusty but not yet dirty. Recommend it be cleaned and serviced within the next year by a licensed HVAC contractor.

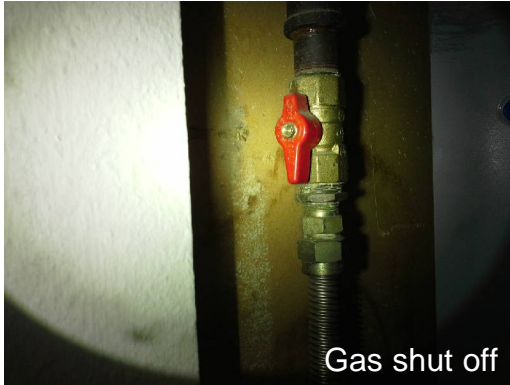
Gas Shut Off: Yes See picture. You can turn the handle a quarter turn to shut off the valve. When the handle is in line with the pipe it is on and when it is perpendicular with the pipe it is off.

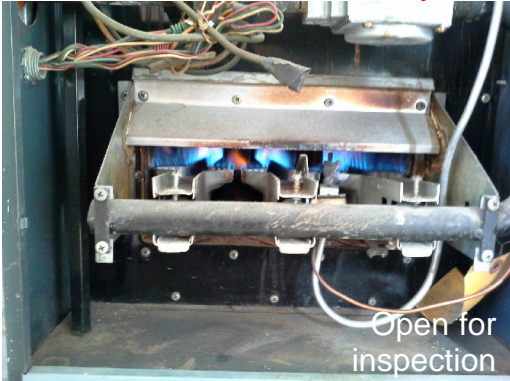
Heating System Operation: Adequate - **1. Due to the age of the furnace, we recommend having it serviced by a licensed HVAC contractor, certify, and inspect the heat exchanger for cracks.**

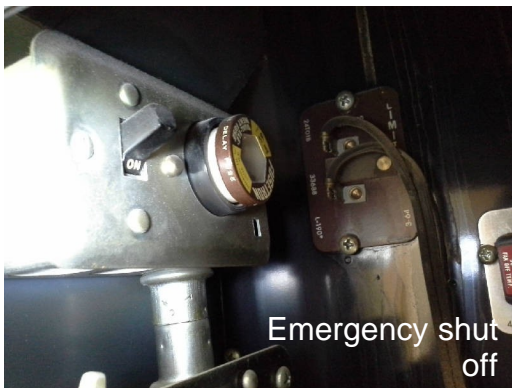
Emergency Shut Off: Yes **See picture. Use this switch when doing any work on the furnace and when changing the furnace filter.**

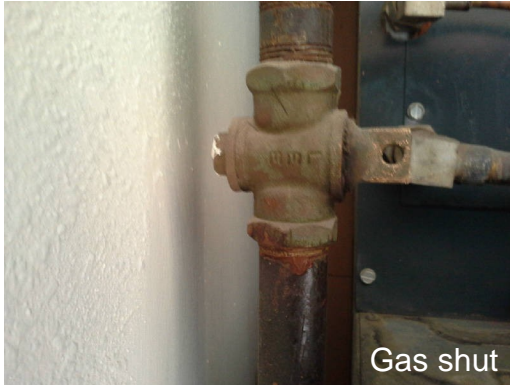
Gas Shut Off: Yes See picture. You can turn the handle a quarter turn to shut off the valve. When the handle is in line with the pipe it is on and when it is perpendicular with the pipe it is off.

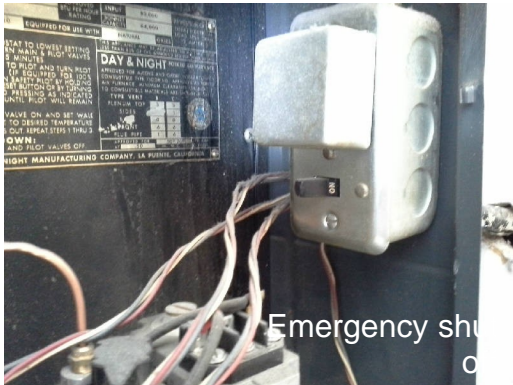
Emergency Shut Off: Yes See picture. Use this switch when doing any work on the furnace and when changing the furnace filter.

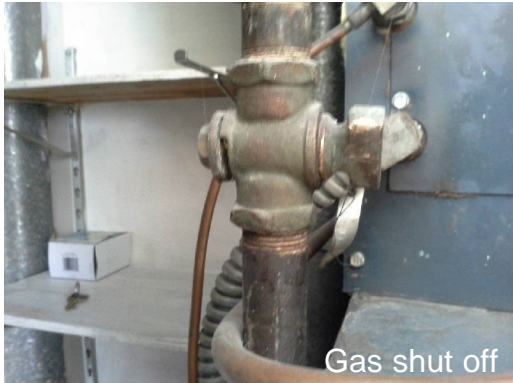
Gas Shut Off: Yes See picture. You can turn the handle a quarter turn to shut off the valve. When the handle is in line with the pipe it is on and when it is perpendicular with the pipe it is off.

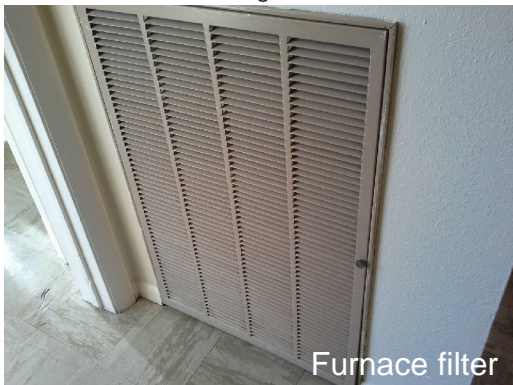
Furnace Filter: Fiberglass 20 X 30

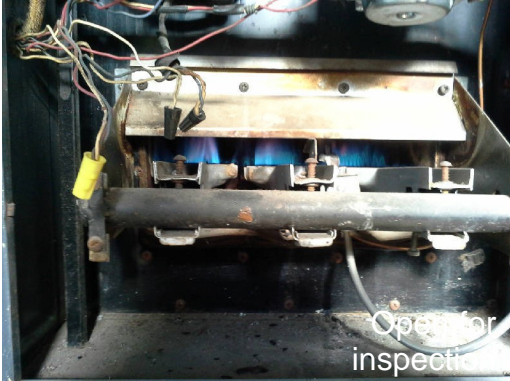
Heating System Operation: Adequate - **1. Due to the age of the furnace, we recommend having it serviced by a licensed HVAC contractor, certify, and inspect the heat exchanger for cracks.**

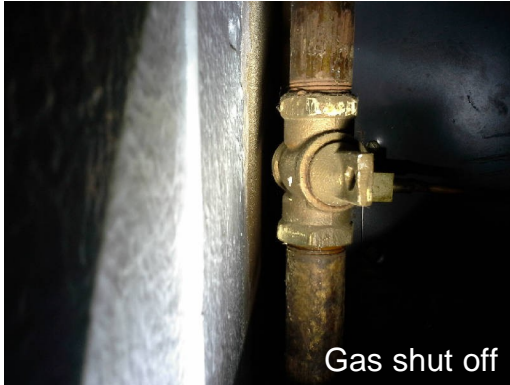
Gas Shut Off: Yes See picture. You can turn the handle a quarter turn to shut off the valve. When the handle is in line with the pipe it is on and when it is perpendicular with the pipe it is off.

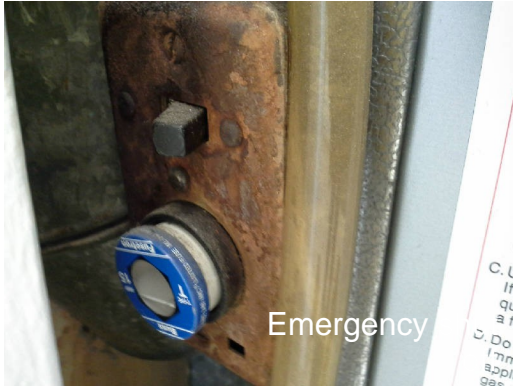
Emergency Shut Off: Yes See picture. Use this switch when doing any work on the furnace and when changing the furnace filter.

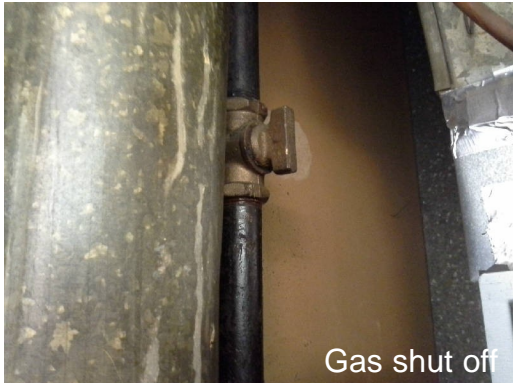
Gas Shut Off: Yes See picture. You can turn the handle a quarter turn to shut off the valve. When the handle is in line with the pipe it is on and when it is perpendicular with the pipe it is off.

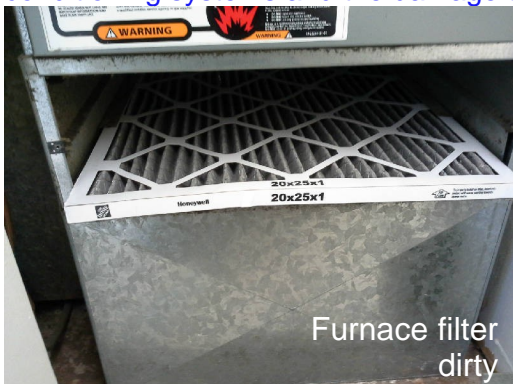
Furnace Filter: Fiberglass 20 X 25 - 1. Air filter needs replacement. Clogged filters can restrict airflow and increase internal temperatures, possibly resulting in fires. A clean air filter will help increase the efficiency and prolong the life expectancy of the heating and cooling system. Due to the expense of repairing or replacing heating and air conditioning systems and the damage that can be caused by dirty or clogged coils, recommend replacing filter

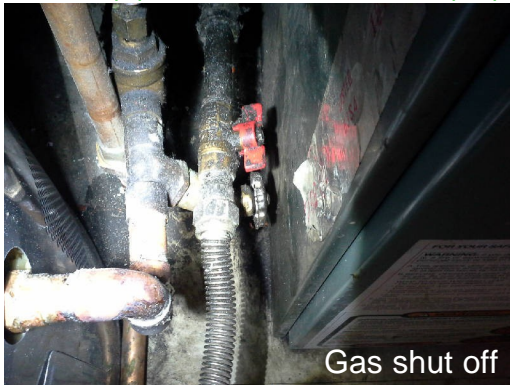
Gas Shut Off: Yes **See picture. You can turn the handle a quarter turn to shut off the valve. When the handle is in line with the pipe it is on and when it is perpendicular with the pipe it is off.**

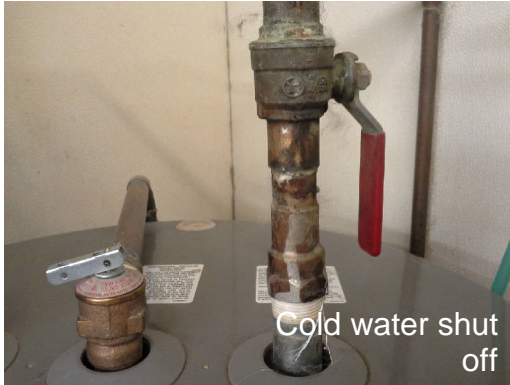
Cold Water Shut Off: Yes See picture. If the water heater ever starts leaking you can turn this valve off and turn the gas off to the water heater and then call a plumber.

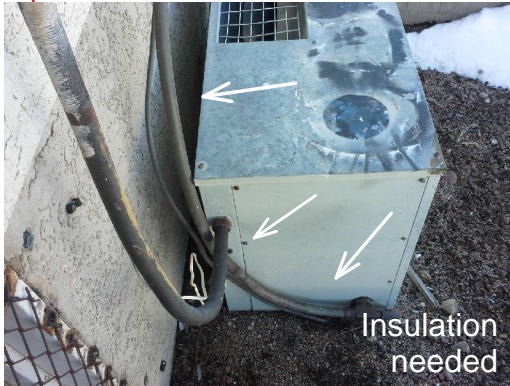
Refrigerant Lines: Repair needed - 1. The exterior AC unit's refrigerant line insulation, unit 2017 is in need of replacement.

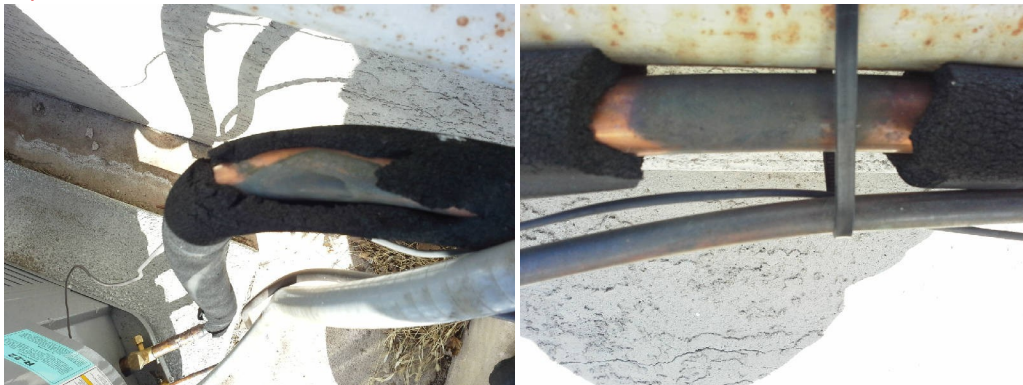
Refrigerant Lines: Repair needed - 1. The exterior AC unit's refrigerant line insulation, unit 2021 is in need of replacement.

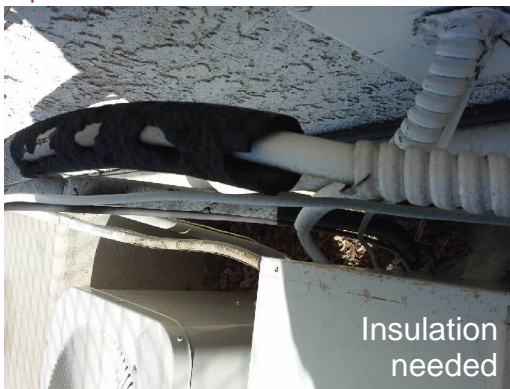
Refrigerant Lines: Repair needed - 1. The exterior AC unit's refrigerant line insulation, unit 2025 is in need of replacement.

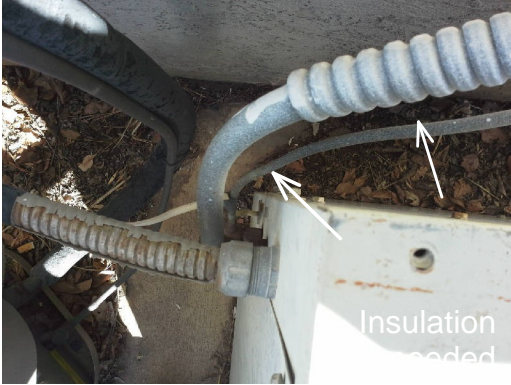
Refrigerant Lines: Repair needed - 1. The exterior AC unit's refrigerant line insulation, unit 2027 is in need of replacement.

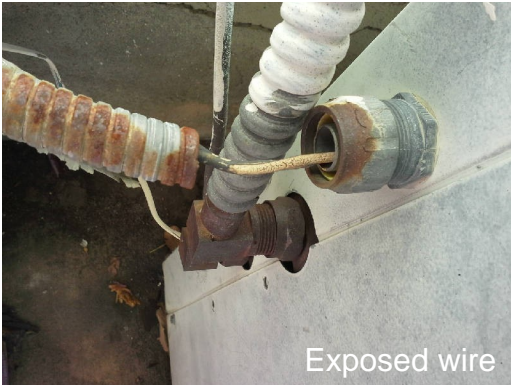
Electrical Disconnect: Breaker disconnect - 1. There are exposed 220 electrical wire for the 2029 air conditioning unit.

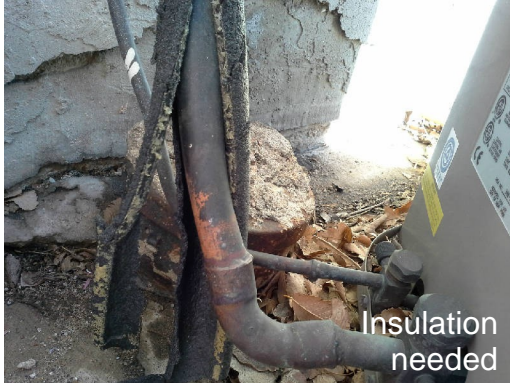
Refrigerant Lines: Repair needed - 1. The exterior AC unit's refrigerant line insulation is in need of replacement.

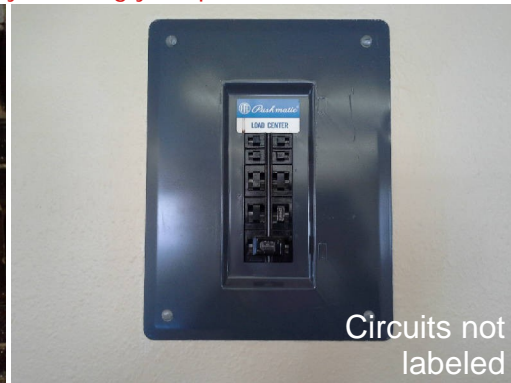
2. The circuits are not properly labeled at dead front cover. This is important in an emergency to know what circuit breaker to turn off. I recommend properly labeling your panel.

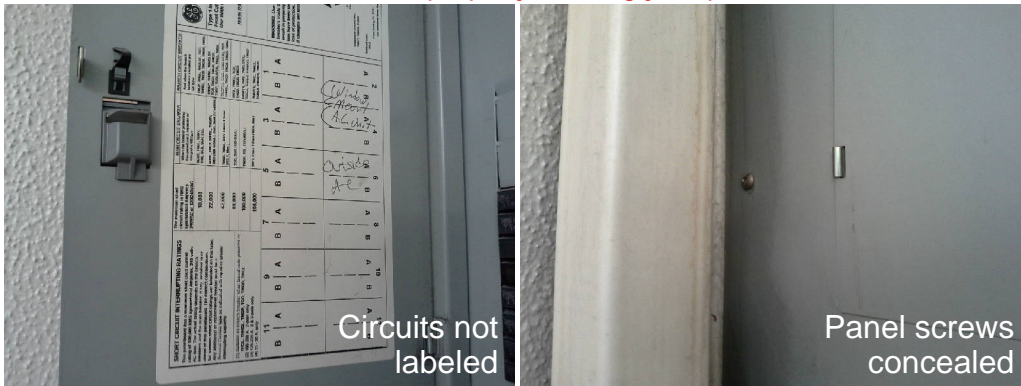
1. The circuits are not properly labeled at dead front cover. This is important in an emergency to know what circuit breaker to turn off. I recommend properly labeling your panel.

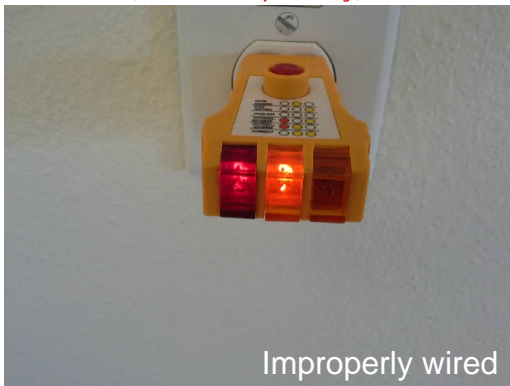
Electrical: 110 VAC - 1. The unit 2025 West outlet was found to be improperly wired, having their hot and neutral wires reversed (Reversed polarity).

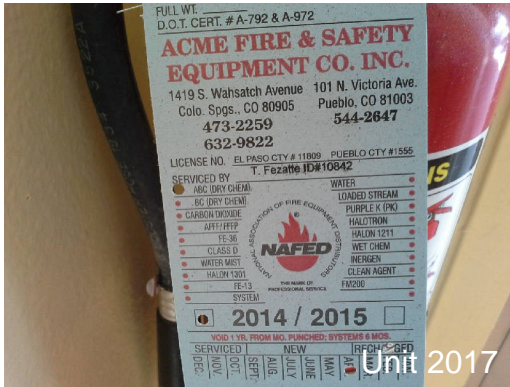
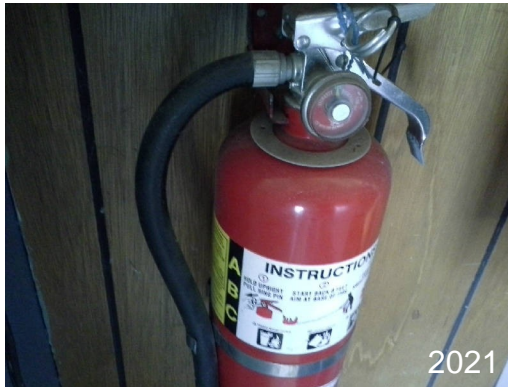
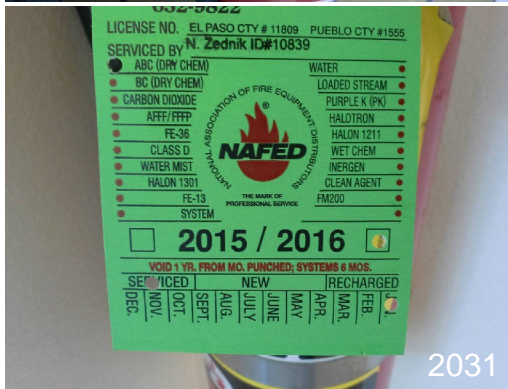
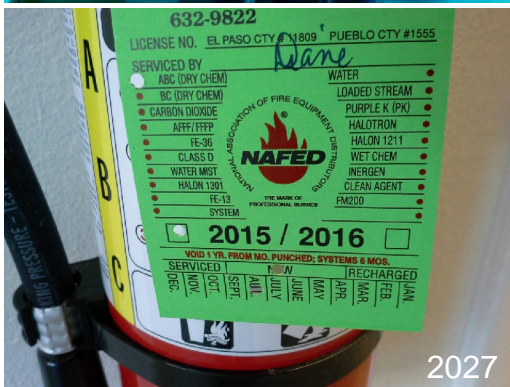
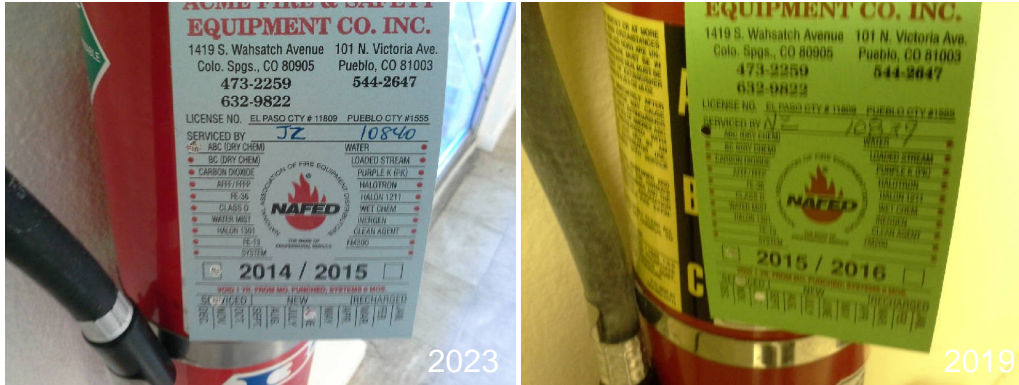
Fire Extinguishers: ABC dry chemical - Fire extinguishers need to be serviced and inspected:

- 2017
- 2019
- 2021
- 2023
- 2025
- 2027
- 2029

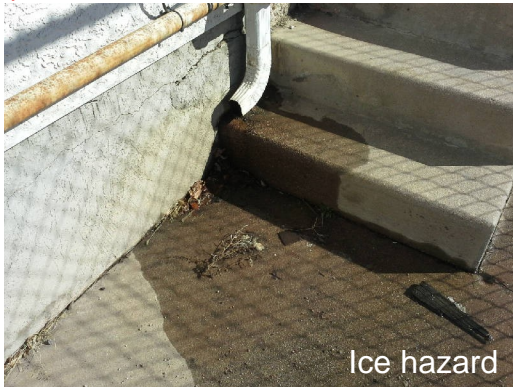
1. Leader/Extension: Functional - 1. The rear downspout at 2025 is discharging water on bottom step. This is a potential ice hazard in the winter.

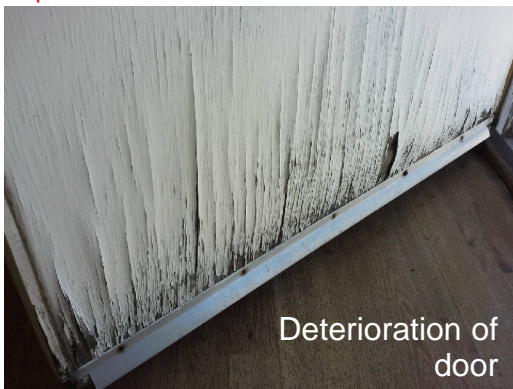
2. Entry Doors: Aluminum full glass - 1. The rear wood entry door in unit 2017 is deteriorated. This door will need replacement soon.

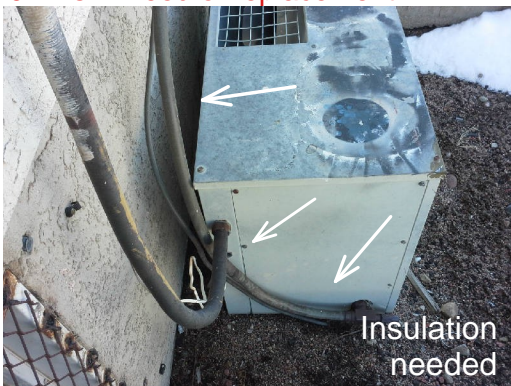
14. 2017 AC System Refrigerant Lines: Repair needed - 1. The exterior AC unit's refrigerant line insulation, unit 2017 is in need of replacement.

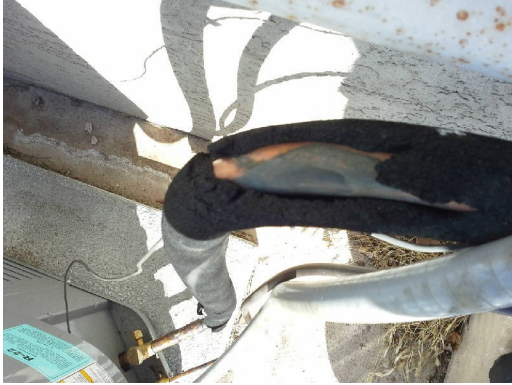
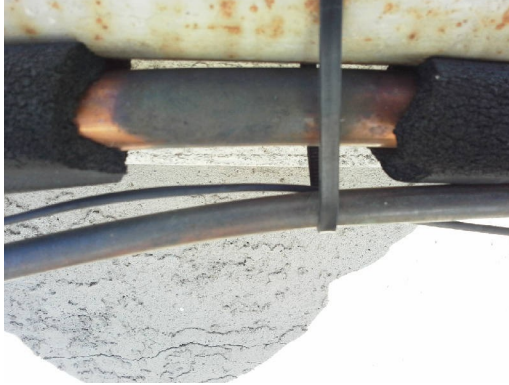
15. 2021 AC System Refrigerant Lines: Repair needed - 1. The exterior AC unit's refrigerant line insulation, unit 2021 is in need of replacement.

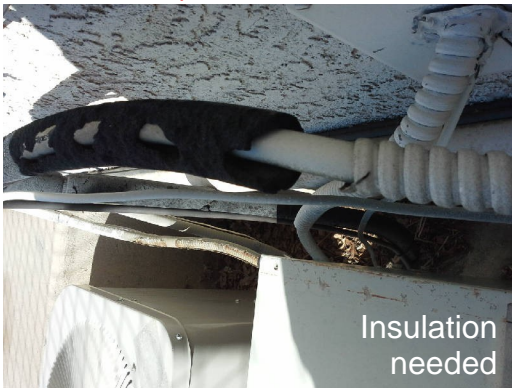
16. 2025 AC System Refrigerant Lines: Repair needed - 1. The exterior AC unit's refrigerant line insulation, unit 2025 is in need of replacement.

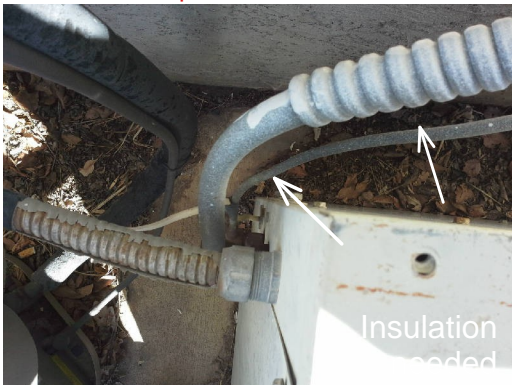
17. 2027 AC System Refrigerant Lines: Repair needed - 1. The exterior AC unit's refrigerant line insulation, unit 2027 is in need of replacement.

18. 2029 AC System Refrigerant Lines: Repair - 1. The exterior AC unit's refrigerant line insulation is in need of replacement.

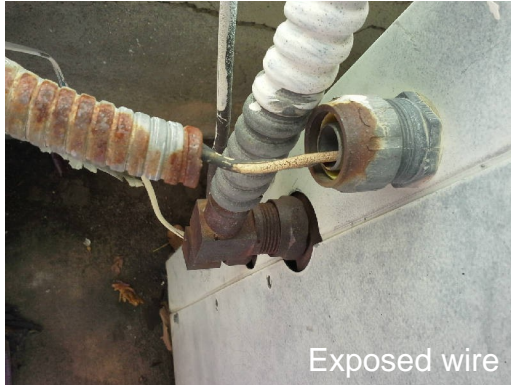
19. 2029 AC System Electrical Disconnect: Breaker disconnect - 1. There are exposed 220 electrical wire for the 2029 air conditioning unit.

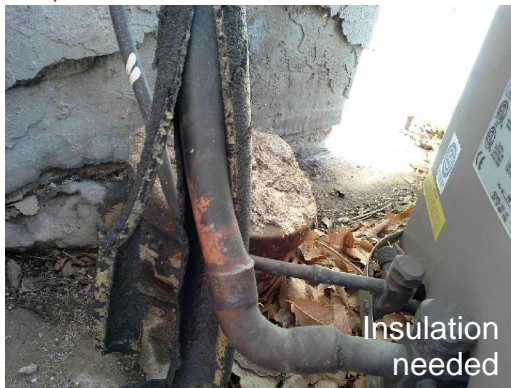
20. 2031 AC System Refrigerant Lines: Repair needed - 1. The exterior AC unit's refrigerant line insulation is in need of replacement.

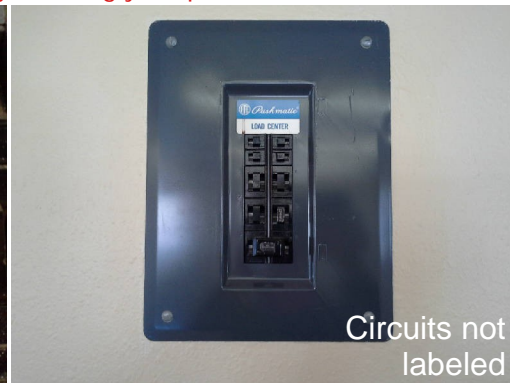
21. 2017 Electric Panel Manufacturer: Push-O-Matic - 1. Two wires are connected to a breaker designed for only one wire. This is known as a double-tap and is a defective condition which should be corrected by a qualified electrical contractor.
2. The circuits are not properly labeled at dead front cover. This is important in an emergency to know what circuit breaker to turn off. I recommend properly labeling your panel.

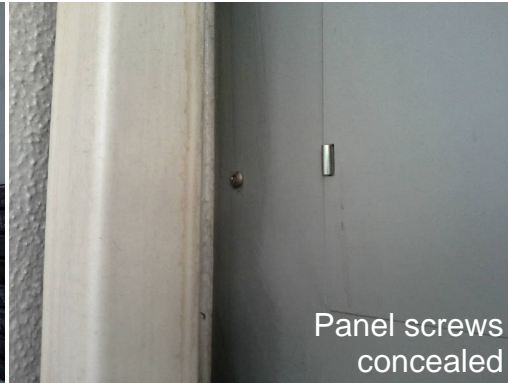
22. 2021 Electric Panel Manufacturer: General Electric - **Note: The panel screws are concealed behind conduit, Unable to open.**

1. The circuits are not properly labeled at dead front cover. This is important in an emergency to know what circuit breaker to turn off. I recommend properly labeling your panel.

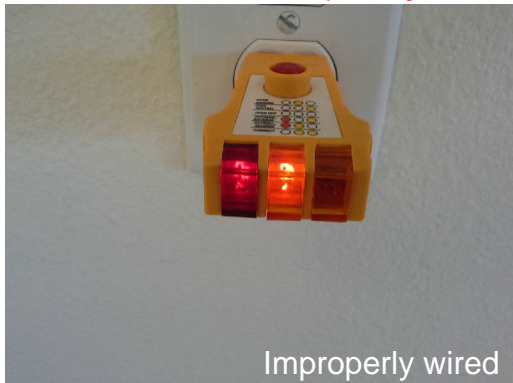
26. Electrical: 110 VAC - 1. The unit 2025 West outlet was found to be improperly wired, having their hot and neutral wires reversed (Reversed polarity).
