Pro-Check Home Inspections

Property Inspection Report

3738 Sample Cir
Colorado Springs, Colorado 80921

10/01/2018

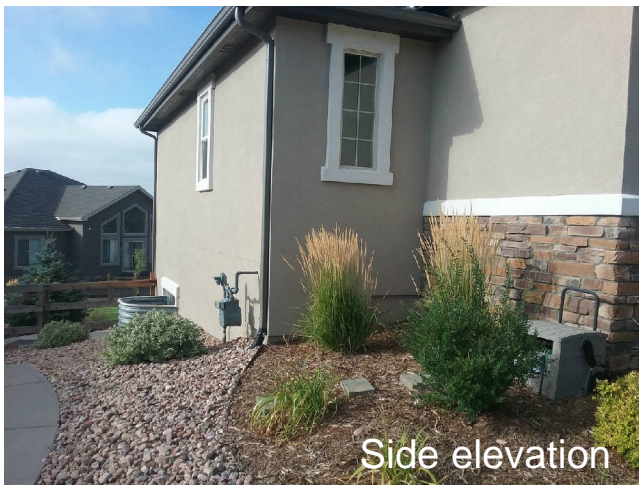
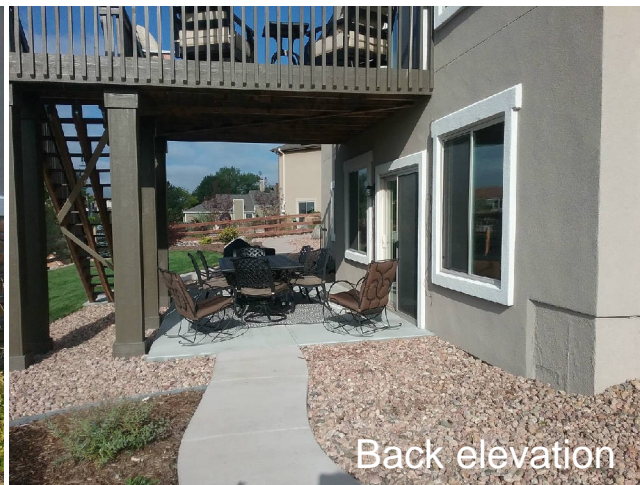
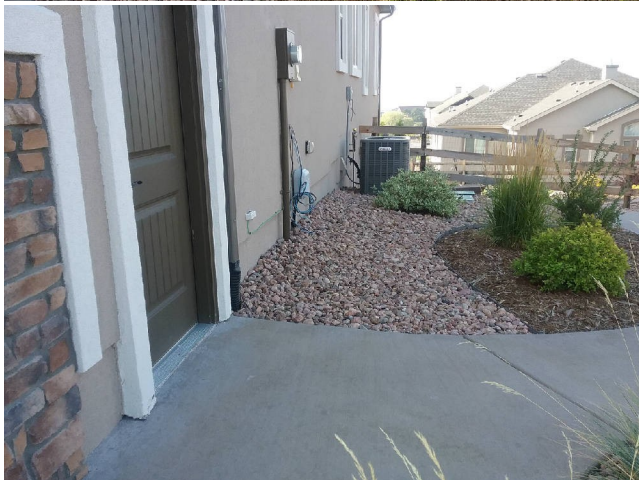
Grading: Moderate slope -

The general grading around the house foundation perimeter appears functional. Ideally the grading should slope about 6 inches over the first 10 feet away from the house foundation. Monitoring during a rainstorm is recommended.

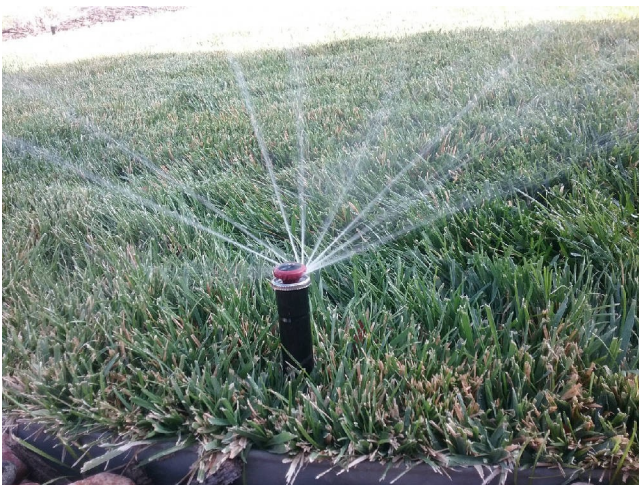
Lawn Sprinklers: Front and back yard -

The visual inspection of the sprinkler system showed all lines held pressure. During the inspection, some sprinkler zones were turned on at the zone valves. We are unable to determine the condition of components buried in the ground. We do not check the function at the control timer. Some heads may need adjustment but the system as a whole appears to be functioning properly.

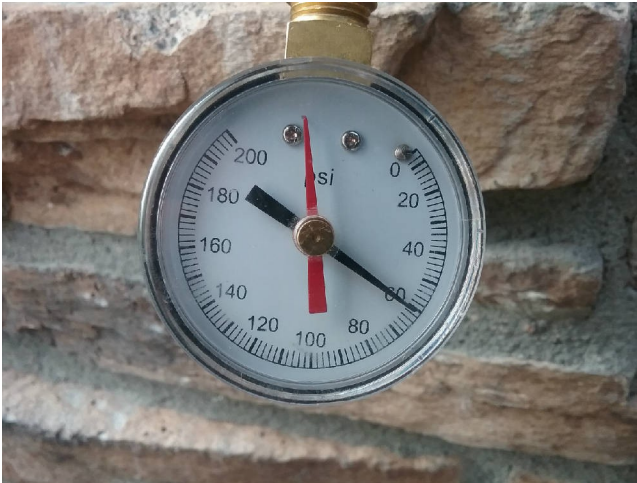
Water Pressure Test: 61 PSI -

Home water supply pressure was within the acceptable limits of 40 pounds per square inch (PSI) and 80 PSI at the time of the inspection.

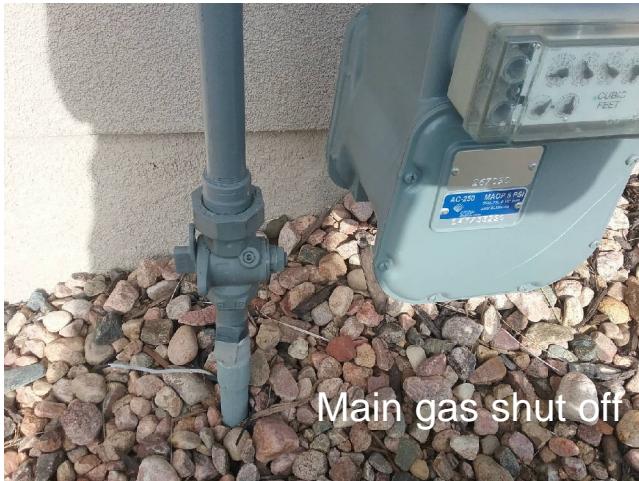
Main Gas Valve: Located at gas meter -

The main gas shut-off valve is located near the gas meter at the side of the house. You will need a large wrench to turn 90 degrees.

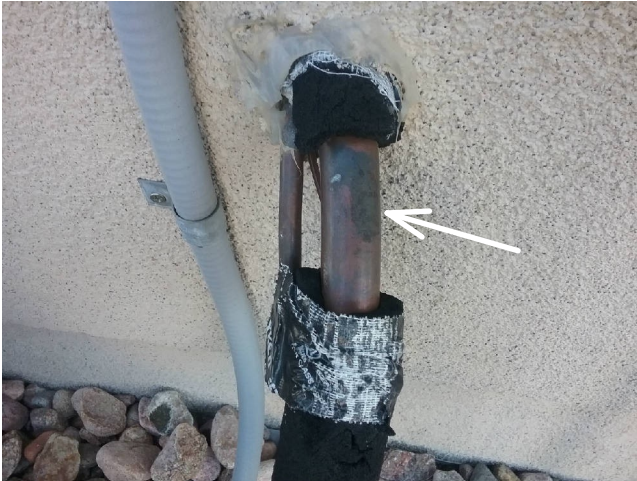
Refrigerant Lines: Serviceable condition -

The exterior AC unit's refrigerant line insulation is in need of repair.

Recommend a licensed HVAC contractor repair items listed below:

1. The exterior AC unit's refrigerant line insulation is in need of repair.

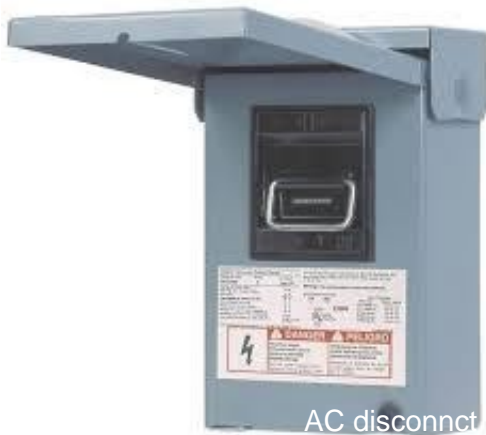
Electrical Disconnect: Breaker disconnect -

See picture. Use this disconnect to shut of power to the AC unit.

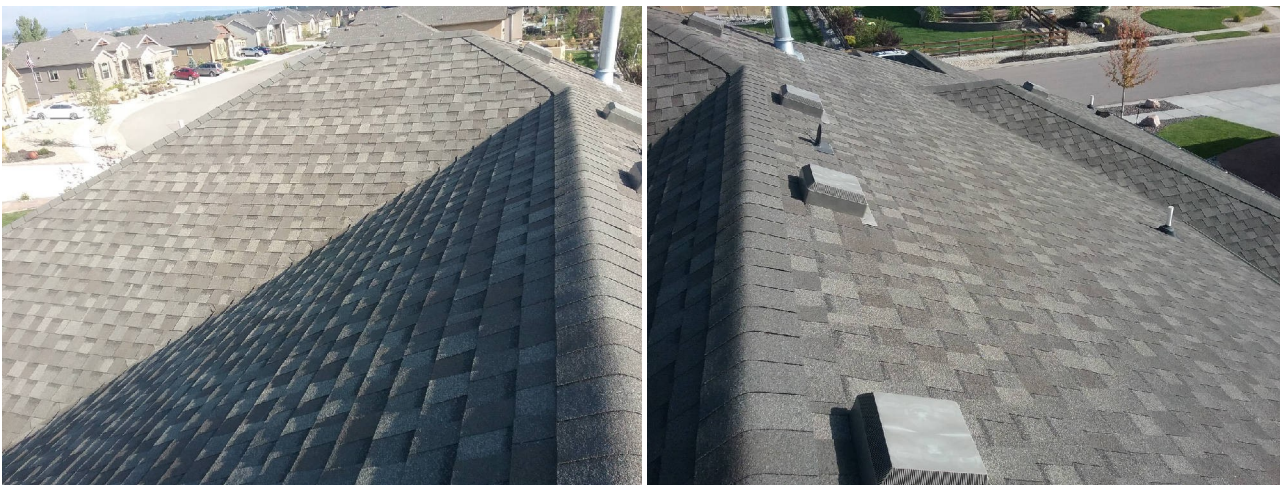
Material: Asphalt Composition Shingle -

Asphalt shingles (also called composition shingles) are the most common roofing material used today. The shingles consist of asphalt-impregnated felt paper or glass fiber mats, coated with a layer of asphalt and covered with granular material.

The asphalt shingles roof is in serviceable condition, however this is not a guarantee against leaks. For a guarantee, you would need to have a roofing company perform a water-test and issue a roof certification. Further evaluation from a qualified roofer is still recommended for more information about your roof, including maintenance tips and advise.

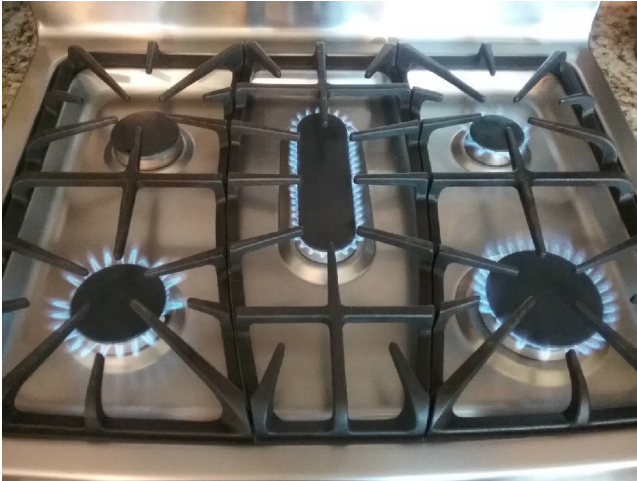
Range: General Electric -

The left rear cook top burner did not light with its igniter.

Recommend a appliance repair technician repair items listed below:

1. The left rear cook top burner did not light with its igniter.

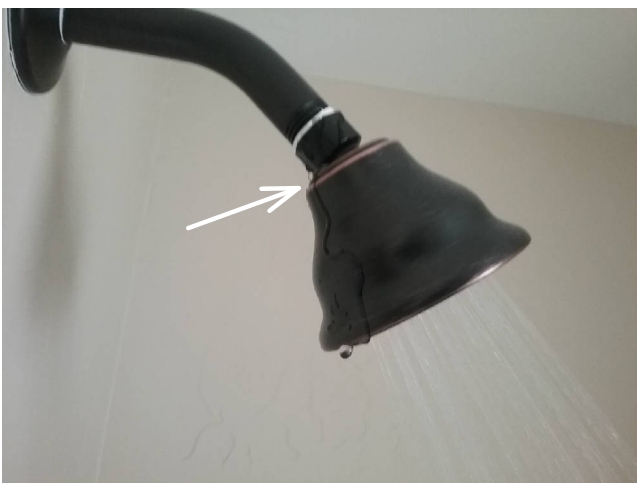
Tub/Showers: Porcelain tub and tile surround -

Water leaks from around the 1st floor bathroom shower head at the swivel.

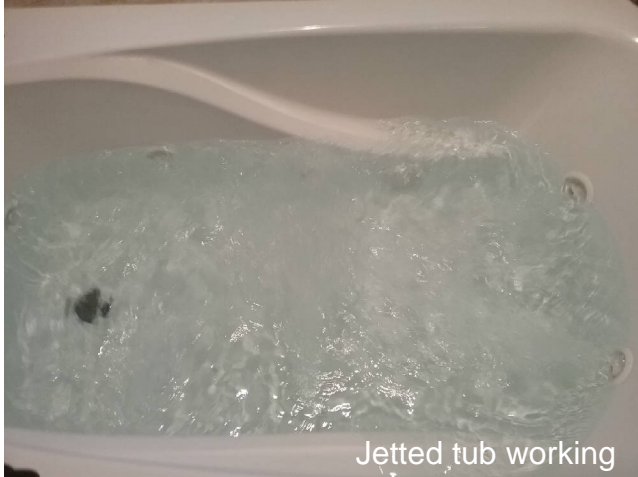
Spa Tub/Surround: Fiberglass tub and tile surround -

The whirlpool tub is functional but should be flushed with a cleanser. Black substance come out of the jets when operated.

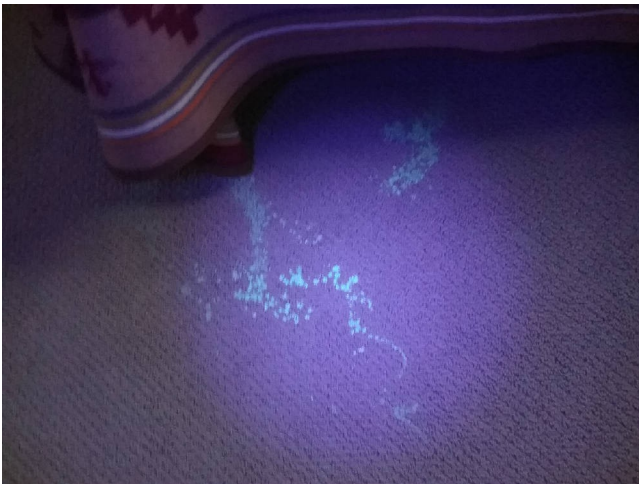
Closet: Bi-pass
Ceiling: Drywall
Walls: Drywall
Floor: Carpet -

Pet stains were found in the Southeast bedroom carpet.

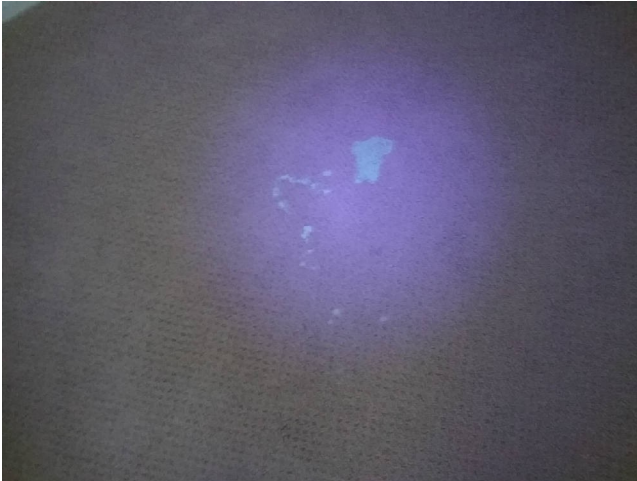
Floor: Carpet -

Pet stains were found in the Southwest basement bedroom.

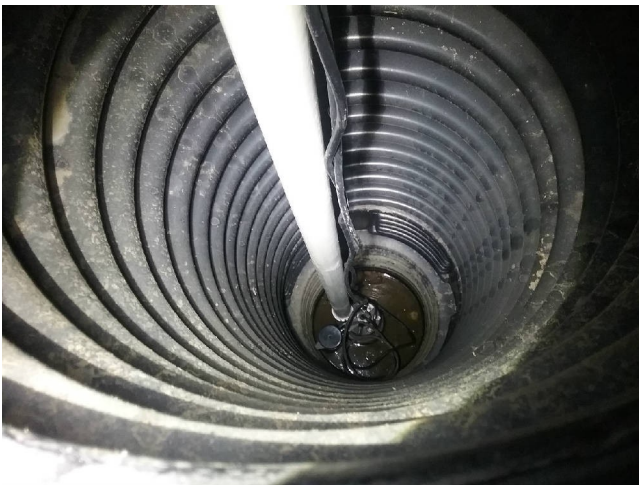
Sump Pump: Submerged -

The sump pump is too low in the sump pit to test. (the sump pit had a small amount of water during the inspection, however we did not observe any evidence this pit has overflowed in the past). The client should be aware that the service life of most sump pumps is 5-7 years, and that the pump may need replacing soon depending on its age and how often it operates.

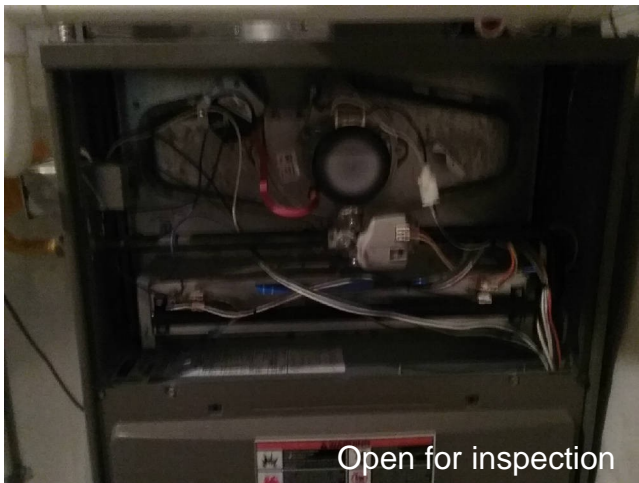
Heating System Operation: Adequate -

This unit was working properly at the time of the inspection. Mechanical equipment tested for functional operation at the time of inspection only. Inspection does not determine sizing of the system. The inspection covers only the visible components of the heating system. Hidden problems may exist that are not documented in this report. Annual maintenance will ensure the system is safe and is functioning properly. Servicing can also uncover problems not discovered or that are beyond the scope of home inspection standards. Inspection standards do not require me to verify if appliances need replacing, just that they are functioning.

Manufacturer: Lennox

Type: Forced air Capacity: 132,000 BTUHR

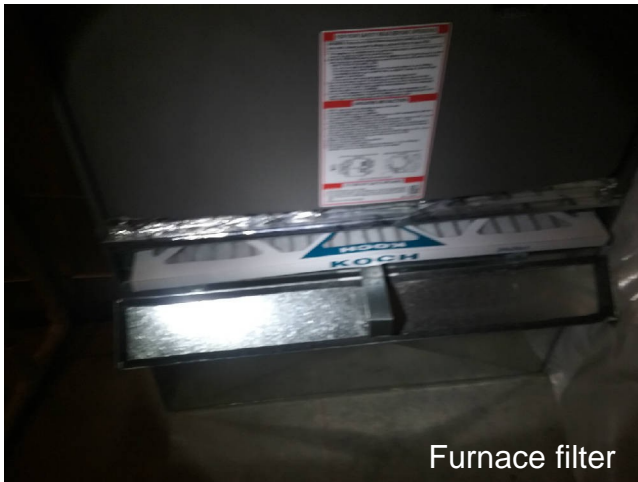
Furnace filter

Furnace Filter: Fiberglass 24 X 24 -

The air filter(s) should be inspected at least monthly and cleaned or replaced as required. There are two types of filters commonly used: (1) Washable filters, (constructed of aluminum mesh, foam, or reinforced fibers) these may be cleaned by soaking in mild detergent and rising with water. Or (2) Fiberglass disposable filters that must be REPLACED before they become clogged. Remember that dirty filters are the most common cause of inadequate heating or cooling performance.

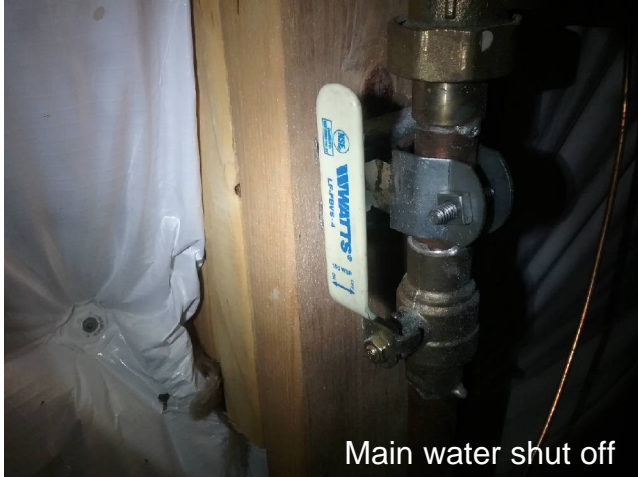
Water Pressure Regulator: Basement -

The water pressure regulator valve appears to be correctly installed. This allows adjustment of the incoming water pressure.

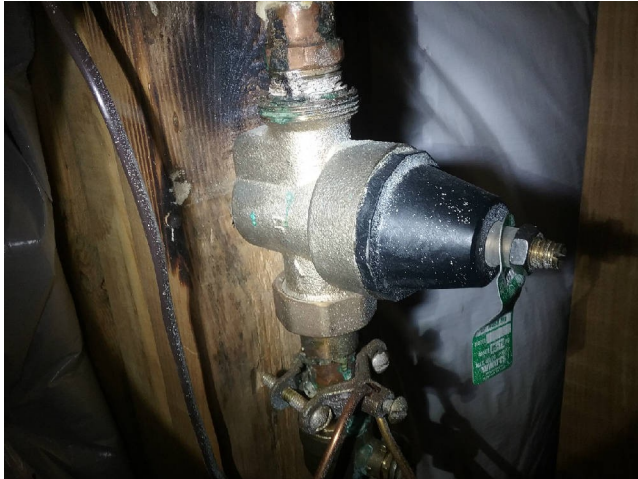
Water Meter: Basement -

The water meter is located near the main water shut-off valve

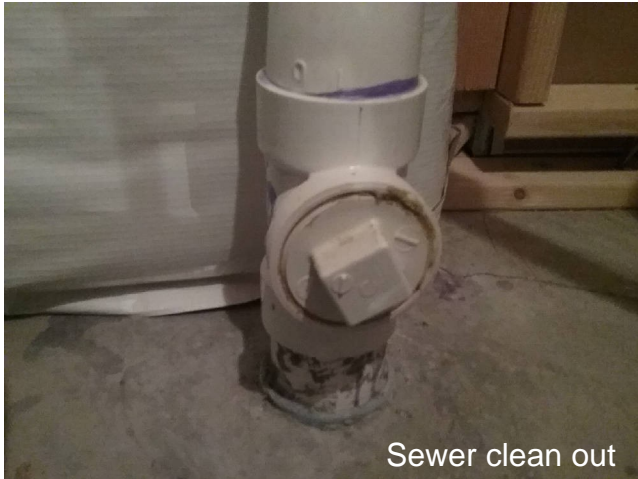
Sewer Cleanout: Accessible -

See picture. This cap can be removed to allow the main sewer line from the house to the street to be cleaned.

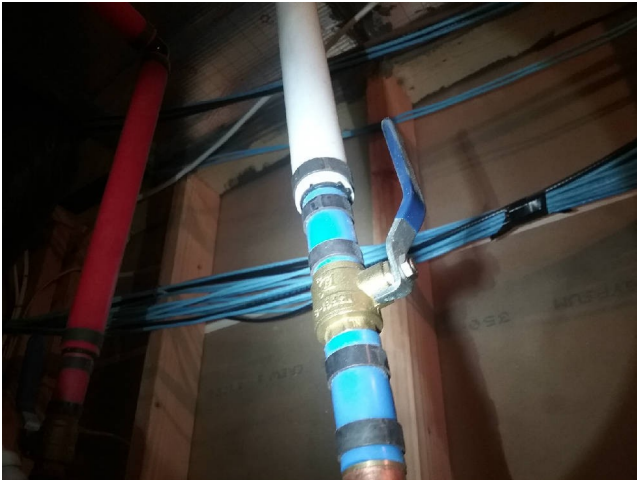
Cold Water Shut Off: Yes -

The photo shows the location of the shut-off valve for water at the water heater.. If the water heater ever starts leaking you can turn this valve off and turn the water off to the water heater and then call a plumber.

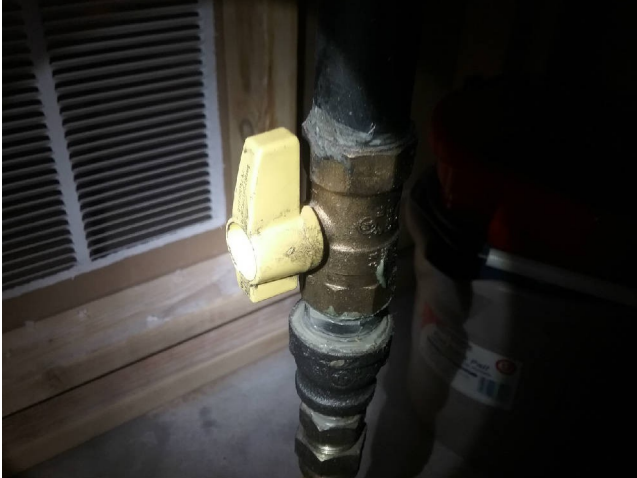
Gas Shut Off: Yes -

The photo shows the location of the shut-off valve for gas at the water heater. You can turn the handle a quarter turn to shut off the valve. When the handle is in line with the pipe it is on and when it is perpendicular with the pipe it is off.

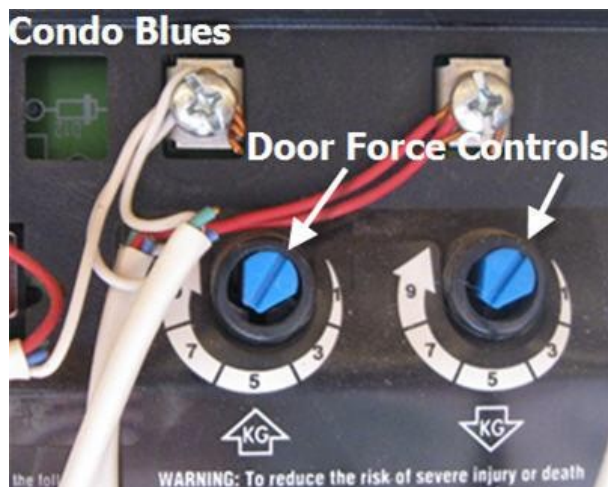
Door Operation/Safety Devices: Mechanized -

The double garage door openers pressure reverse needs to be adjusted. We test this by placing a 1 1/2 block under the garage door. The door is lowered and when it closes on the block, if it does not reverse then it needs to be adjusted. This adjustment is done on the garage door opener itself using the close force and open force screw adjustments.

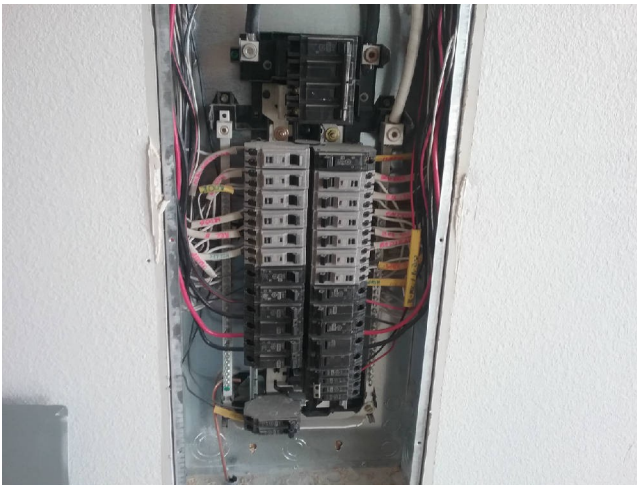
Manufacturer: General Electric -

Circuit breakers in the main electrical service panel appeared to be in serviceable condition at the time of the inspection. Labeling of electric circuit locations on Main Electrical Panel are not checked for accuracy.

Maximum Capacity: 200 Amps

Main Breaker Size: 200 Amps -

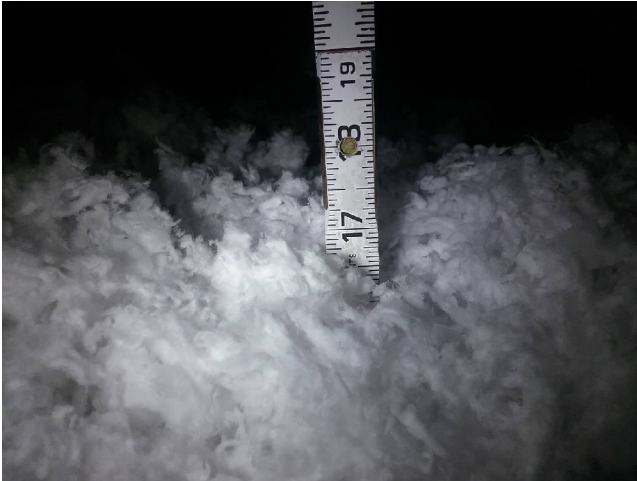
Insulation Depth: 17" -

The insulation levels were acceptable.

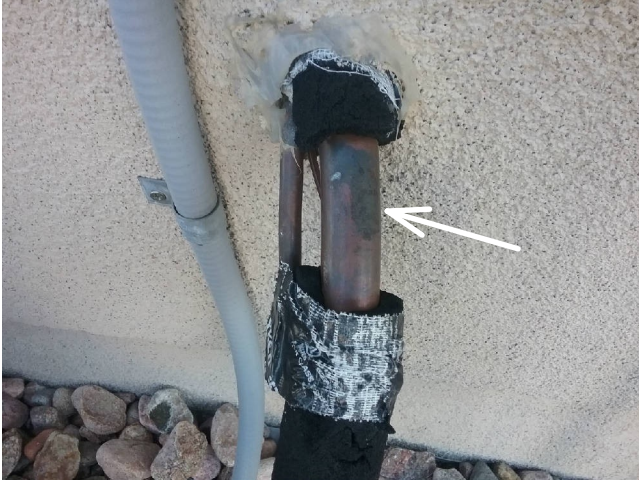
1. West AC System Refrigerant Lines: Serviceable condition -
The exterior AC unit's refrigerant line insulation is in need of repair.

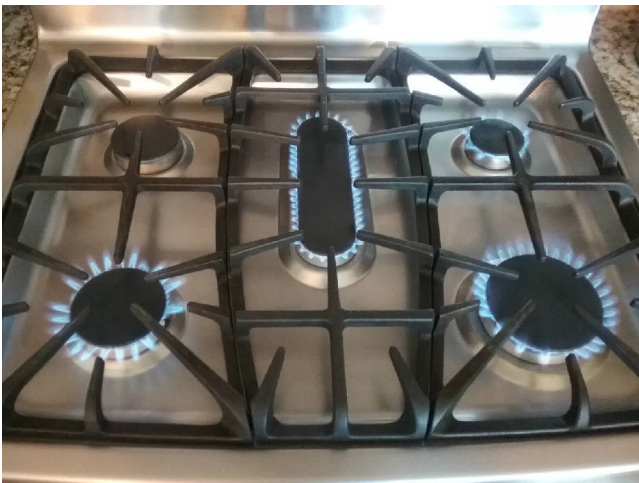
2. 1st Floor Kitchen Range: General Electric -
The left rear cook top burner did not light with its igniter.

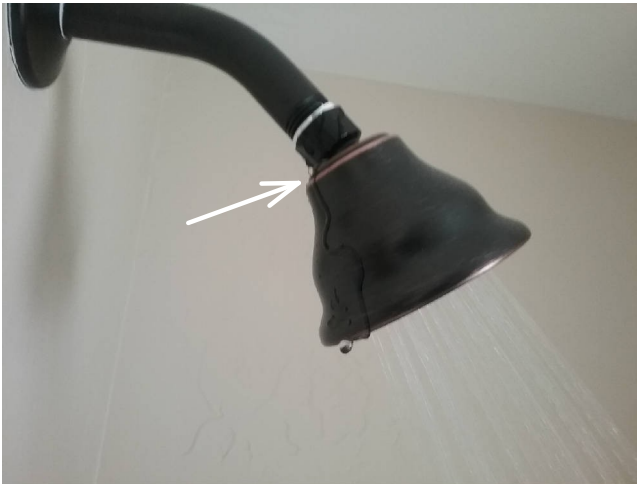
3. 1st floor main Bathroom Tub/Showers: Porcelain tub and tile surround -
Water leaks from around the 1st floor bathroom shower head at the swivel.

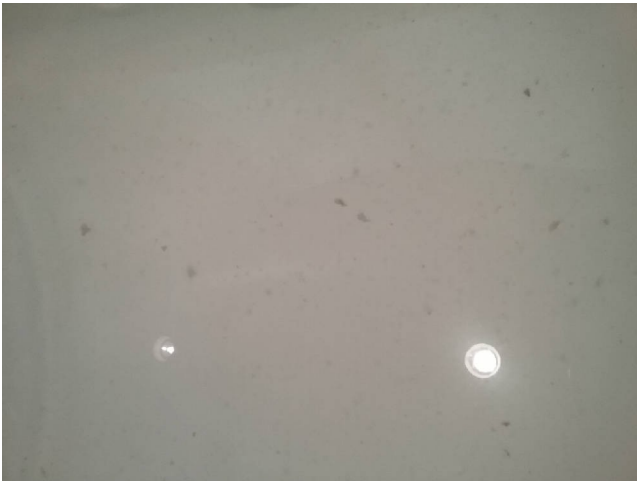
4. Master Bathroom Spa Tub/Surround: Fiberglass tub and tile surround -
The whirlpool tub is functional but should be flushed with a cleanser. Black substance come out of the jets when operated.

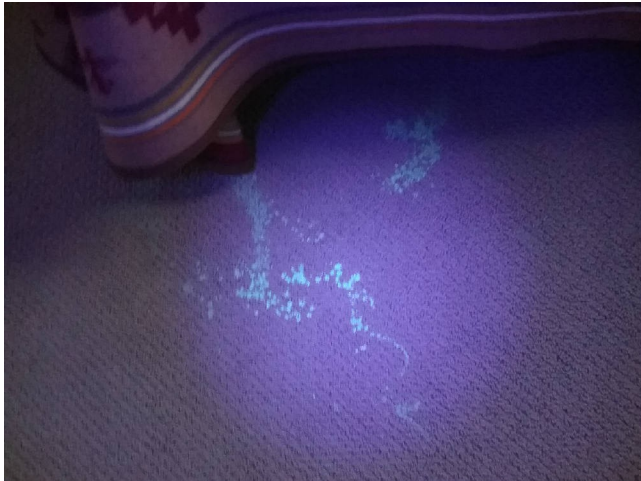
6. Southeast Bedroom Floor: Carpet -
Pet stains were found in the Southeast bedroom carpet.

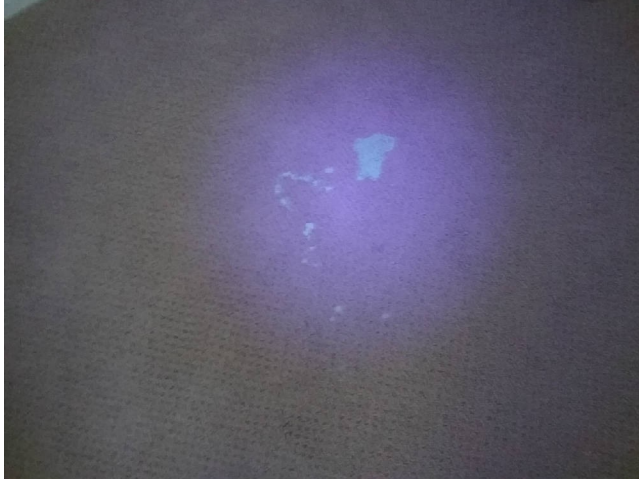
7. Southwest basement Bedroom Floor: Carpet -
Pet stains were found in the Southwest basement bedroom.

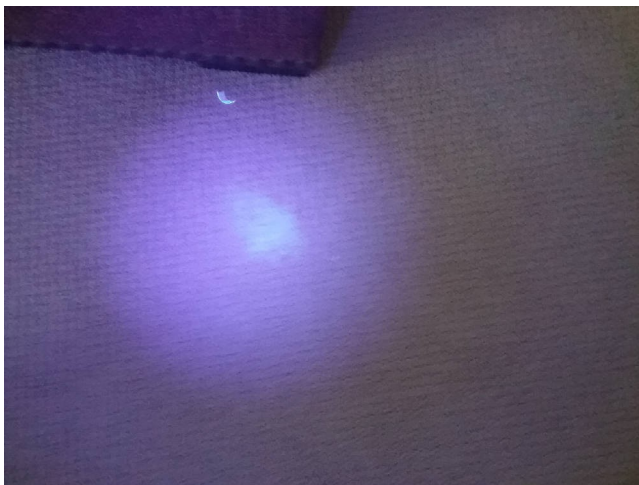
There is a pet stain in the basement family room carpet.

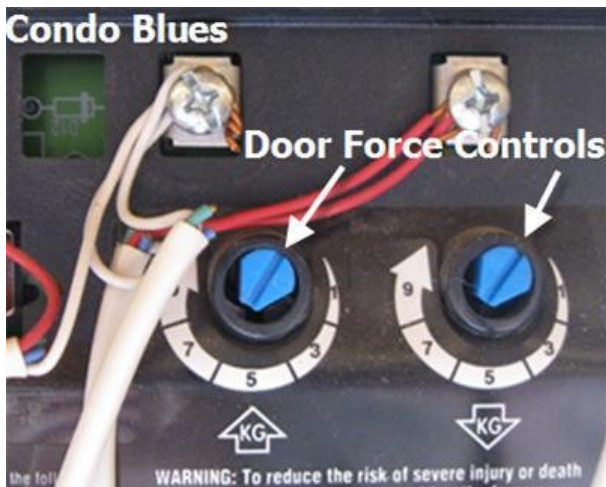
The double garage door openers pressure reverse needs to be adjusted. We test this by placing a 1 1/2 block under the garage door. The door is lowered and when it closes on the block, if it does not reverse then it needs to be adjusted. This adjustment is done on the garage door opener itself using the close force and open force screw adjustments.
