Pro-Check Home Inspections

Property Inspection Report

10518 Sample Pt
Fountain, Colorado 80817

08/24/2018

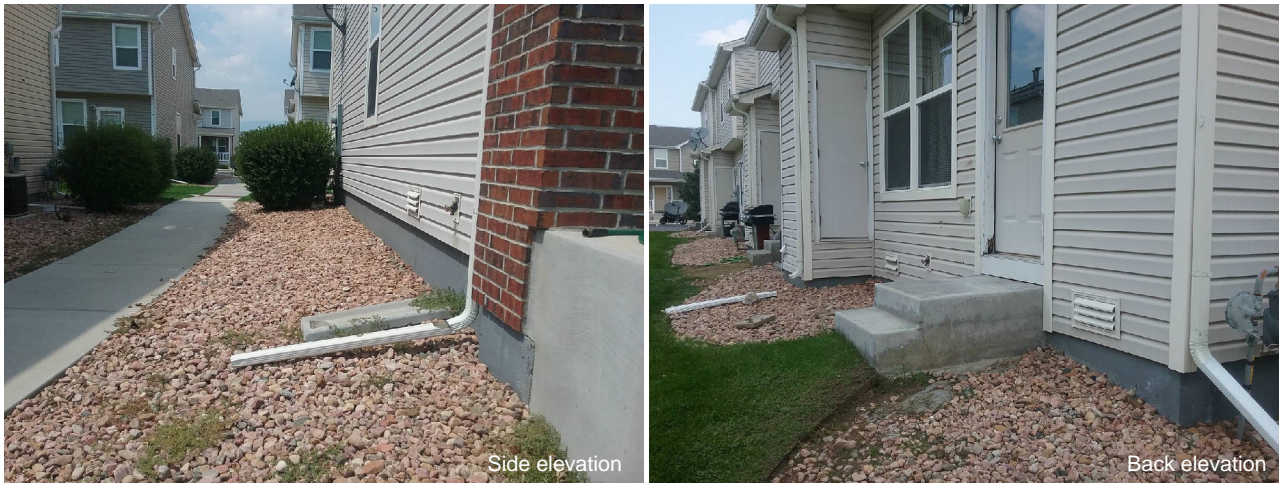
Grading: Minor slope -

The general grading around the house foundation perimeter appears functional. Ideally the grading should slope about 6 inches over the first 10 feet away from the house foundation. Monitoring during a rainstorm is recommended.

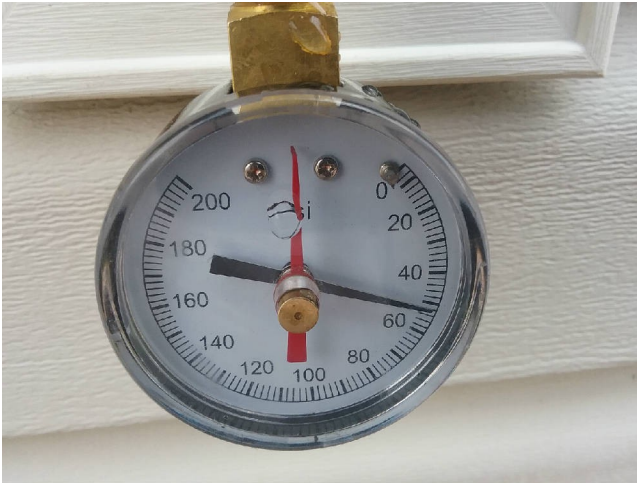
Water Pressure Test: 52 PSI -

Home water supply pressure was within the acceptable limits of 40 pounds per square inch (PSI) and 80 PSI at the time of the inspection.

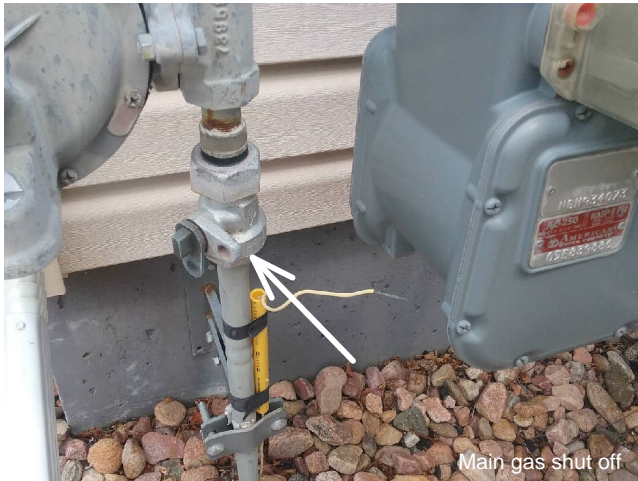
Main Gas Valve: Located at gas meter -

The main gas shut-off valve is located near the gas meter at the side of the house. You will need a large wrench to turn 90 degrees.

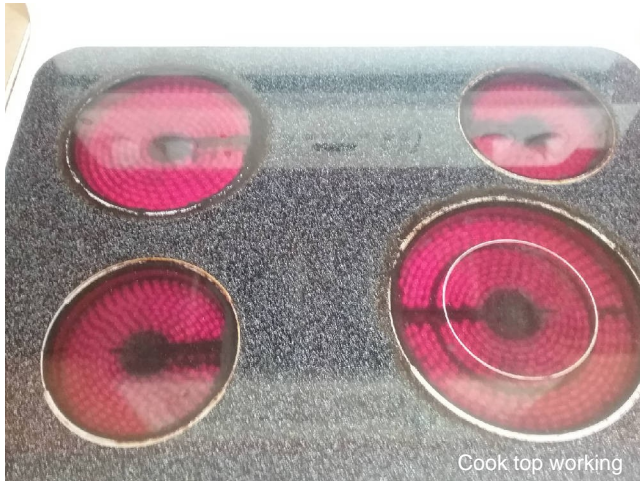
Range: General Electric -

The heating elements/burners and oven operated when tested. This does not confirm the efficiency of the system.

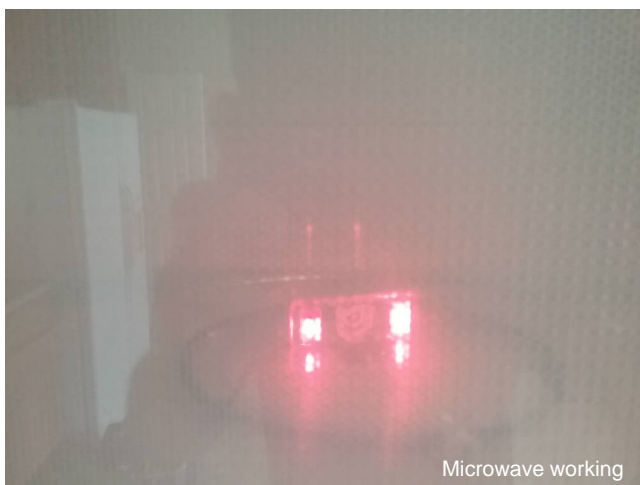
Microwave: General Electric -

The over range mounted microwave was installed securely, was tested and operational at time of inspection.

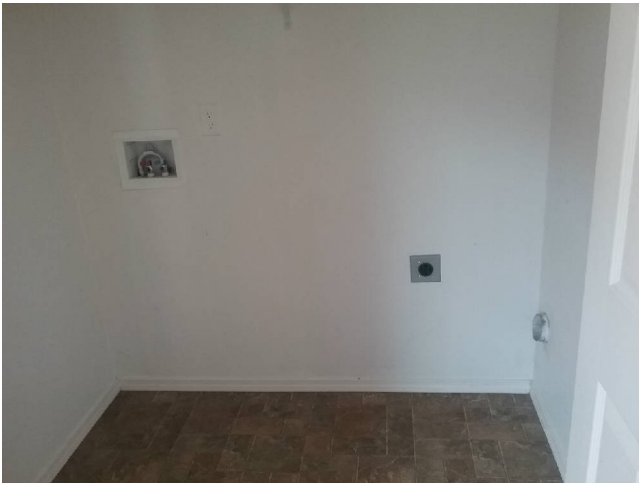
Washer Hose Bib: Rotary -

There was no washing machine present at the time of the inspection. The washer supply valves and drain were not tested.

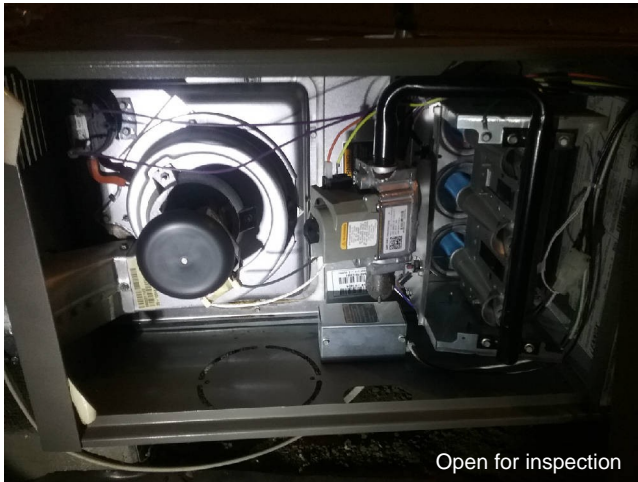
Heating System Operation: Adequate -

This unit was working properly at the time of the inspection. Mechanical equipment tested for functional operation at the time of inspection only. Inspection does not determine sizing of the system. The inspection covers only the visible components of the heating system. Hidden problems may exist that are not documented in this report. Annual maintenance will ensure the system is safe and is functioning properly. Servicing can also uncover problems not discovered or that are beyond the scope of home inspection standards. Inspection standards do not require me to verify if appliances need replacing, just that they are functioning.

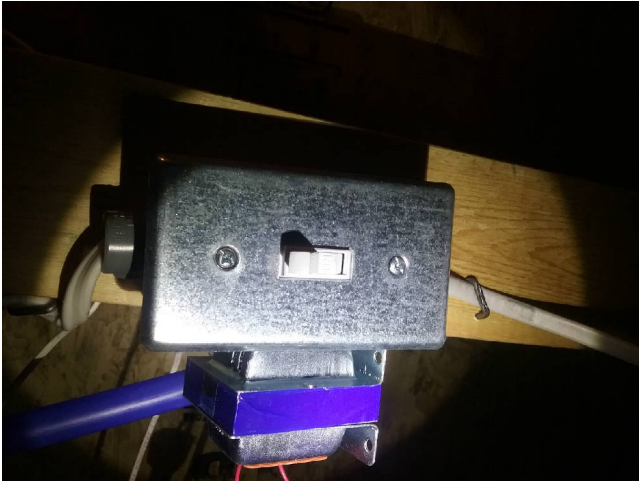
Emergency Shut Off: Yes -

See picture. Use this switch when doing any work on the furnace and when changing the furnace filter.

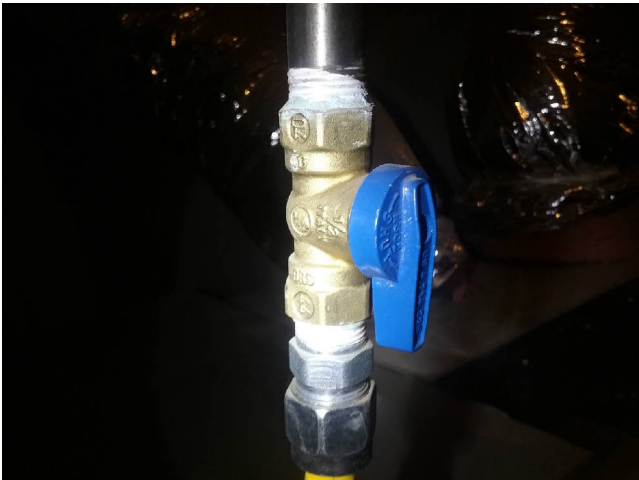
Gas Shut Off: Yes -

See picture. You can turn the handle a quarter turn to shut off the valve. When the handle is in line with the pipe it is on and when it is perpendicular with the pipe it is off.

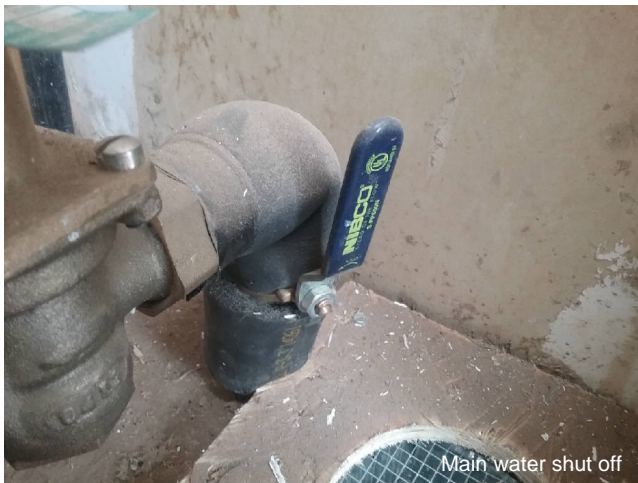
Main Water Shutoff: Utility closet -

See picture. You can use this valve in an emergency situation to quickly shut off water to the entire home.

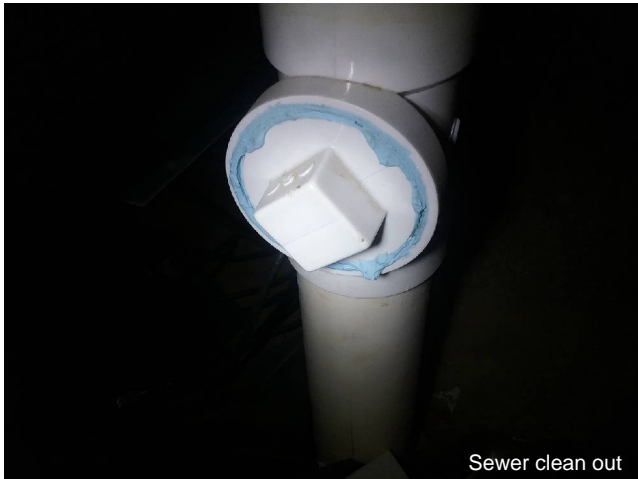
Sewer Cleanout: Accessible -

See picture. This cap can be removed to allow the main sewer line from the house to the street to be cleaned.

Regardless of the age of the home, we recommend a sewer line inspection. This separate video scope inspection will show the condition of the buried sewer line from the home to the city main. Items such as tree roots, broken drain pipes, and other obstructions will be revealed.

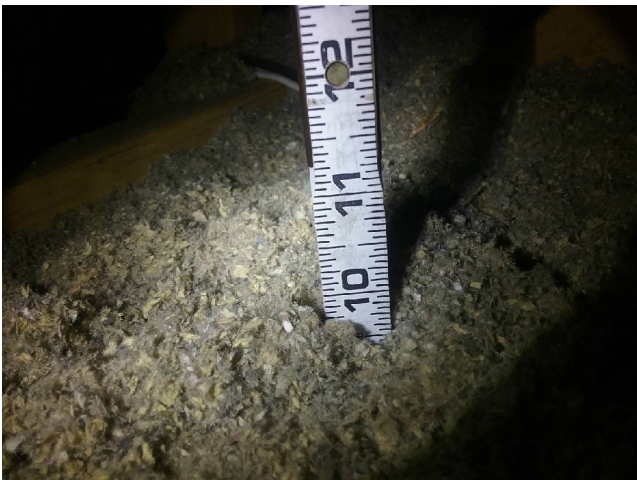
Insulation Depth: 10" -

The insulation levels were acceptable.

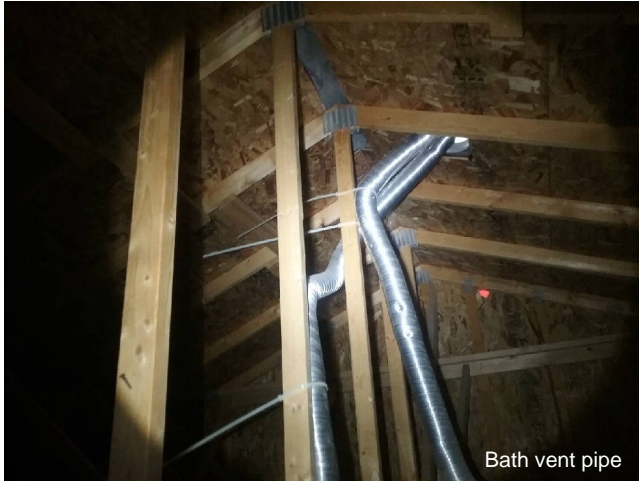
Bathroom Fan Ventilation Flex pipe -

The bathroom exhaust fans are properly venting to within 1' of an attic roof vent.
