Pro-Check Home Inspections

Property Inspection Report

622 Sample Circle
Colorado Springs, Colorado 80919

08/25/2018

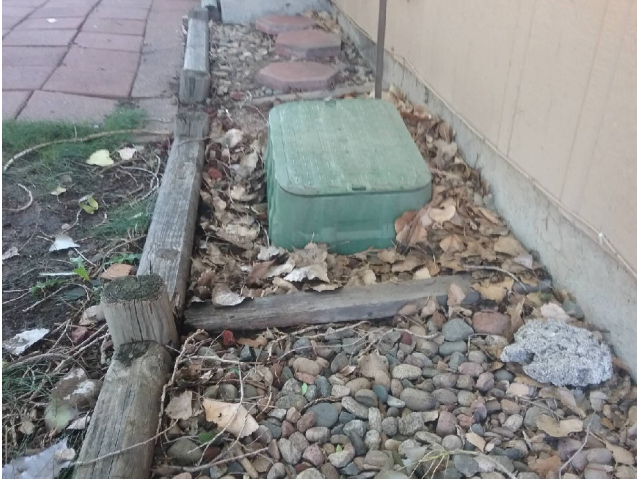
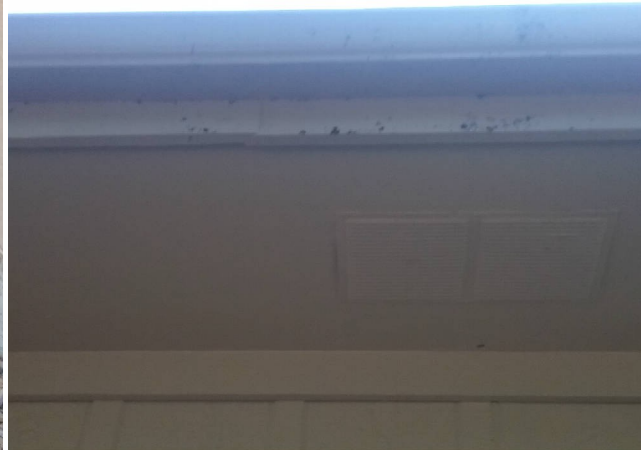
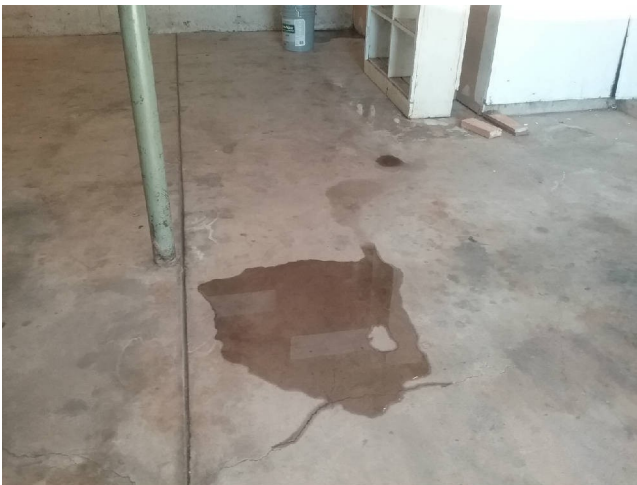
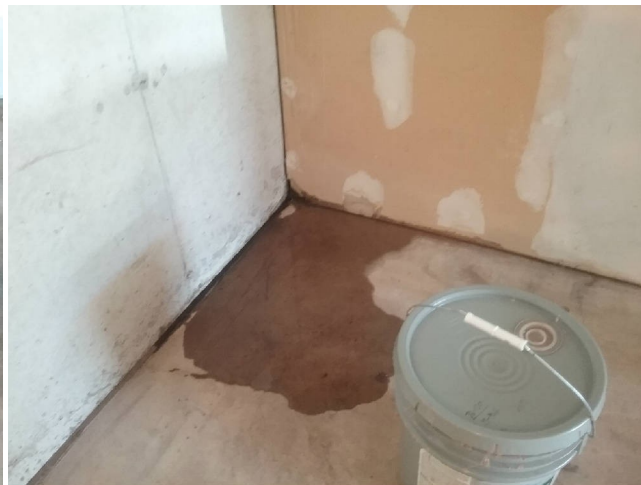
The majority of water penetration problems are caused by surface water that is not managed properly. Grading which slopes towards the foundation of the home permits water to accumulate at the foundation; poor maintenance of gutter and downspout systems also contributes to water accumulation problems.

Flower beds, loose mulched areas, railroad ties and other such landscaping items close to the foundation trap moisture and contribute to wet basements. To establish a positive grade, a proper slope away from the house is 1 per foot for approximately 5-6 feet. Recommend ground cover planting or grass up to foundation.

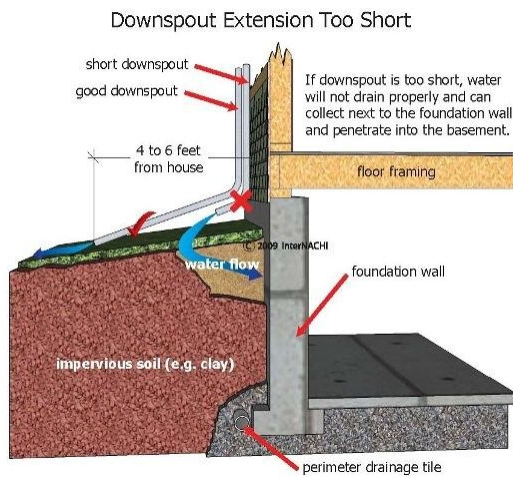
Leader/Extension: Extension needed -

1. We recommend installing downspout extensions where there are none currently. Current splash blocks do not allow water to run off. Downspouts will discharge water away from the foundation. Storm water should be encouraged to flow away from the building at the point of discharge. Adding downspout extensions will help prevent water from pooling next to the foundation.
2. The galvanized gutter over the deck has rusted through.

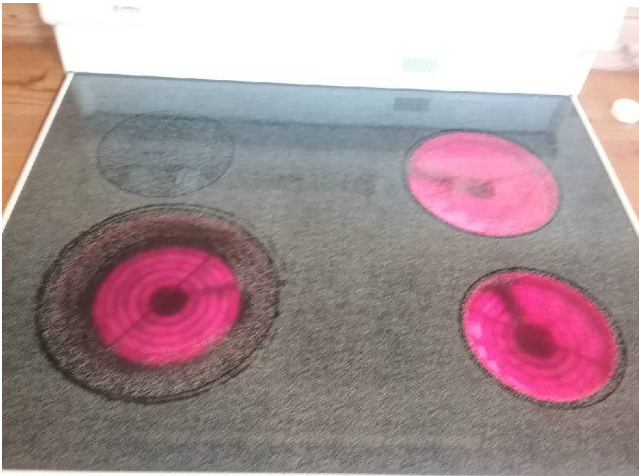
Range: Kenmore -

The left rear cook top burner did not work.

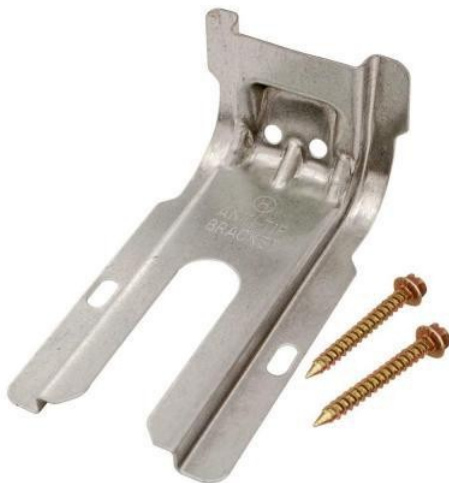
Range Anti-tip Bracket: None present -

Recommend installing an anti-tip bracket on the range. These brackets have been a safety requirement since 1991.

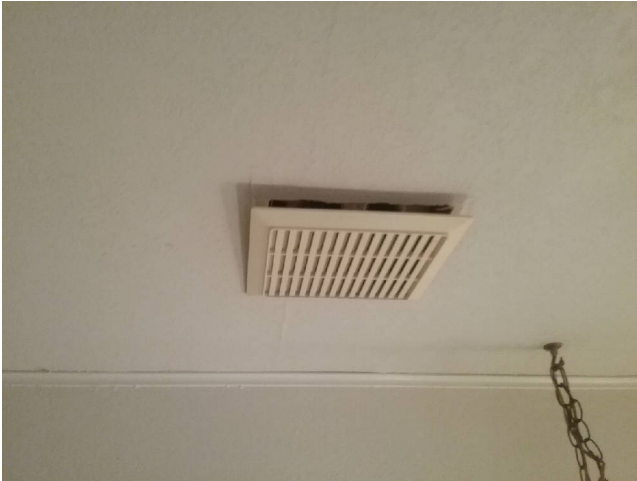
Vent Fan: Electric ventilation fan -

The main hall bathroom vent fan cover is not secure to the ceiling.

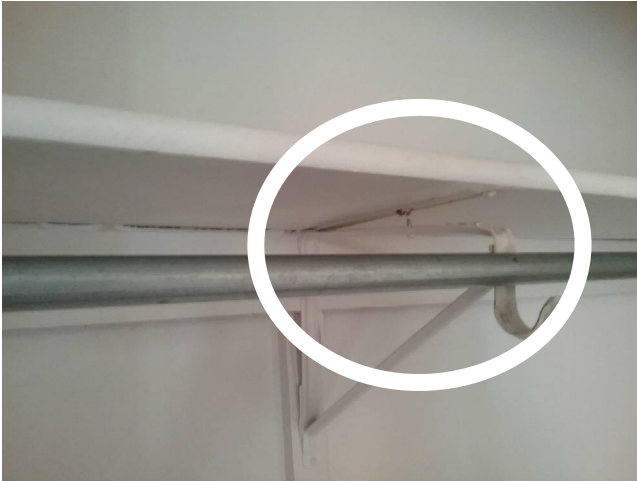
Closet: Bi-fold -

The master bedroom closet clothes pole support bracket is not secure.

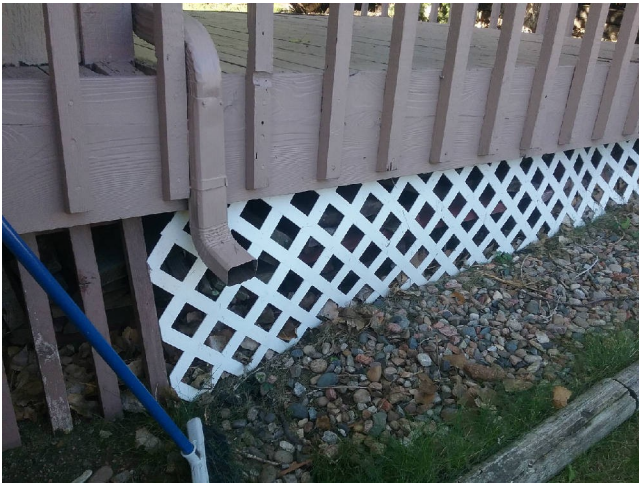
1. Deck: Stained wood -

1. The deck construction permitted with the Regional Building Dept. in 2004.
2. The skirting around the deck makes visual inspection impossible. There may be issues not visible.

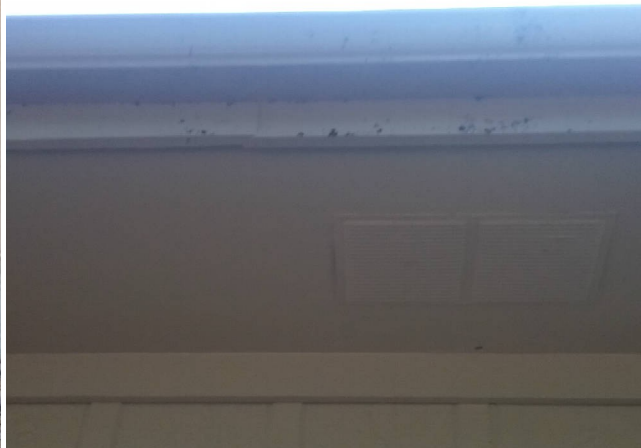
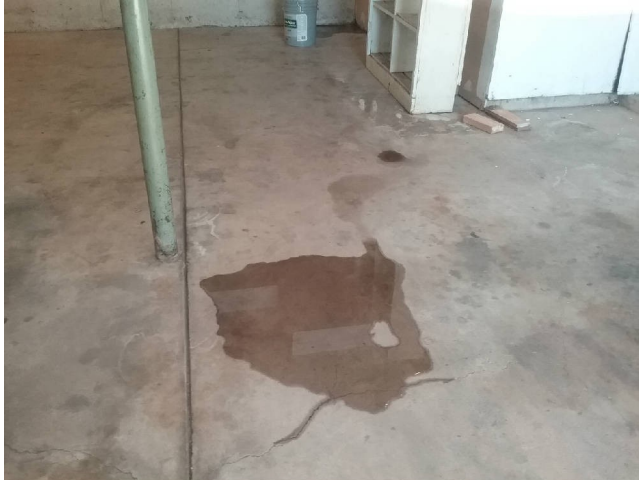
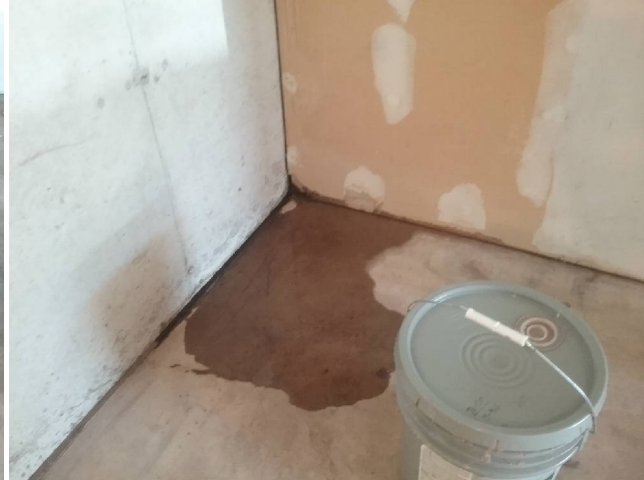
3. Grading: Minor slope -

There is a low area at the sprinkler zone valve box in the back that may have contributed to pooling water. It appears water has run over the gutters and may have pooled in this area and found its way into the garage and utility room.

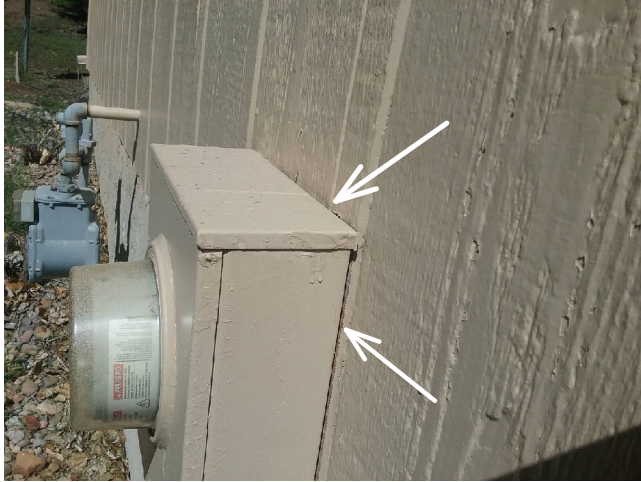
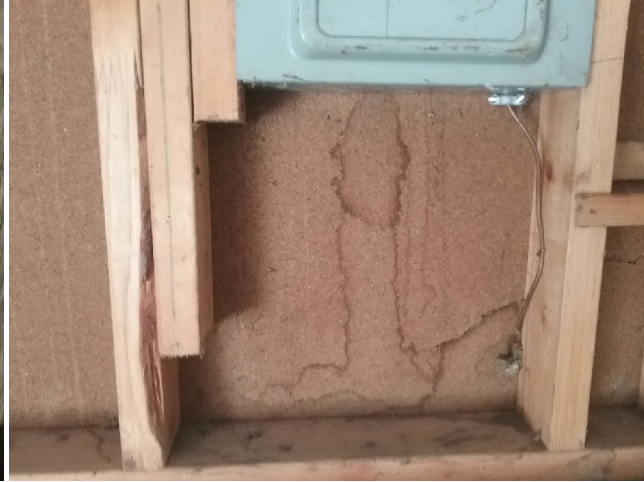
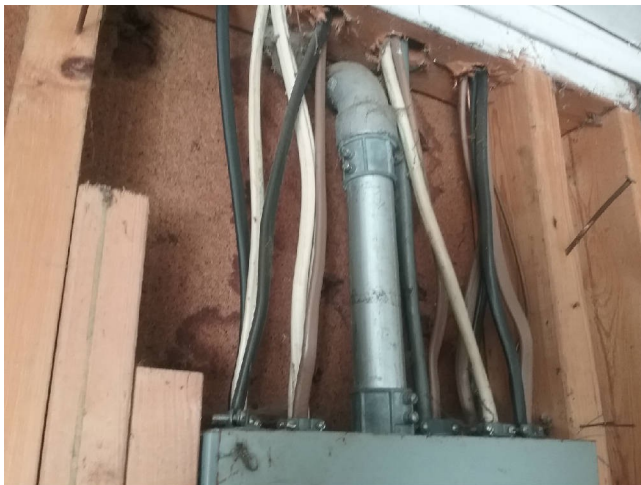
6. Siding type: Hardboard/Brick -

3. The galvanized gutter over the deck has rusted through.
4. There is deterioration of the North hardboard siding close to the ground and above windows. They will require at the very least regular painting and maintenance. It is possible they may need to be replaced.

5. There is mortar missing in some areas of the front brick veneer. The type of repair is called "tuck pointing". Recommend a licensed contractor evaluate and make repairs.

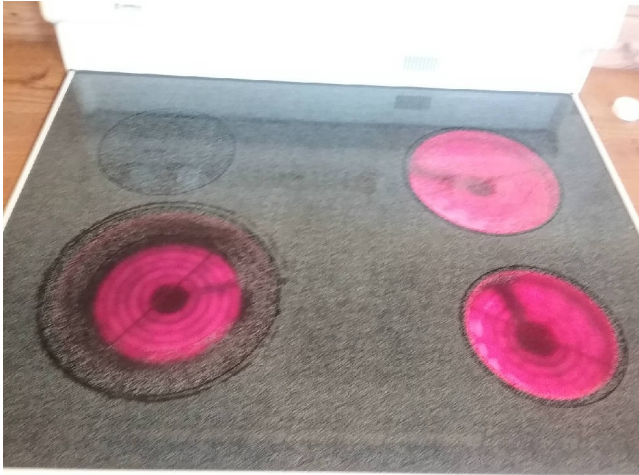
13. 1st Floor Kitchen Range: Kenmore -
The left rear cook top burner did not work.

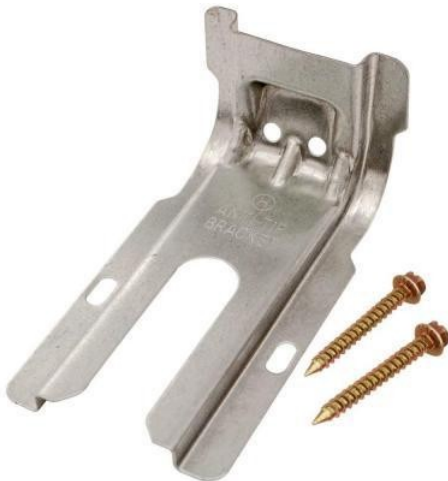
14. 1st Floor Kitchen Range Anti-tip Bracket: None present -
Recommend installing an anti-tip bracket on the range. These brackets have been a safety requirement since 1991.

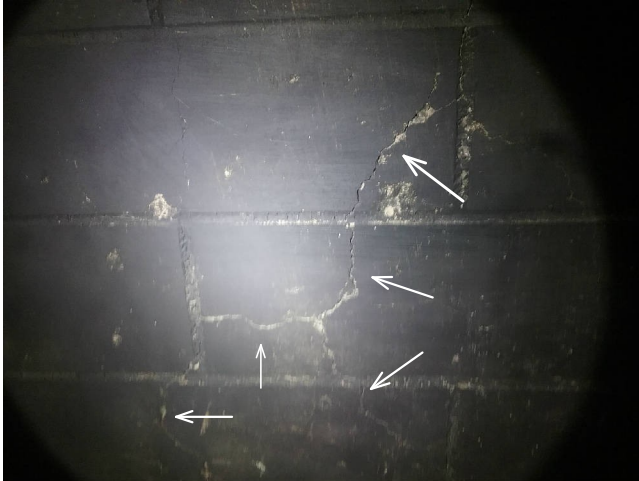
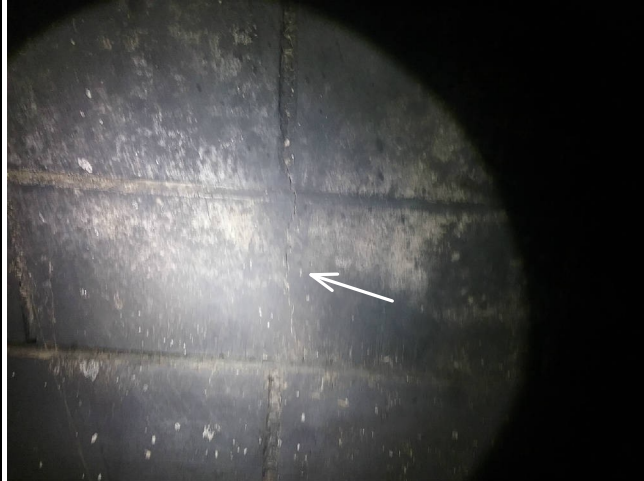
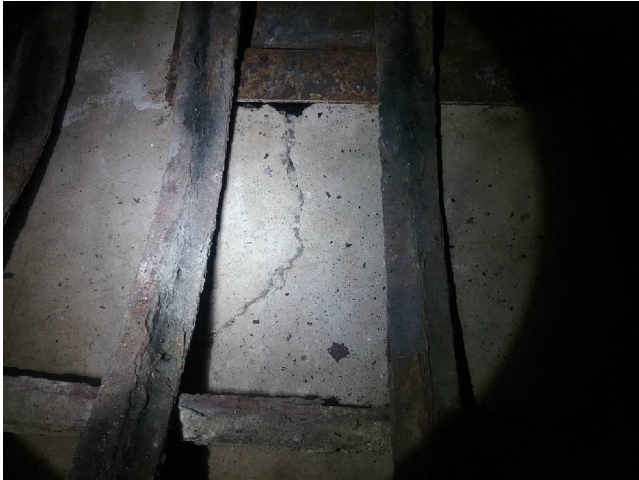
The firebrick in the living room fireplace has broken or cracked brick . This is a potential safety concern and should be further evaluated by a qualified contractor.

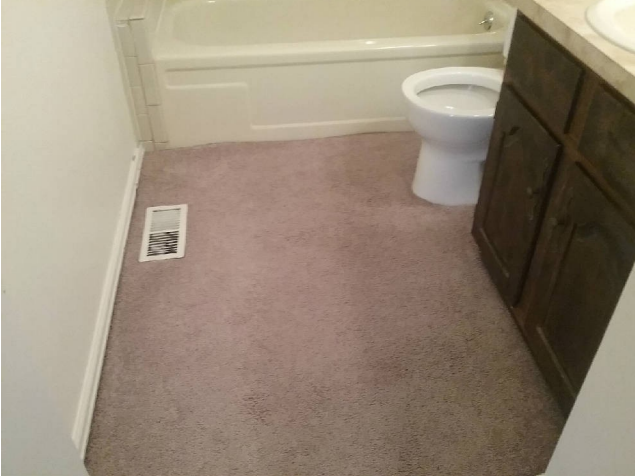
20. Main hall bath Bathroom Floor: Carpet -

Carpet installed in bath areas are a potential contamination issue. We were not able to inspect under the carpet, so there is no way to determine if the toilet is or has been leaking.

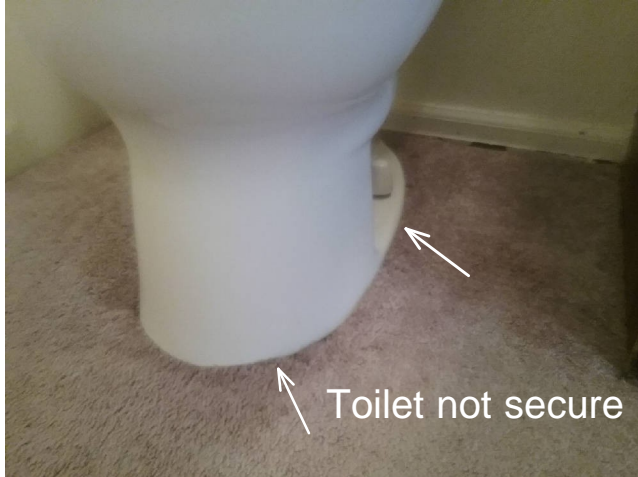
22. Main hall bath Bathroom Toilets: American Standard -
The main hall bathroom toilet is not secure at floor. Condition typically is caused by loose bolts. Loose toilets can result in damage to water supply lines, cause leaks, water damage, and mold, as well as damage to the toilet. Repairs may involve installing a new wax seal at the base of the toilet. It is recommended that this be repaired by a qualified plumbing contractor.
