Pro-Check Home Inspections

Property Inspection Report

618 Sample St
Colorado Springs, Colorado 80903

08/25/2018

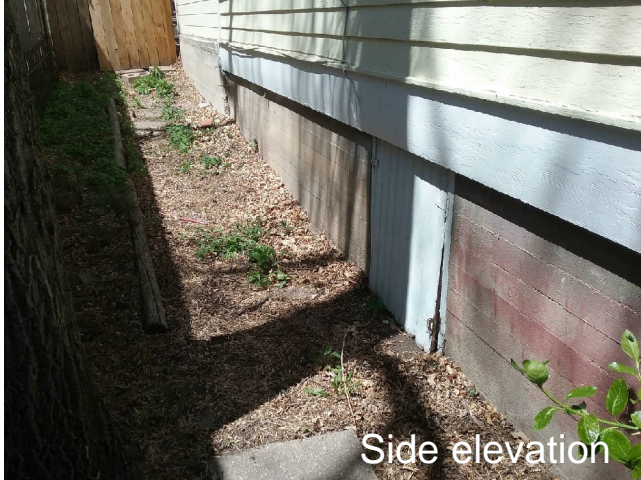
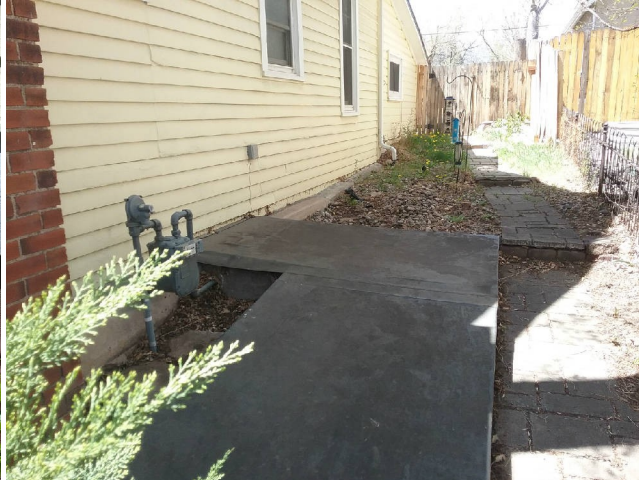
Vegetation: Trees -

Vegetation such as trees, shrubs and/or vines are in contact with or less than one foot from the structure's exterior. Vegetation can serve as a conduit for wood destroying insects and may retain moisture against the exterior after it rains. Vegetation should be pruned and/or removed as necessary to maintain a one foot clearance between it and the structure's exterior.

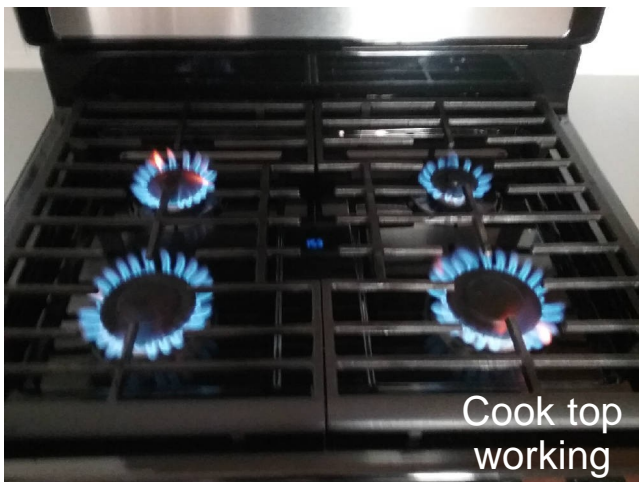
Range: Whirlpool -

The heating elements/burners and oven operated when tested. This does not confirm the efficiency of the system.

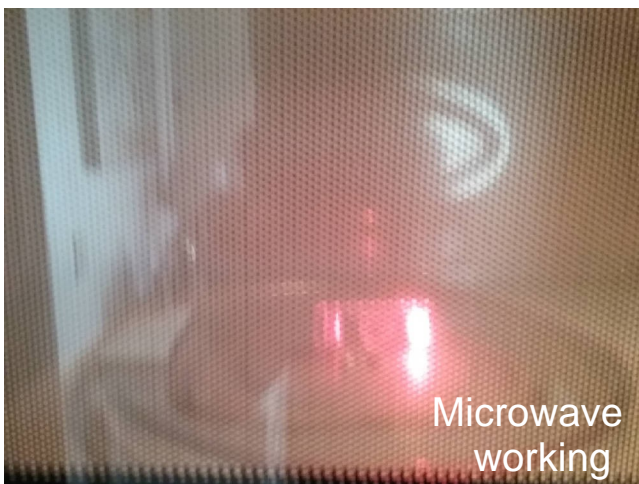
Microwave: Whirlpool -

The over range mounted microwave was installed securely, was tested and operational at time of inspection.

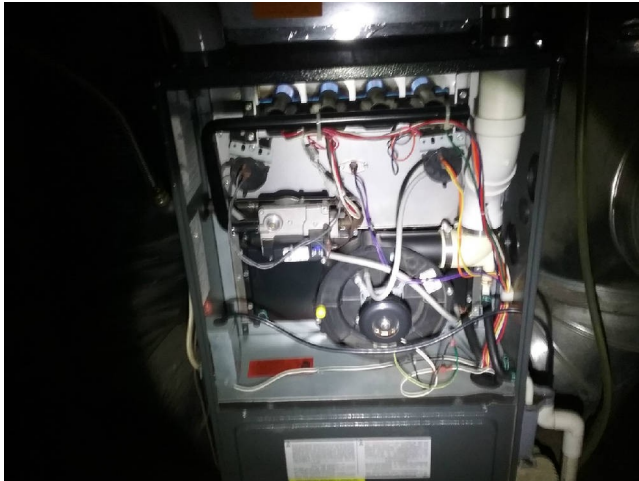
Heating System Operation: Adequate -

This unit was working properly at the time of the inspection. Mechanical equipment tested for functional operation at the time of inspection only. Inspection does not determine sizing of the system. The inspection covers only the visible components of the heating system. Hidden problems may exist that are not documented in this report. Annual maintenance will ensure the system is safe and is functioning properly. Servicing can also uncover problems not discovered or that are beyond the scope of home inspection standards. Inspection standards do not require me to verify if appliances need replacing, just that they are functioning.

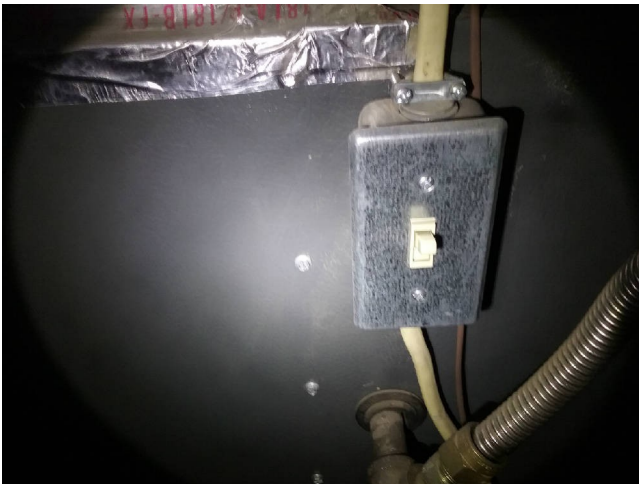
Emergency Shut Off: Yes -

See picture. Use this switch when doing any work on the furnace and when changing the furnace filter.

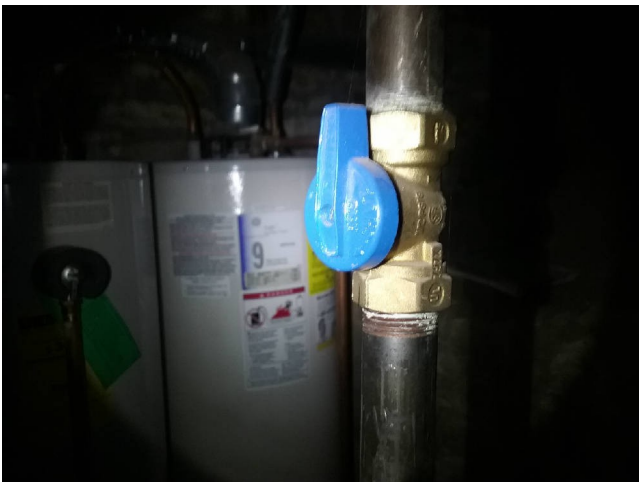
Gas Shut Off: Yes -

See picture. You can turn the handle a quarter turn to shut off the valve. When the handle is in line with the pipe it is on and when it is perpendicular with the pipe it is off.

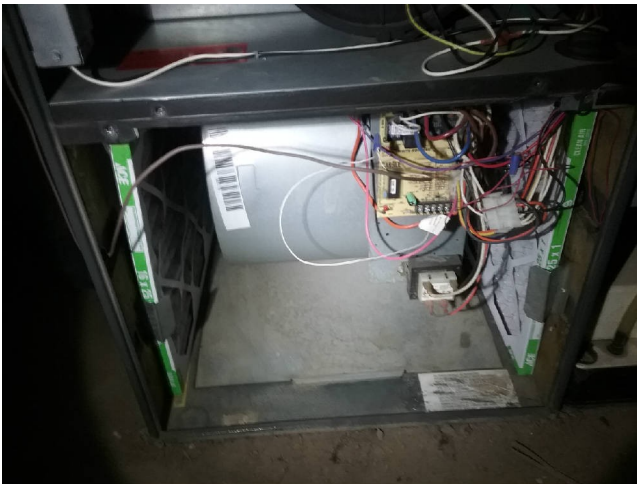
Furnace Filter: Fiberglass 16 X 25 -

The air filter(s) should be inspected at least monthly and cleaned or replaced as required. There are two types of filters commonly used: (1) Washable filters, (constructed of aluminum mesh, foam, or reinforced fibers) these may be cleaned by soaking in mild detergent and rinsing with water. Or (2) Fiberglass disposable filters that must be REPLACED before they become clogged. Remember that dirty filters are the most common cause of inadequate heating or cooling performance.

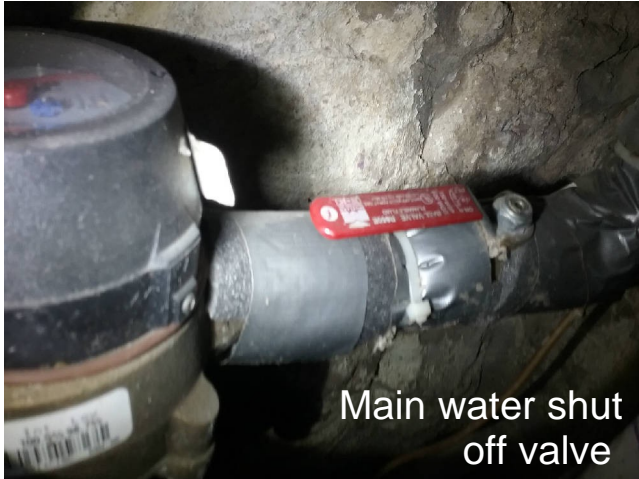
Main Water Shutoff: Basement -

See picture. You can use this valve in an emergency situation to quickly shut off water to the entire home.

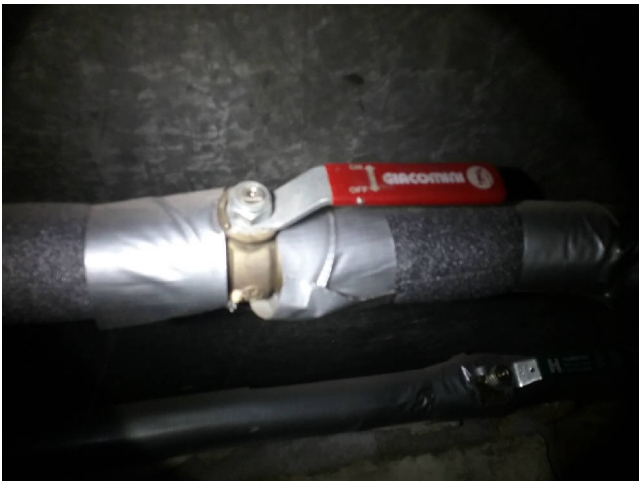
Cold Water Shut Off: Yes -

The photo shows the location of the shut-off valve for water at the water heater.. If the water heater ever starts leaking you can turn this valve off and turn the water off to the water heater and then call a plumber.

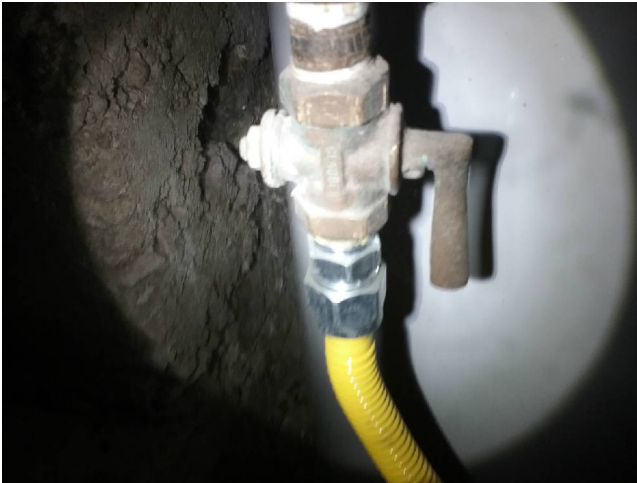
Gas Shut Off: Yes -

The photo shows the location of the shut-off valve for gas at the water heater. You can turn the handle a quarter turn to shut off the valve. When the handle is in line with the pipe it is on and when it is perpendicular with the pipe it is off.

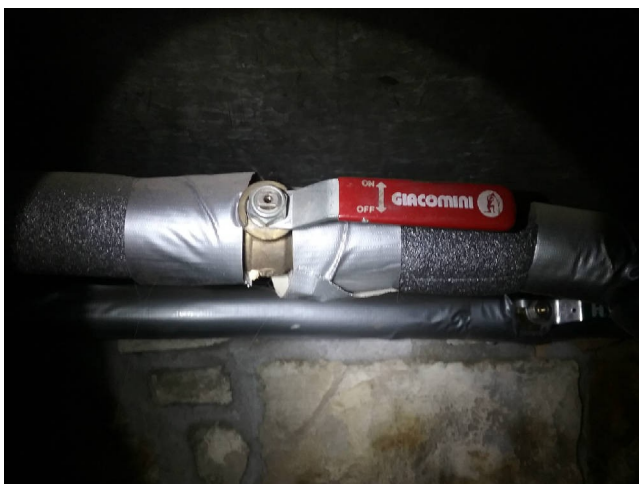
Cold Water Shut Off: Yes -

The photo shows the location of the shut-off valve for water at the water heater.. If the water heater ever starts leaking you can turn this valve off and turn the water off to the water heater and then call a plumber.

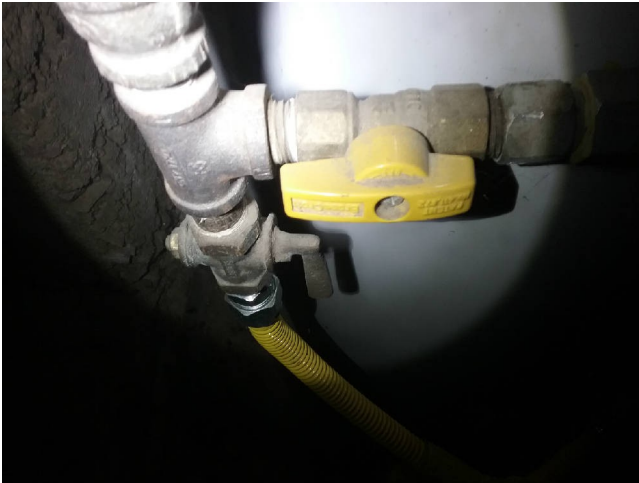
Gas Shut Off: Yes -

The photo shows the location of the shut-off valve for gas at the water heater. You can turn the handle a quarter turn to shut off the valve. When the handle is in line with the pipe it is on and when it is perpendicular with the pipe it is off.

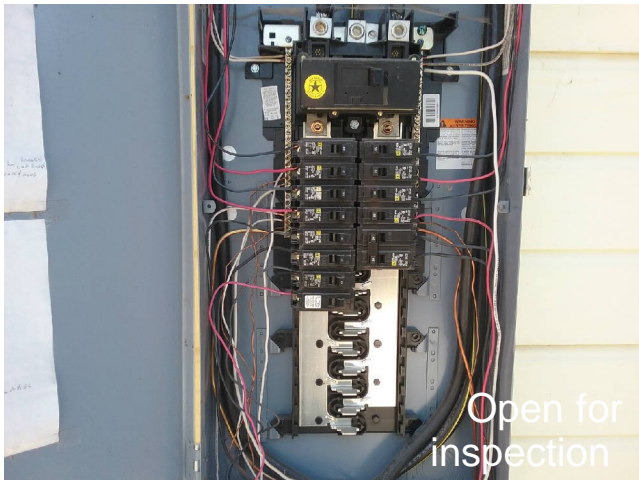
Manufacturer: Square D -

Circuit breakers in the main electrical service panel appeared to be in serviceable condition at the time of the inspection. Labeling of electric circuit locations on Main Electrical Panel are not checked for accuracy.

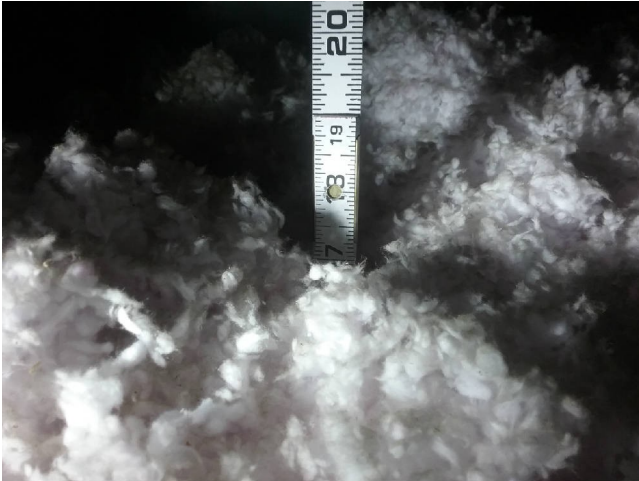
Insulation Depth: 18" -

The insulation levels were acceptable.
